Cross-ministerial Strategic Innovation Promotion Program (SIP) Phase Two/Automated Driving (Expansion of Systems and Services)/Infrastructure Preparation, Advance Verification, and Maintenance and Management for the Metropolitan Expressway Routes Connecting Haneda Airport and the Waterfront City Area, etc.

FY2019-2020 Report

Mitsubishi Electric Corporation

May 2021

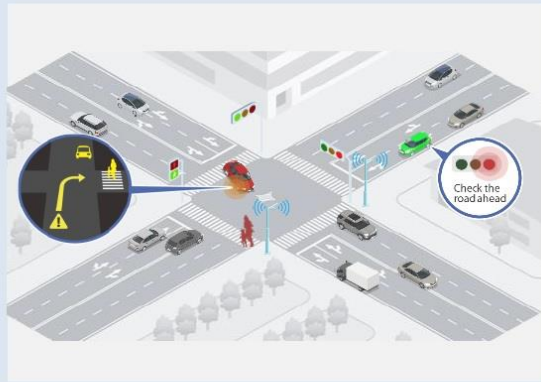
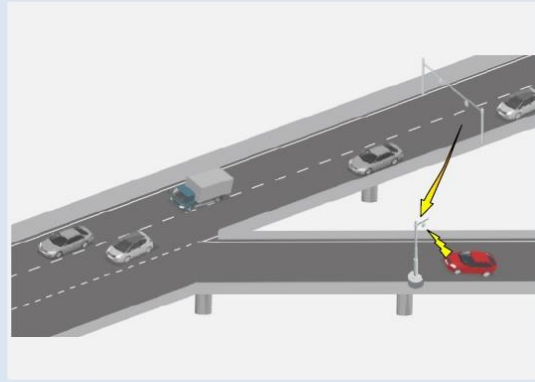
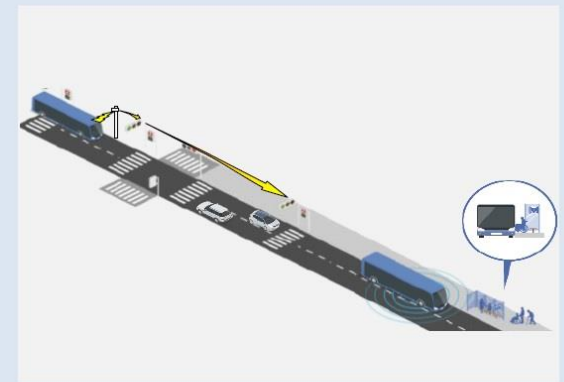
Figure 1-1 FOTs in the Tokyo Waterfront area - Overview of cooperative infrastructure technology FOTs (from Cabinet Office materials)

Advanced automated driving on ordinary roads through distribution of traffic signal information by ITS wireless roadside units

(1) Waterfront City area
(3) Haneda Airport area

Advanced automated driving on expressways through distribution of driving support information and lane-level roadway traffic environments

(2) Expressway routes connecting Haneda Airport and the Waterfront City area, etc.

Advanced Rapid Transit (ART) using bus automated driving technology in mixed transportation environments through the use of infrastructure equipment by setting ODDs, advanced PTPS, etc.

(3) Haneda Airport area

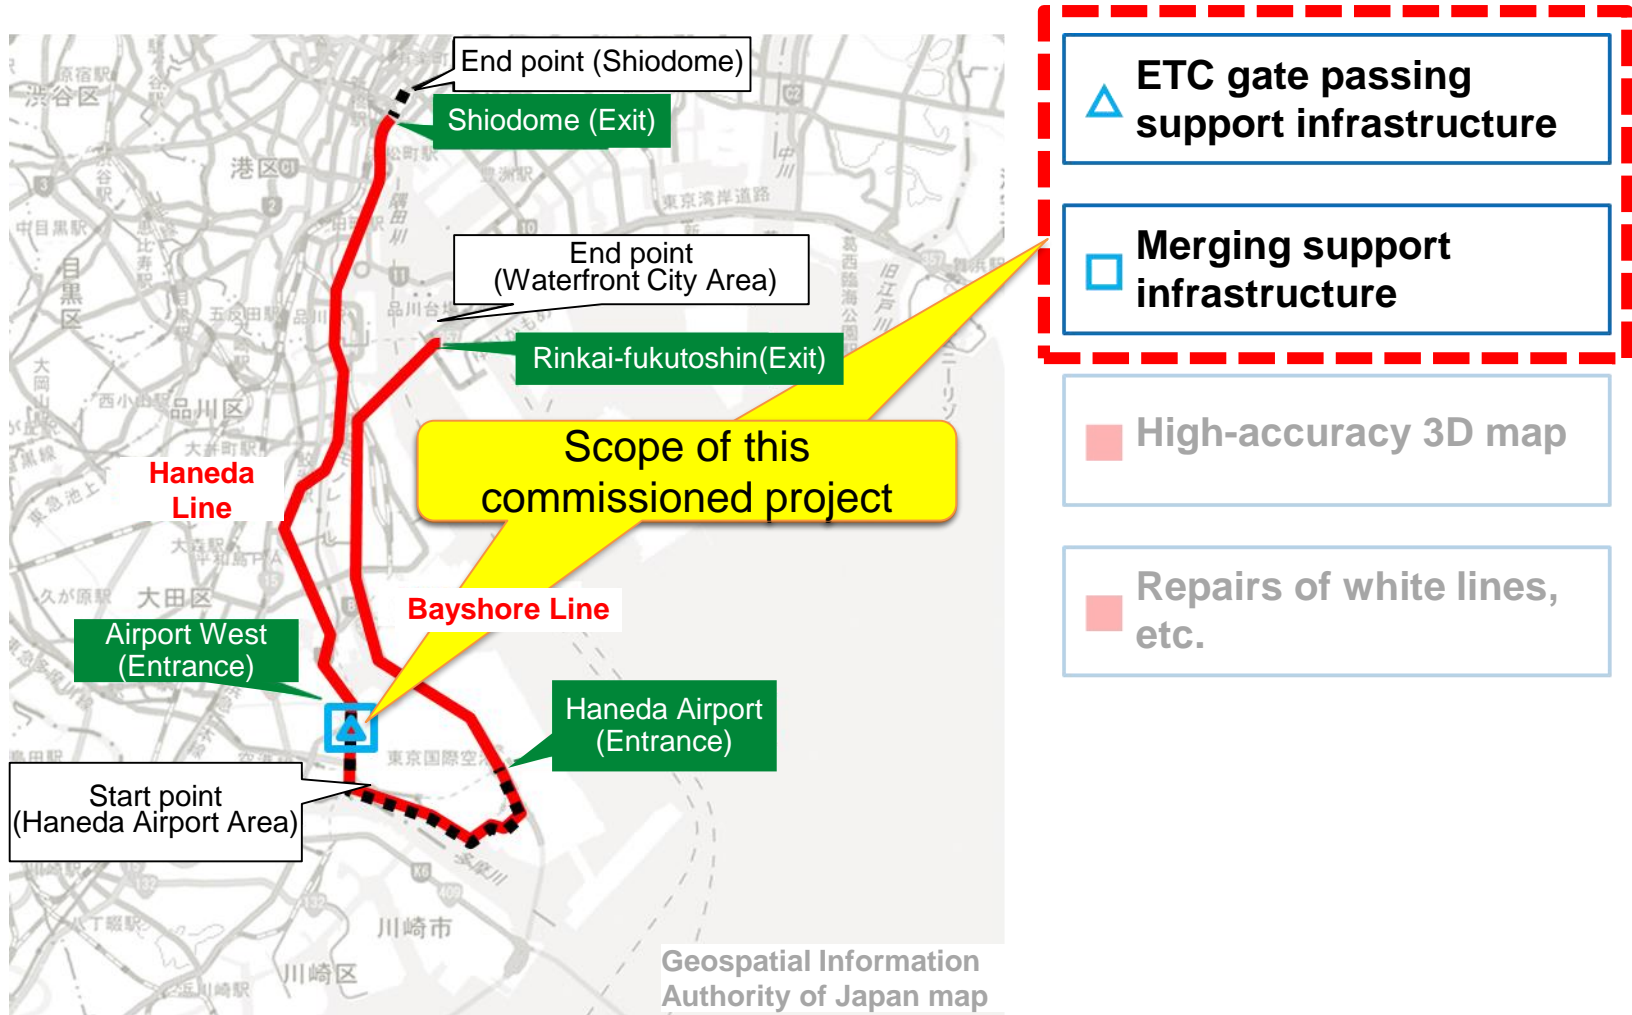
Figure 1-2 Metropolitan Expressway routes connecting Haneda Airport and the Waterfront City area, etc. - FOT area (from Cabinet Office materials)

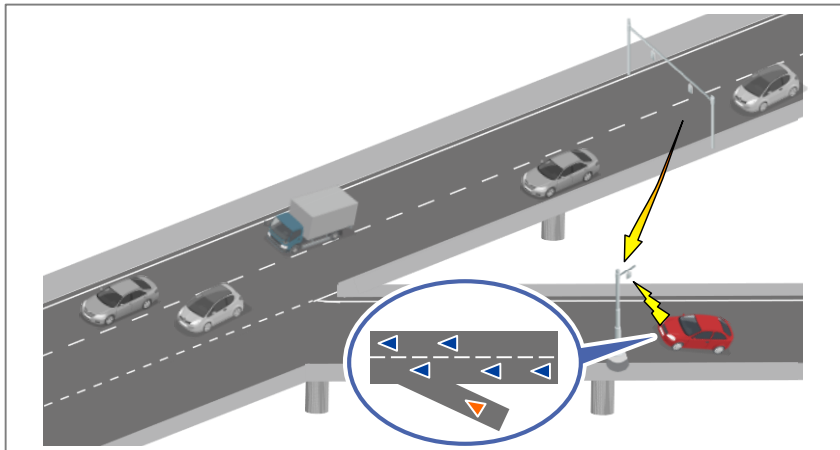
Figure 1-3 Conceptual image of merging support on expressways

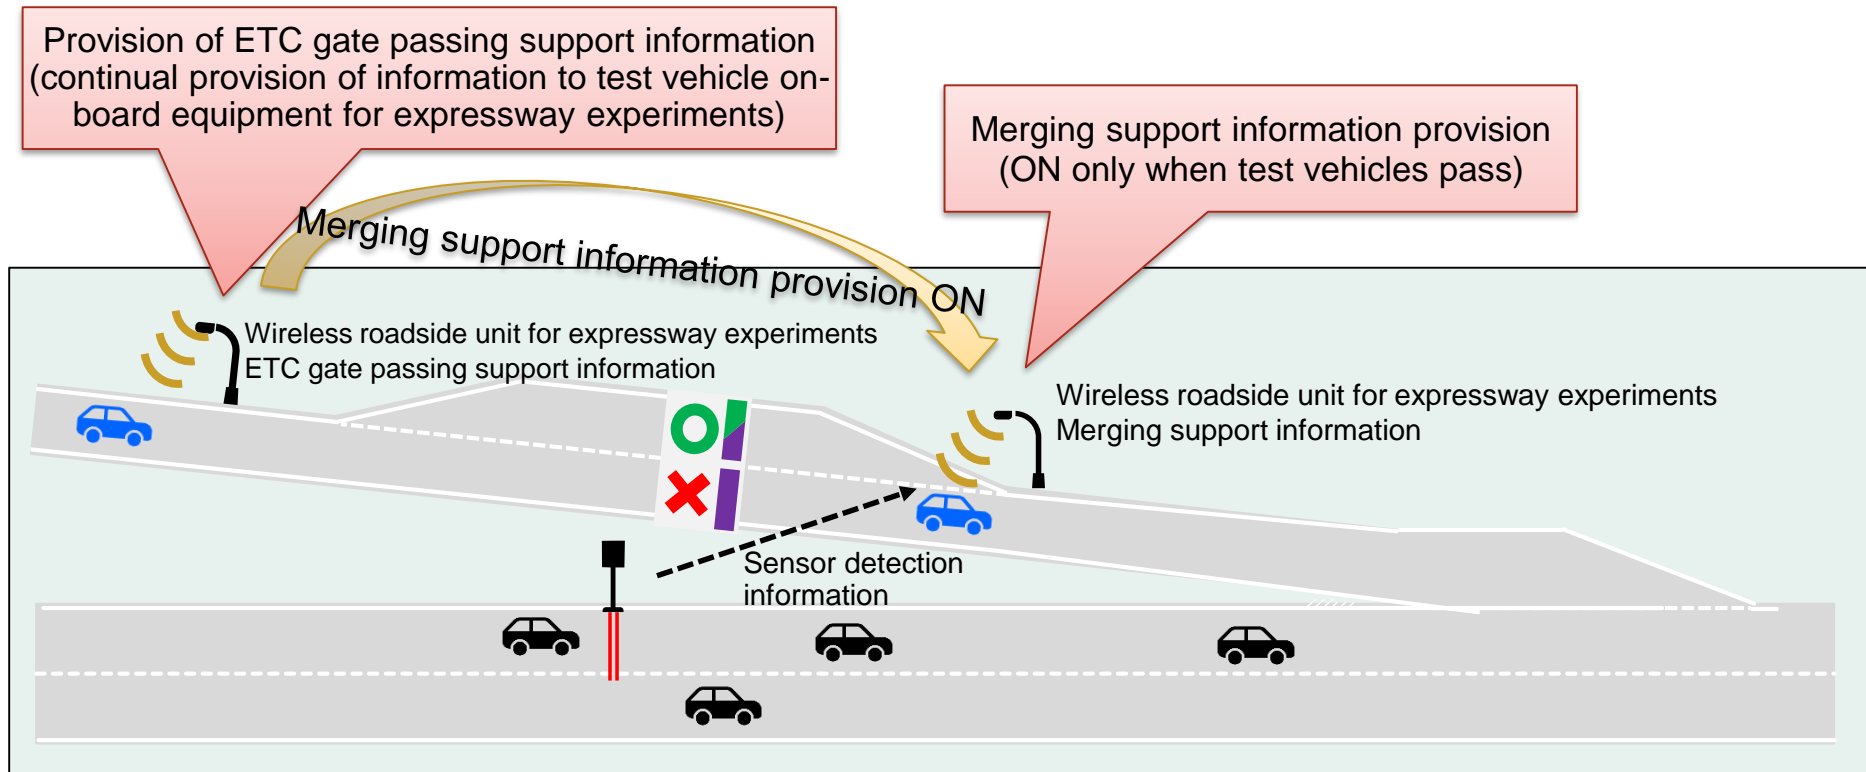
Wireless roadside units that send merging support information only transmit information when they detect that a test vehicle is passing. When they do not detect passing test vehicles, they turn off their radio signal output.

Figure 2-2 Conceptual image of system operation at the Metropolitan Expressway Airport West (Entrance)

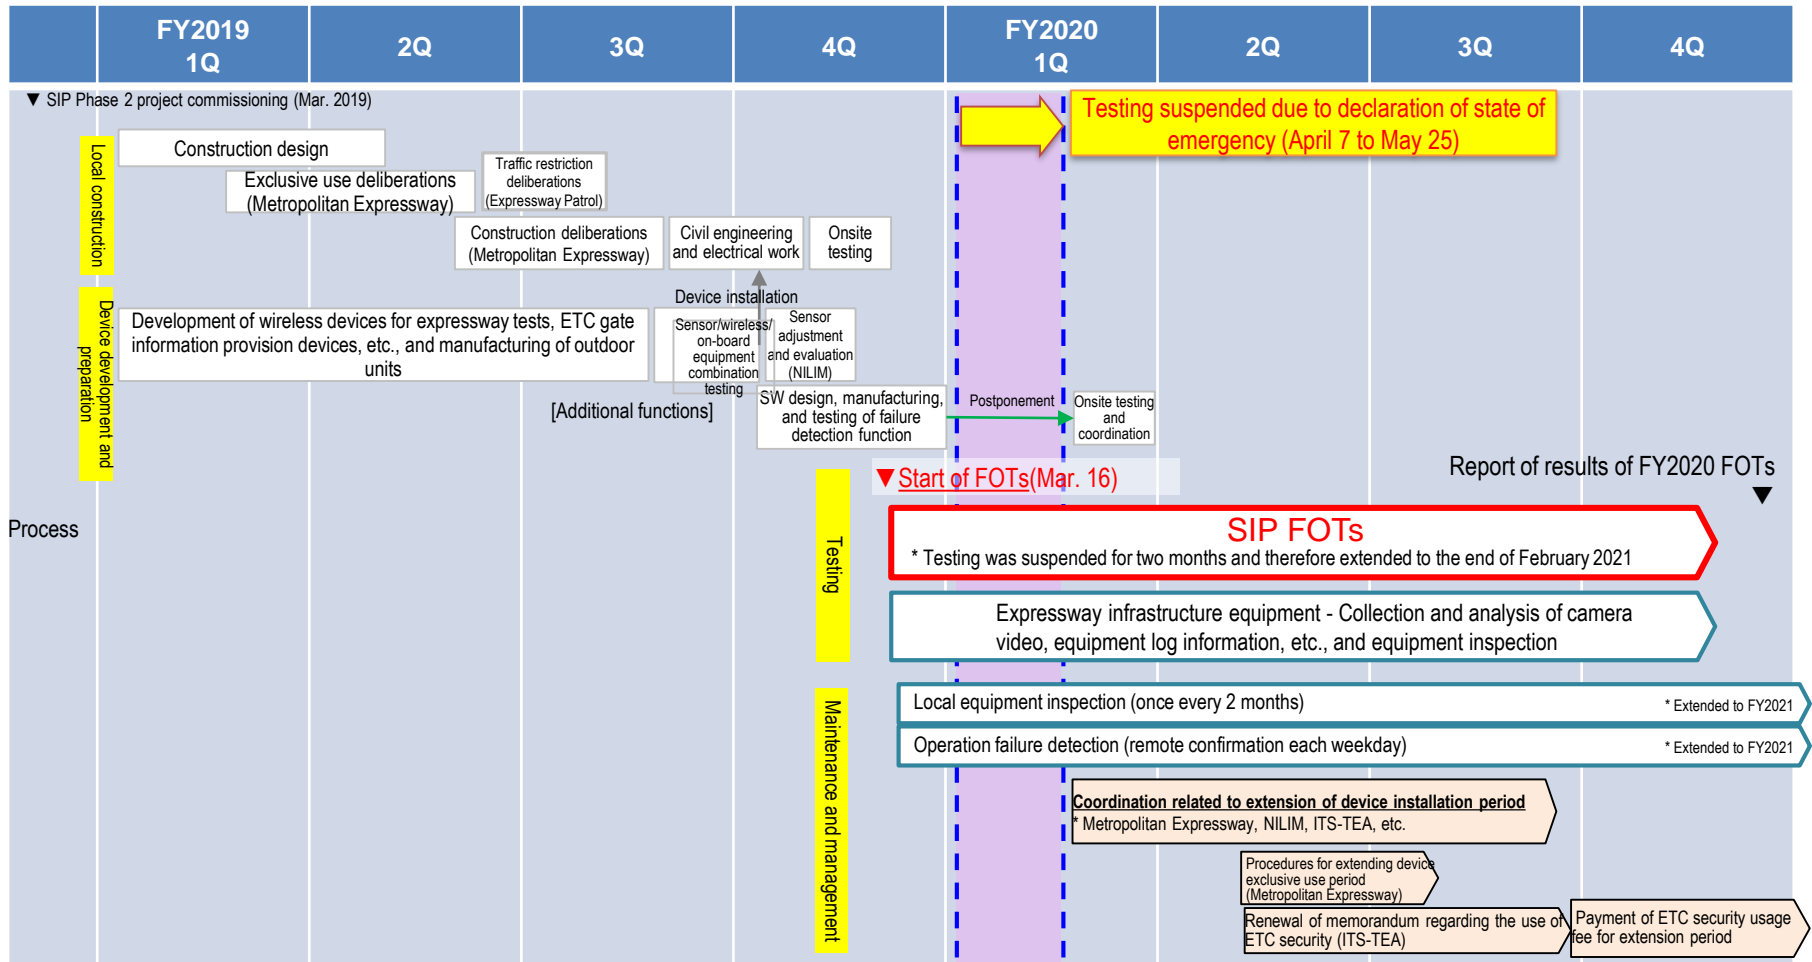
Consultation regarding exclusive use, civil engineering and electrical work, and the development of related devices involved in the installation of test infrastructure equipment on the Metropolitan Expressway have been completed according to schedule. Testing began on March 16, 2020.

The overall process for the two-year period of FY2019 and FY2020 is shown below.

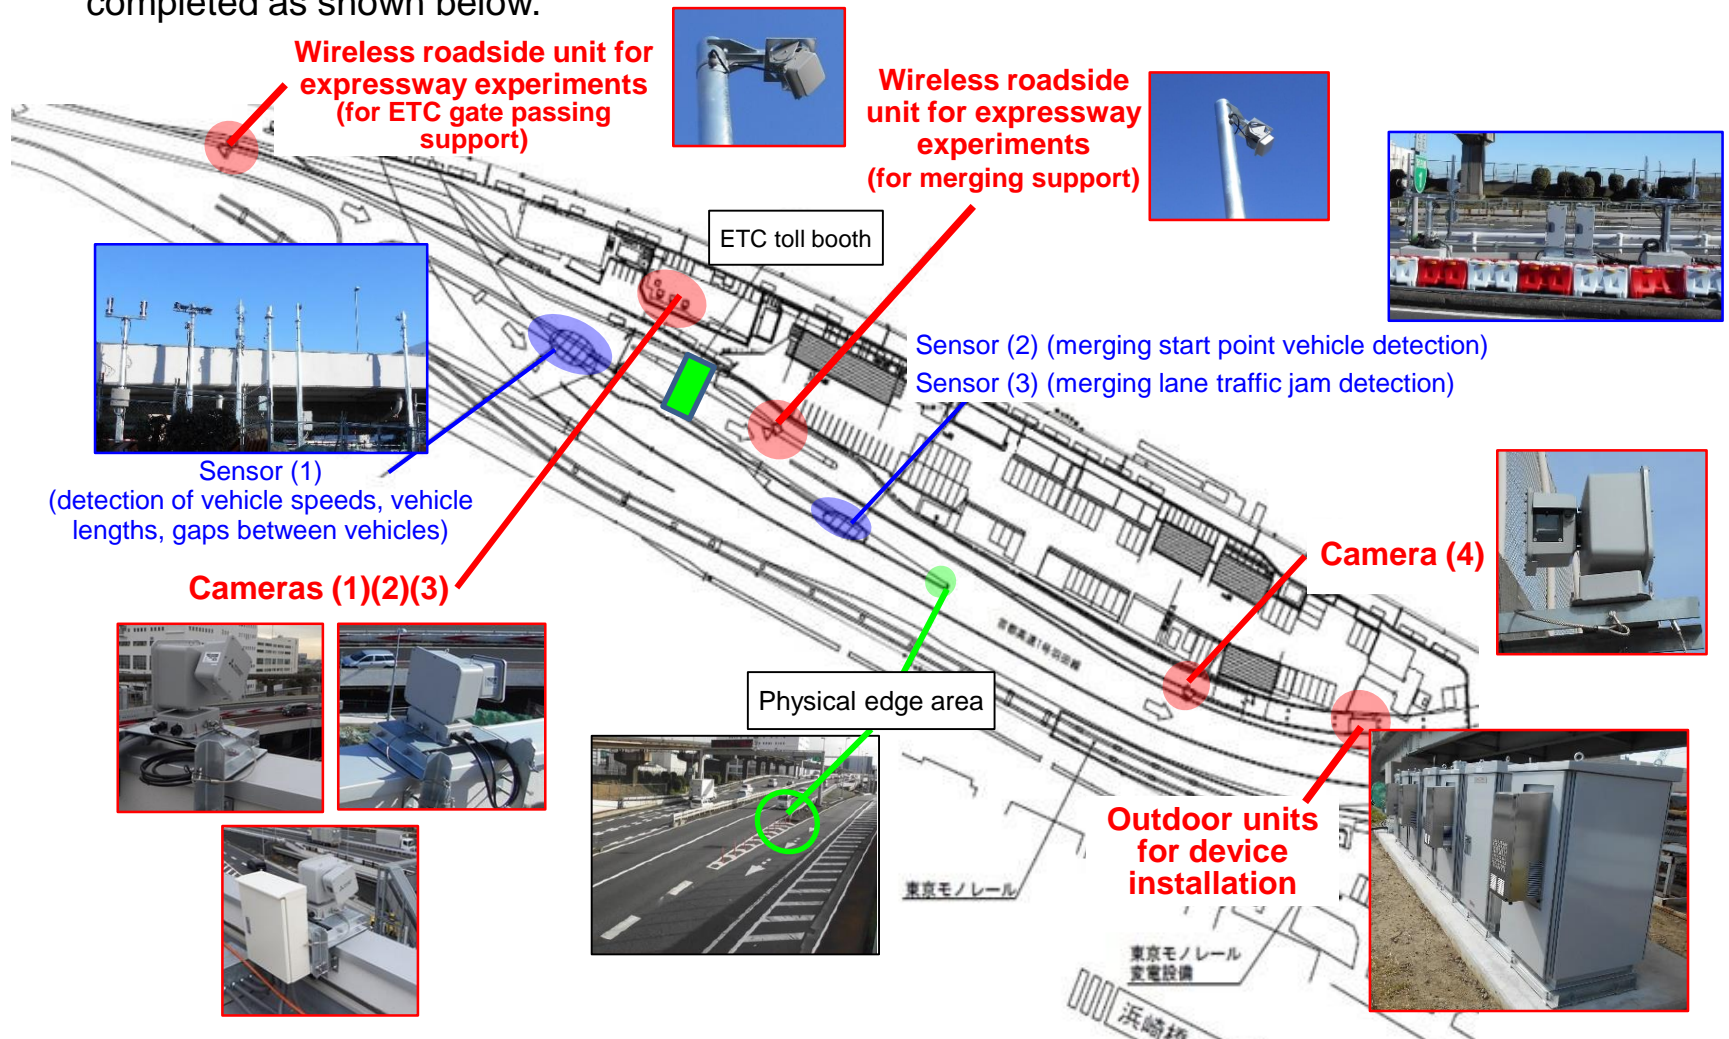
Installation of the equipment necessary for conducting FOTs at the Airport West (Entrance) was completed as shown below.

Figure 3-1 Overall view of locations of test equipment in and around the Metropolitan Expressway Airport West (Entrance)

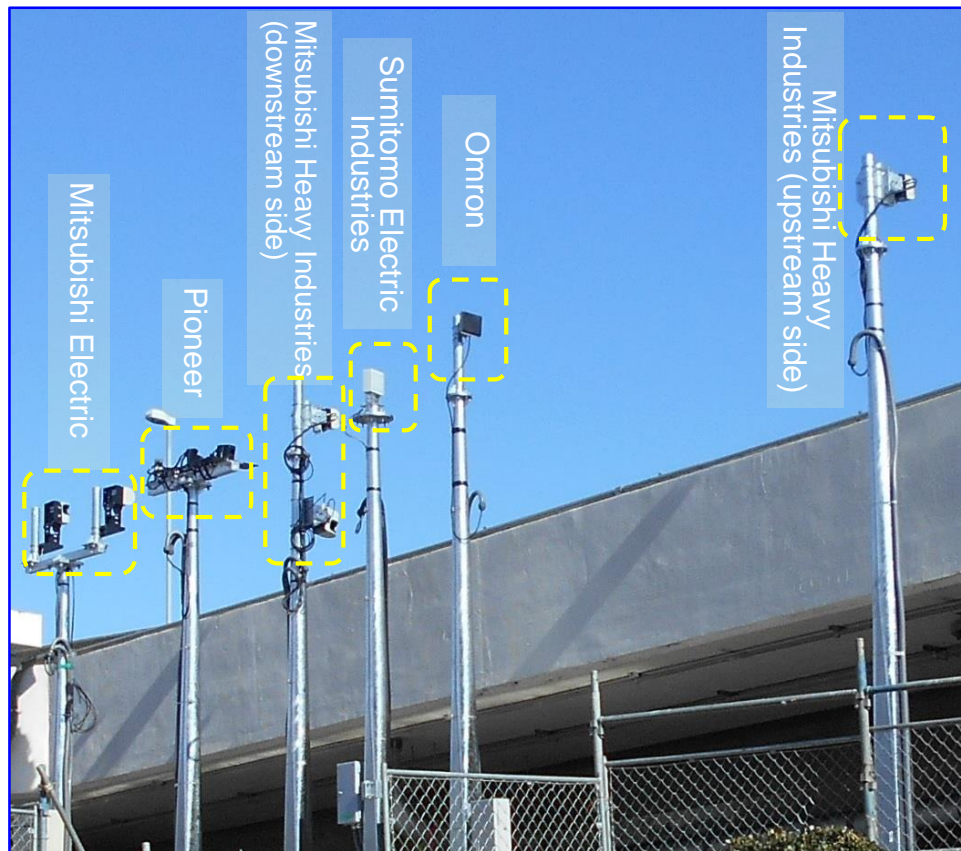
Figure 3-2 Sensor (1) installation (roadside sensors of five companies in NILIM joint research)

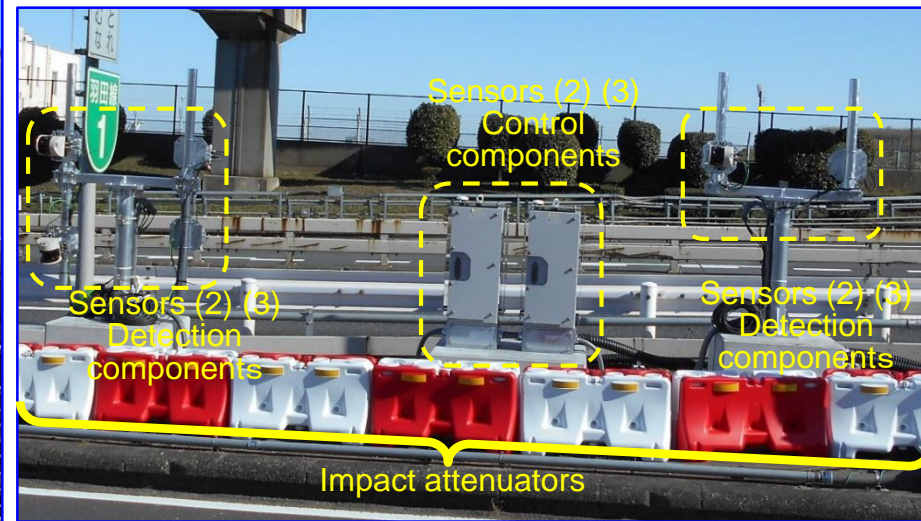
Figure 3-3 Sensors (2) (3) installation and appearance of impact attenuators

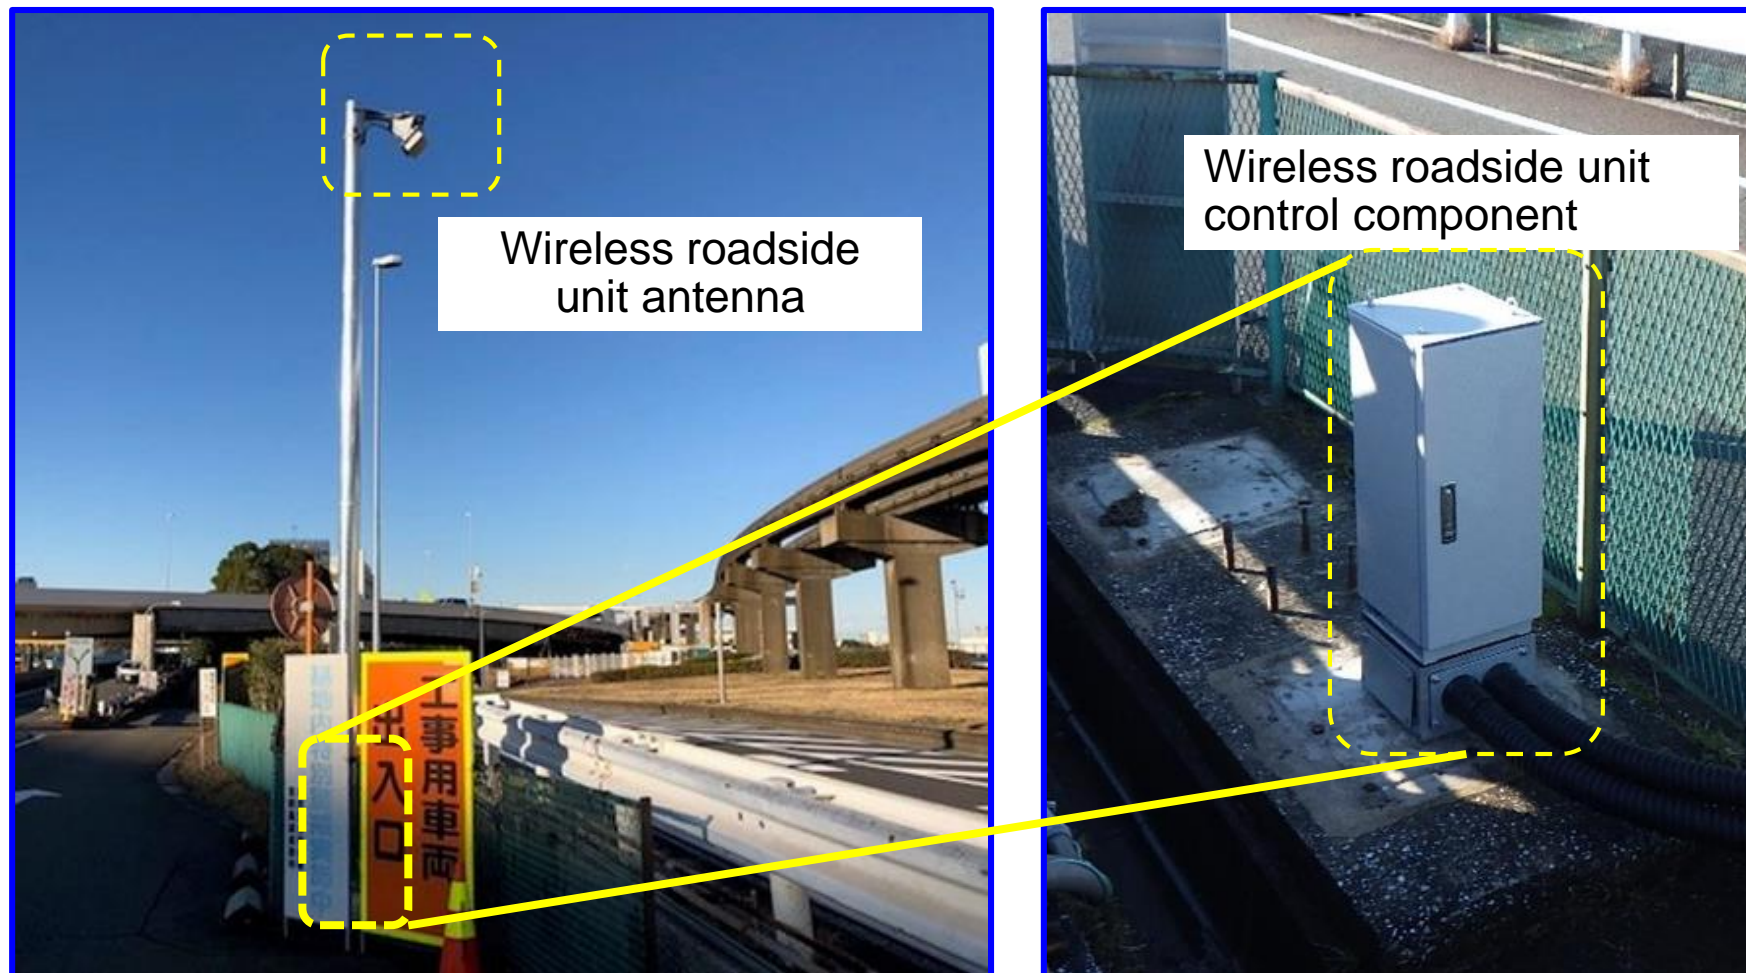
Figure 3-4 Wireless roadside unit for expressway experiments for providing ETC gate passing support information

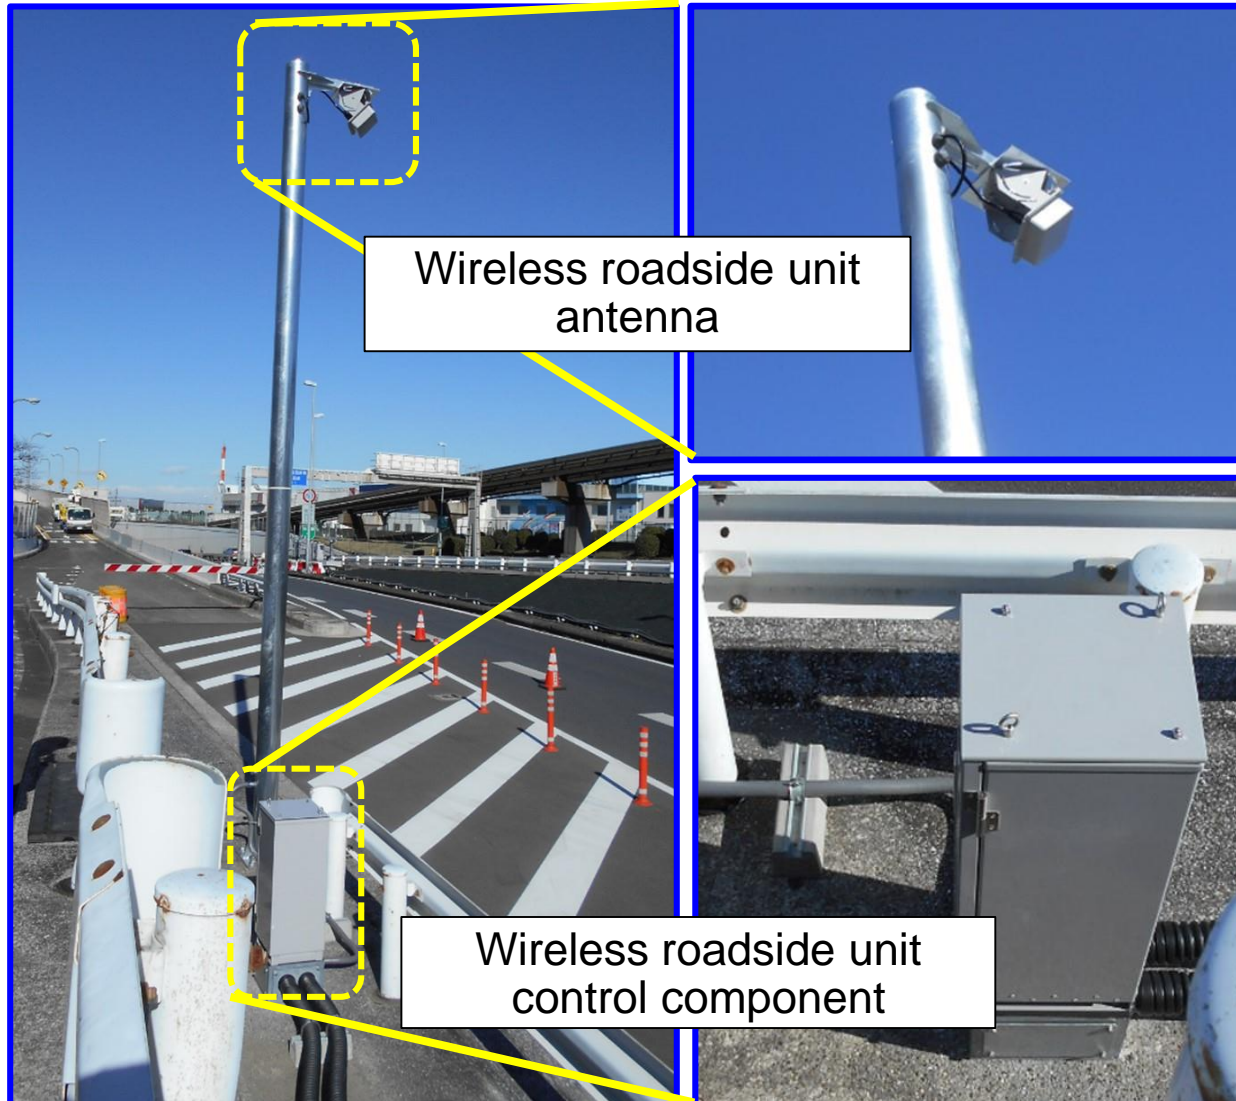
Figure 3-5 Wireless roadside unit for expressway experiments for providing merging support information

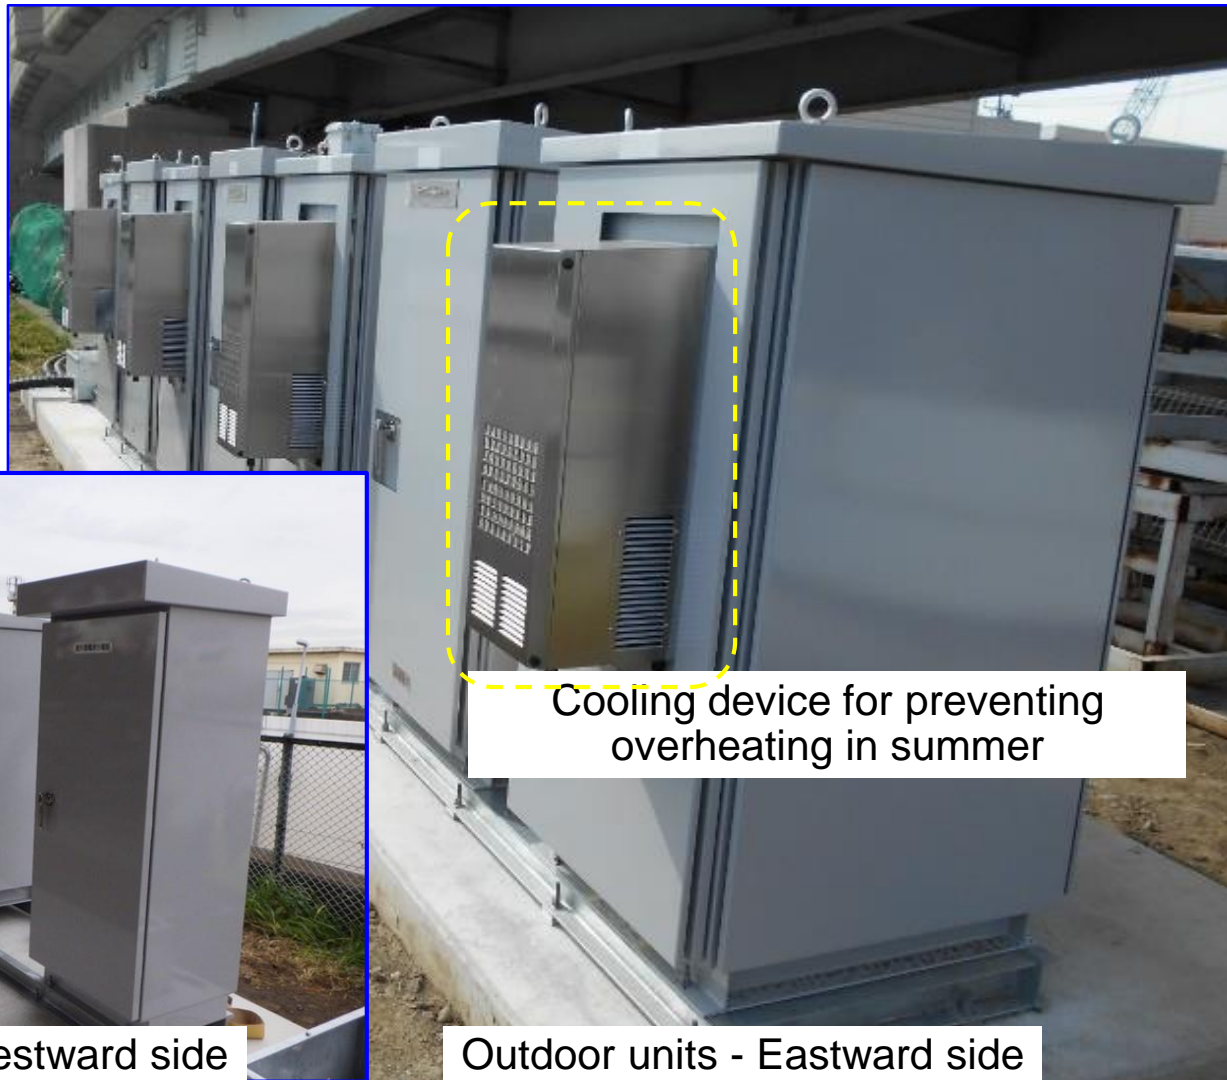
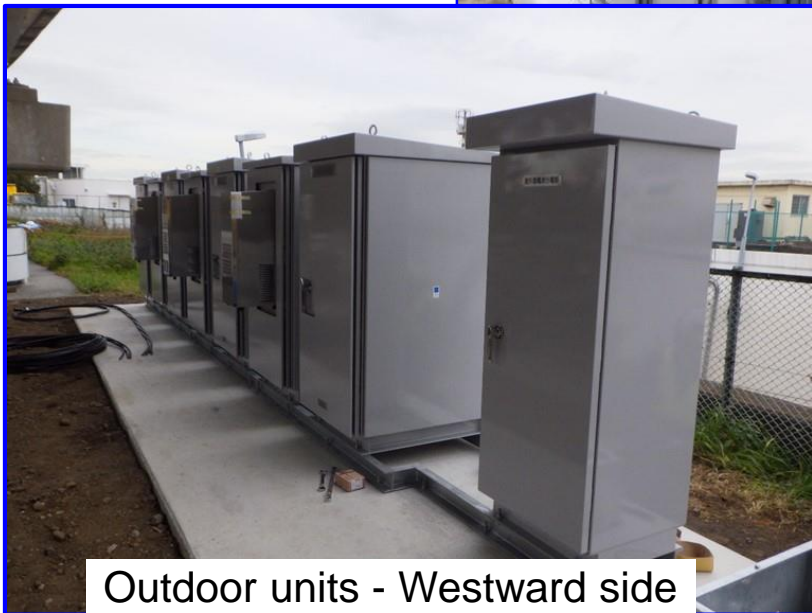
3.5. Individual infrastructure equipment: Outdoor units (containing information provision management servers and individual companies' processing roadside units)

Outdoor units - Westward side

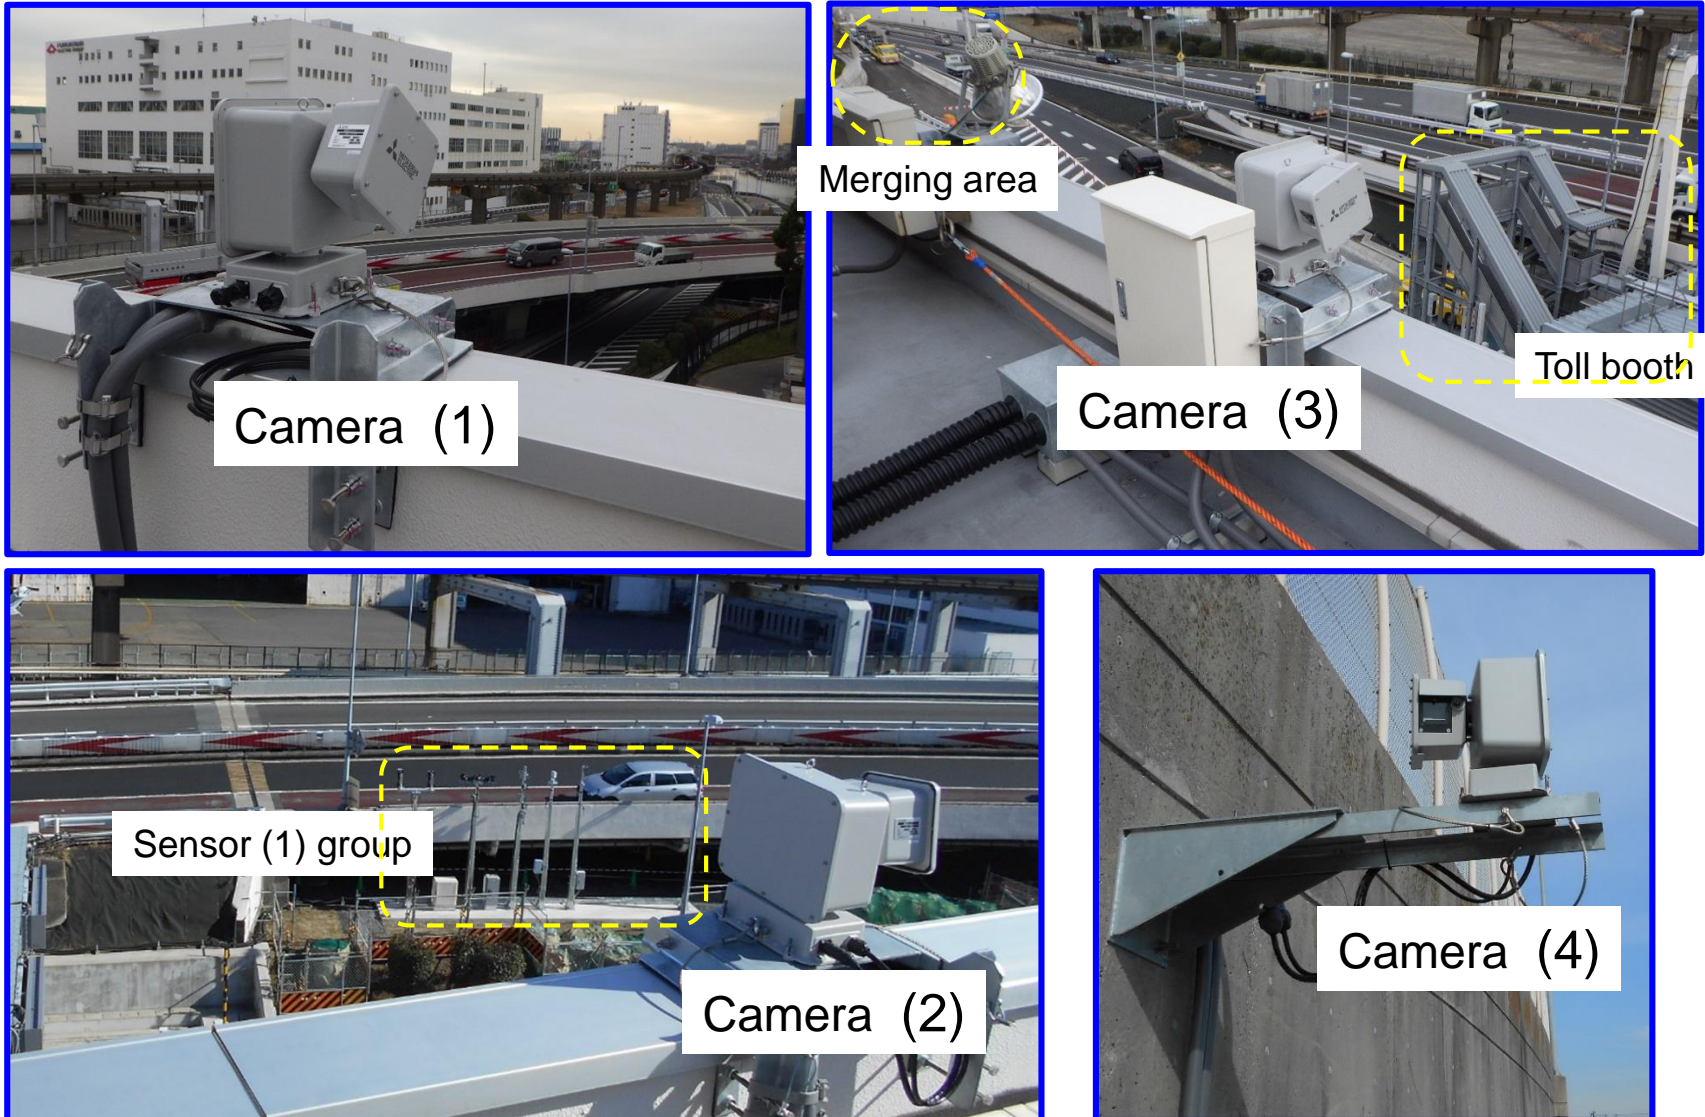
Figure 3-7 Cameras used to film traffic conditions on cruising lines and merging area

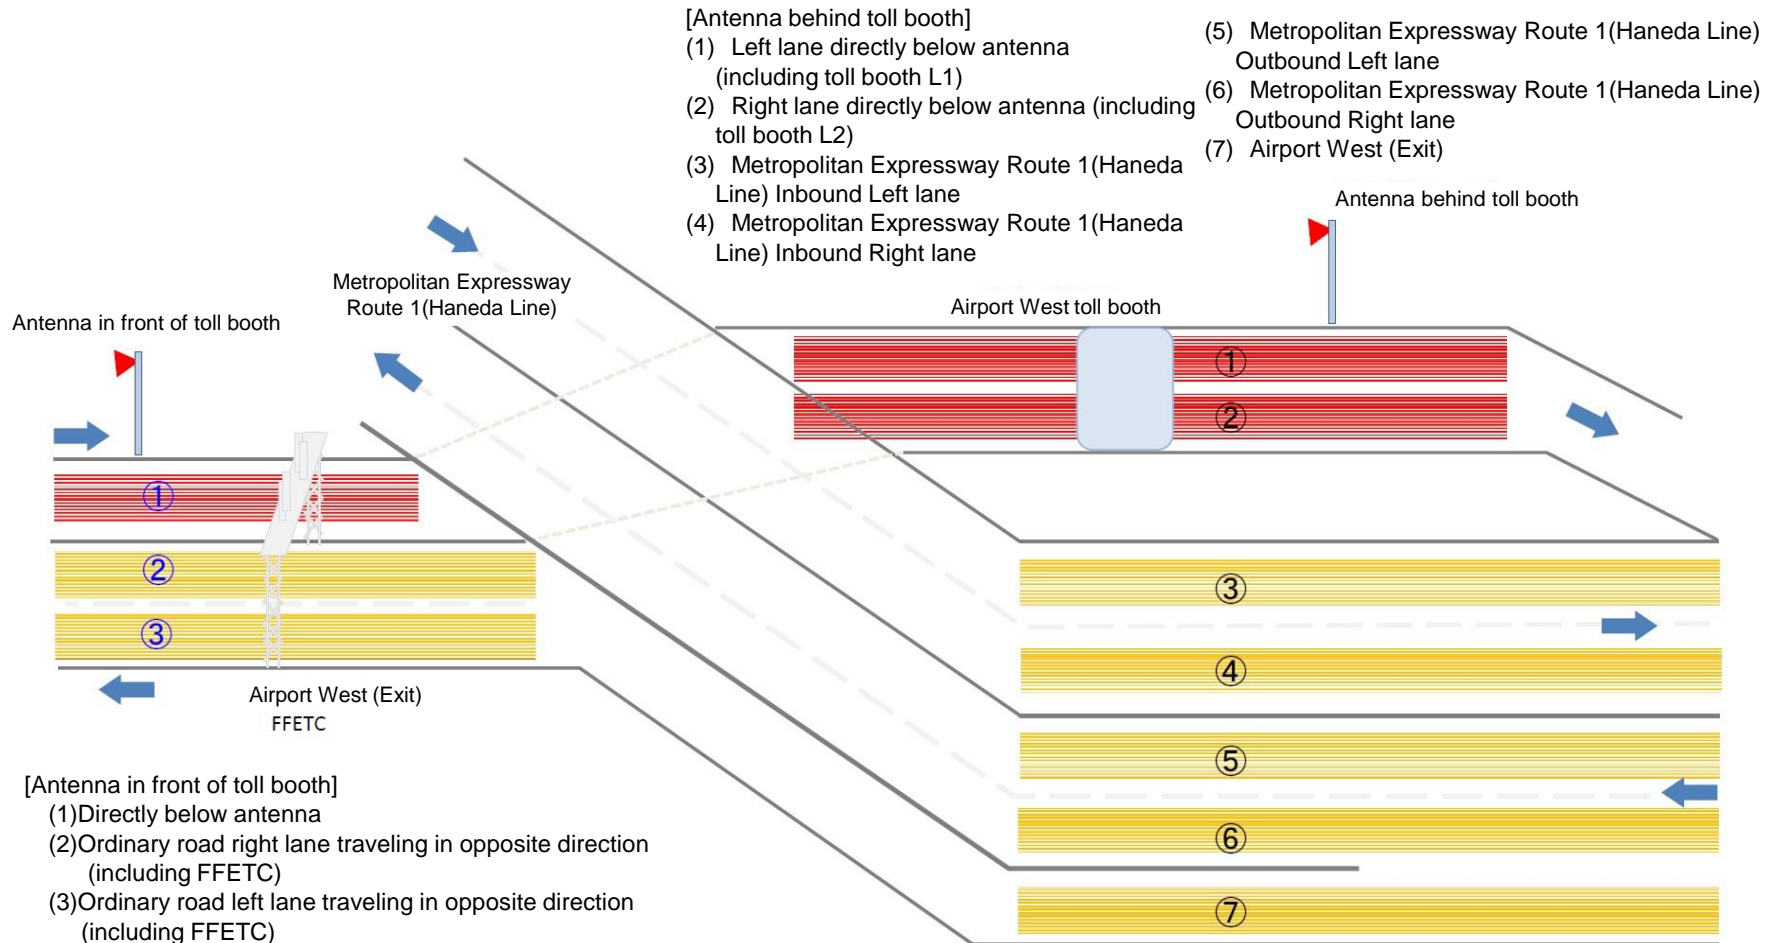
To confirm that radio signals sent out by installed test wireless roadside units do not affect existing expressway facilities, a third party (Shutoko ETC Maintenance Co., Ltd.) performed the following radio signal measurement drives.

Figure 3-8 Radio signal measurement lanes on the Metropolitan Expressway Airport West ramp

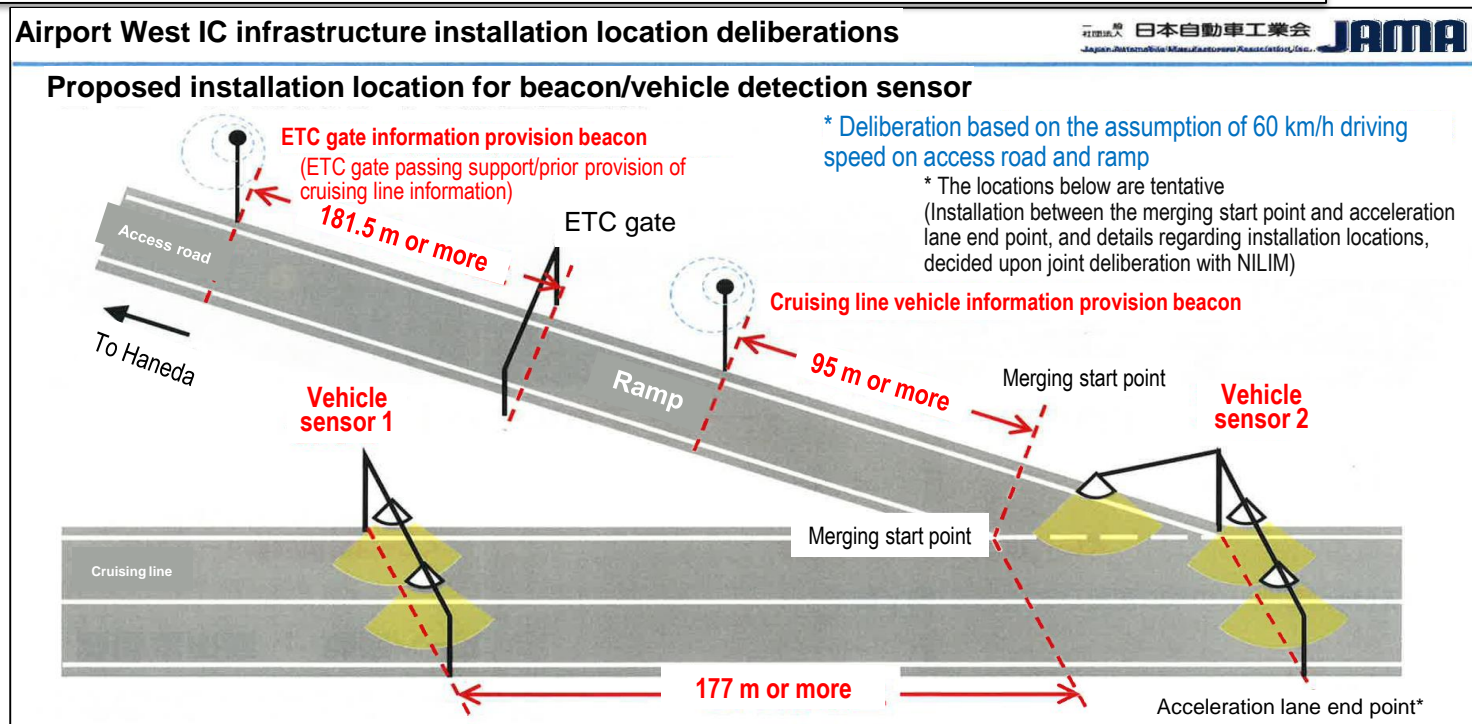
Location of Airport West ramp infrastructure equipment: Values requested by JAMA

Antenna and sensor location conditions requested by JAMA (Source: NILIM merging support system working group materials)

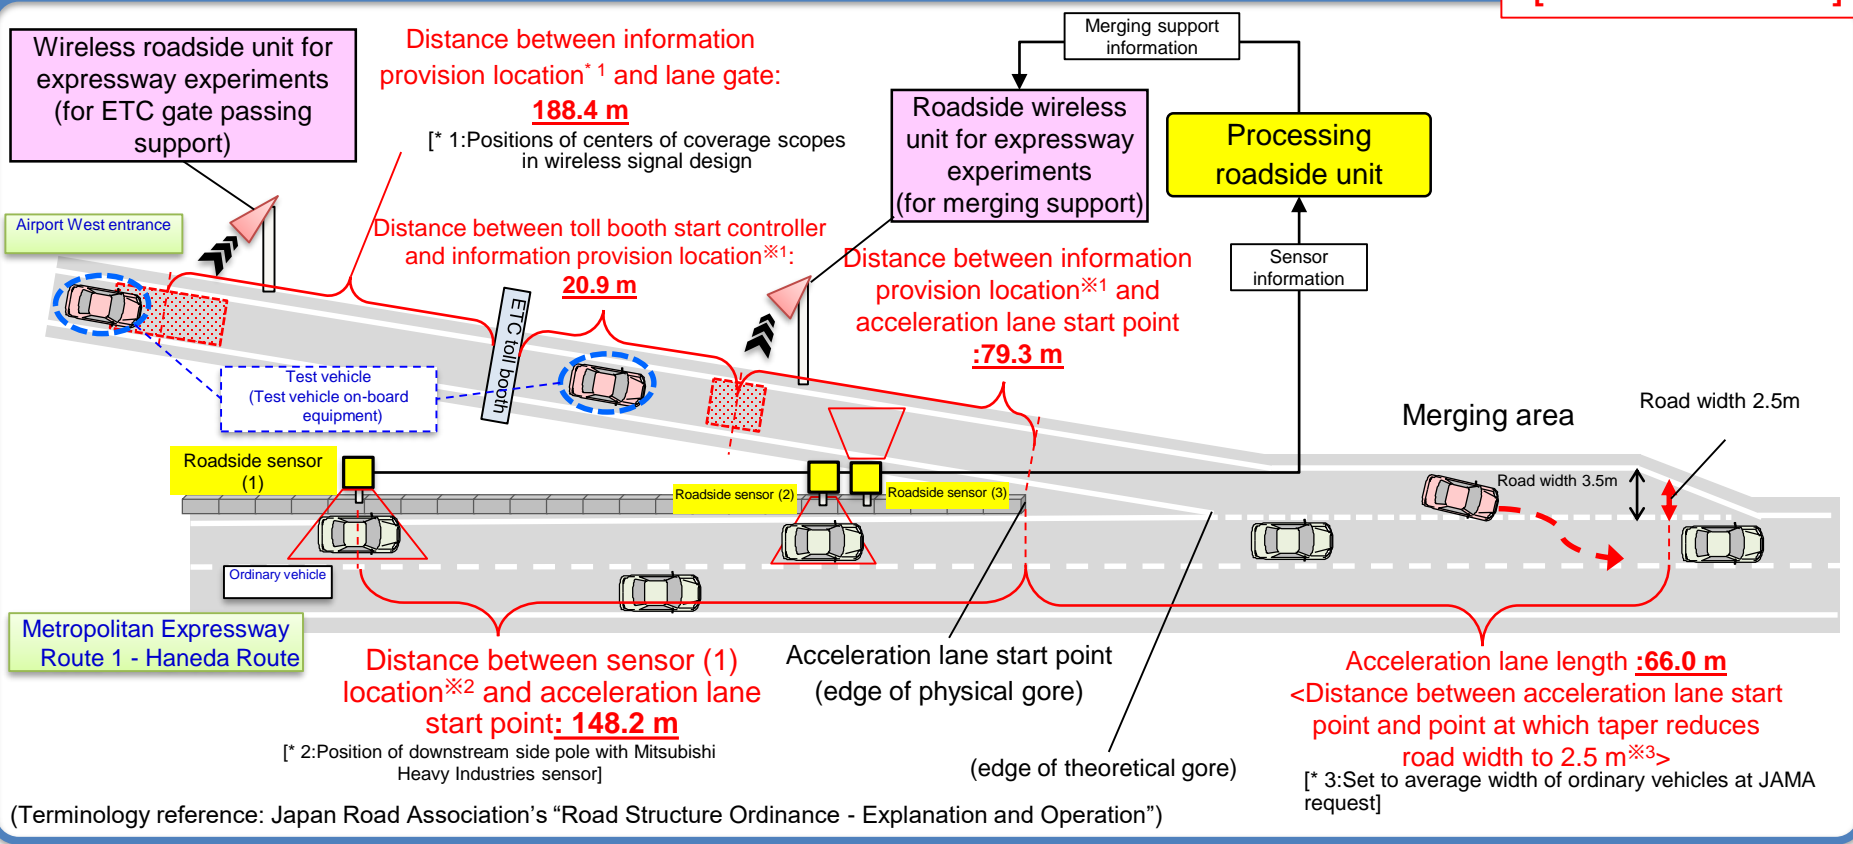
Locations of installed infrastructure equipment (distances between devices)

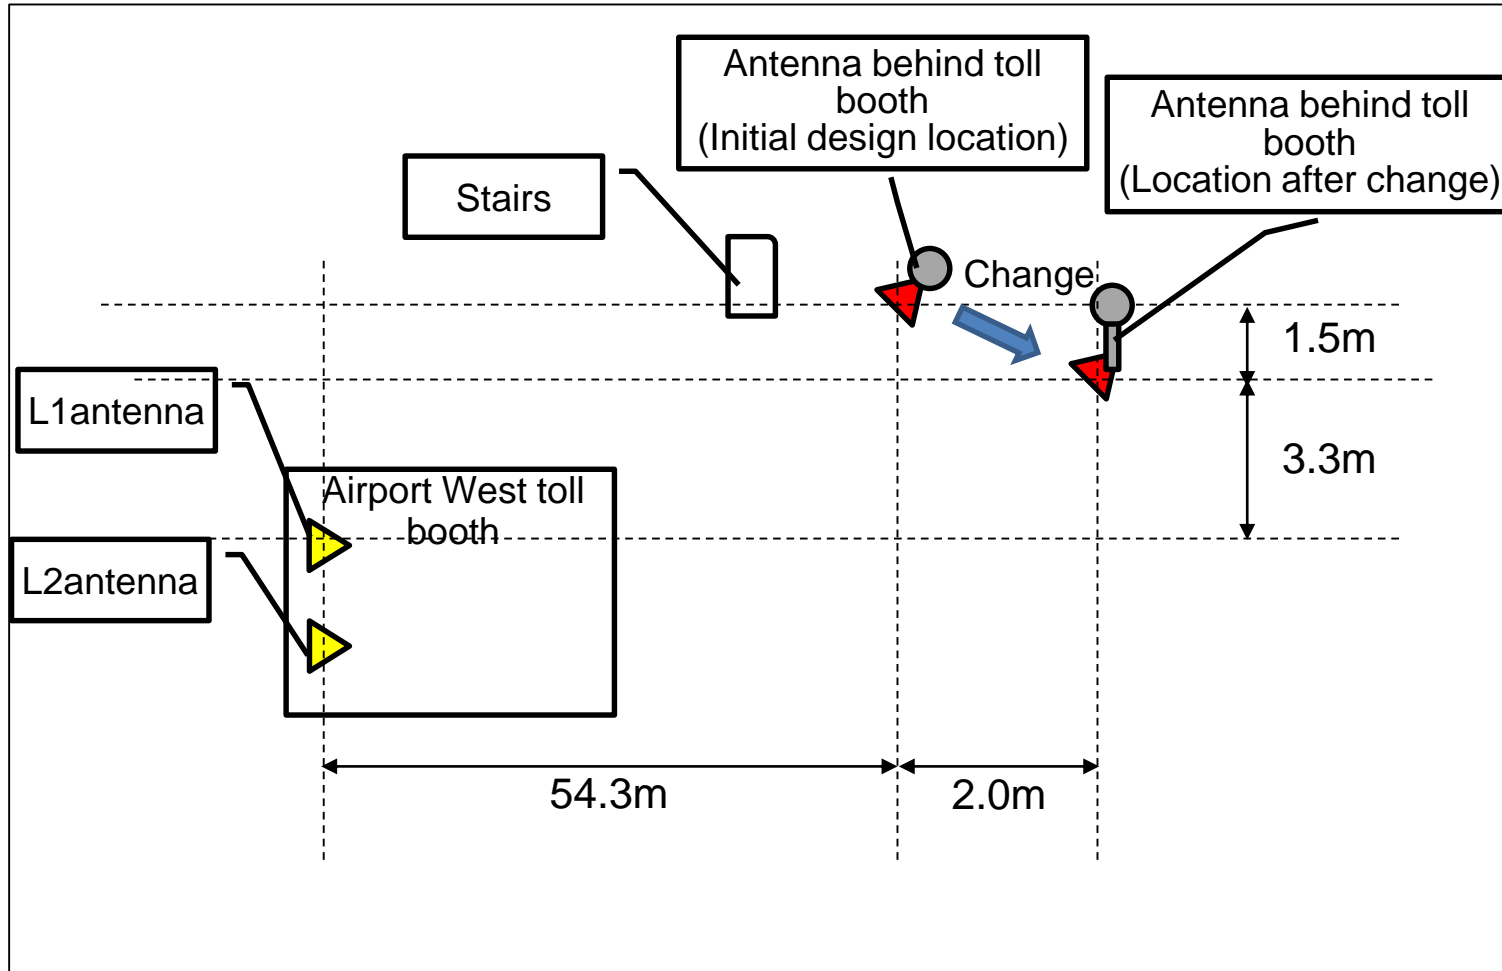
In order to minimize the risk of the radio signals emitted by the equipment causing communication errors affecting the Airport West ETC toll booth, the location of the antenna behind the ETC toll booth was changed as indicated below.

Diagram of location of antenna used to provide merging support information
