Cross-ministerial Strategic Innovation Promotion Program (SIP) Phase Two/Automated Driving (Expansion of Systems and Services)/Infrastructure Preparation, Advance Verification, and Maintenance and Management for the Metropolitan Expressway Routes Connecting Haneda Airport and the Waterfront City Area, etc.

FY2019-2020 Report

Mitsubishi Electric Corporation

May 2021

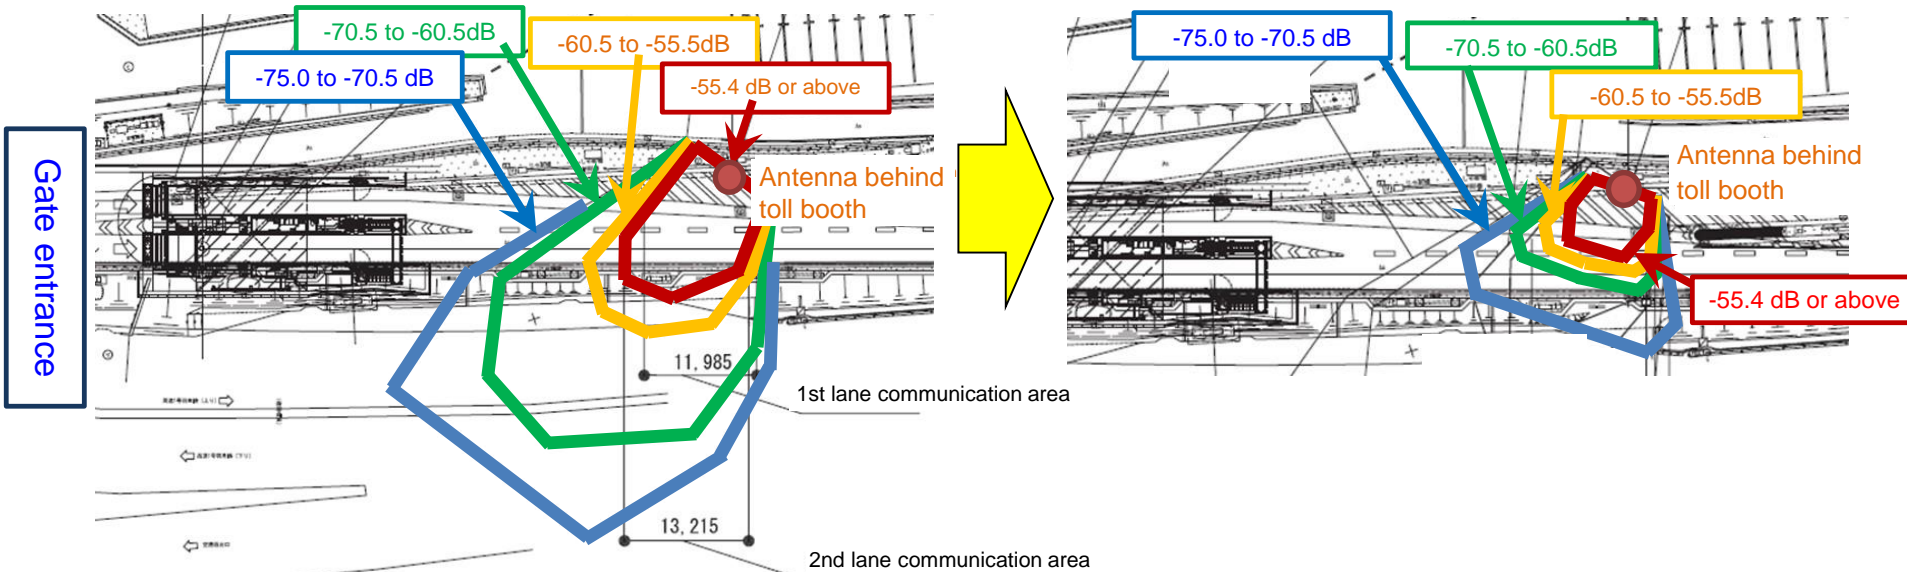
When installing the antenna behind the toll booth, consideration was given to both having a powerful enough radio signal on the lanes on which test driving is performed and avoiding radio interference with existing Metropolitan Expressway equipment such as ETC toll booth equipment, and the radio transmission range was designed accordingly. After local measurements were performed, the radio range was finalized.

Radio signal strength at antenna behind toll booth (design values)

Radio signal strength at antenna behind toll booth (actual measurement values: schematic diagram)

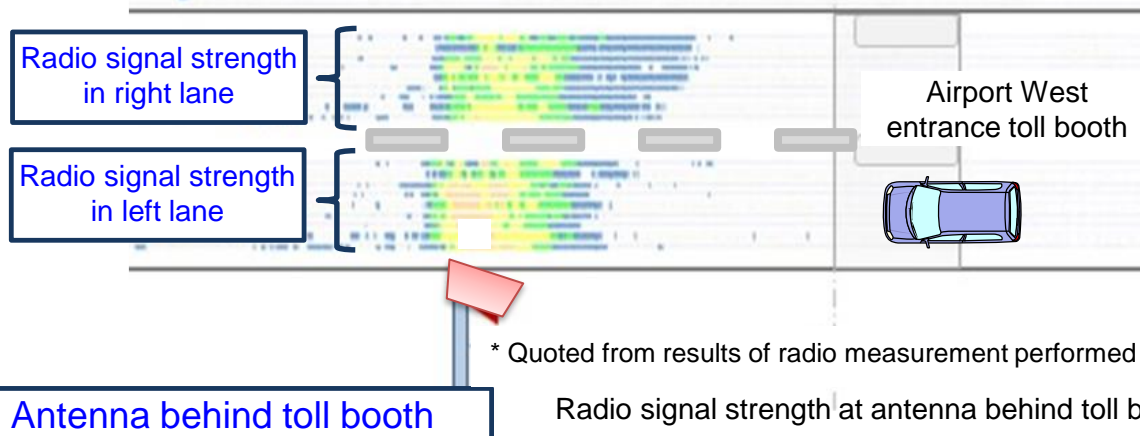
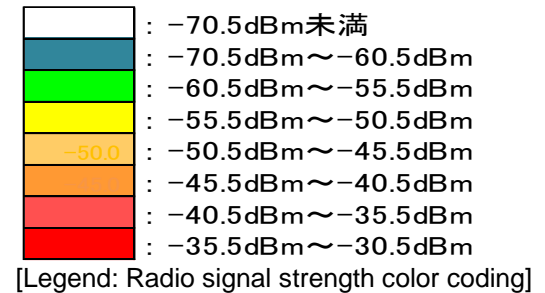
* Quoted from results of radio measurement performed by the Metropolitan Expressway

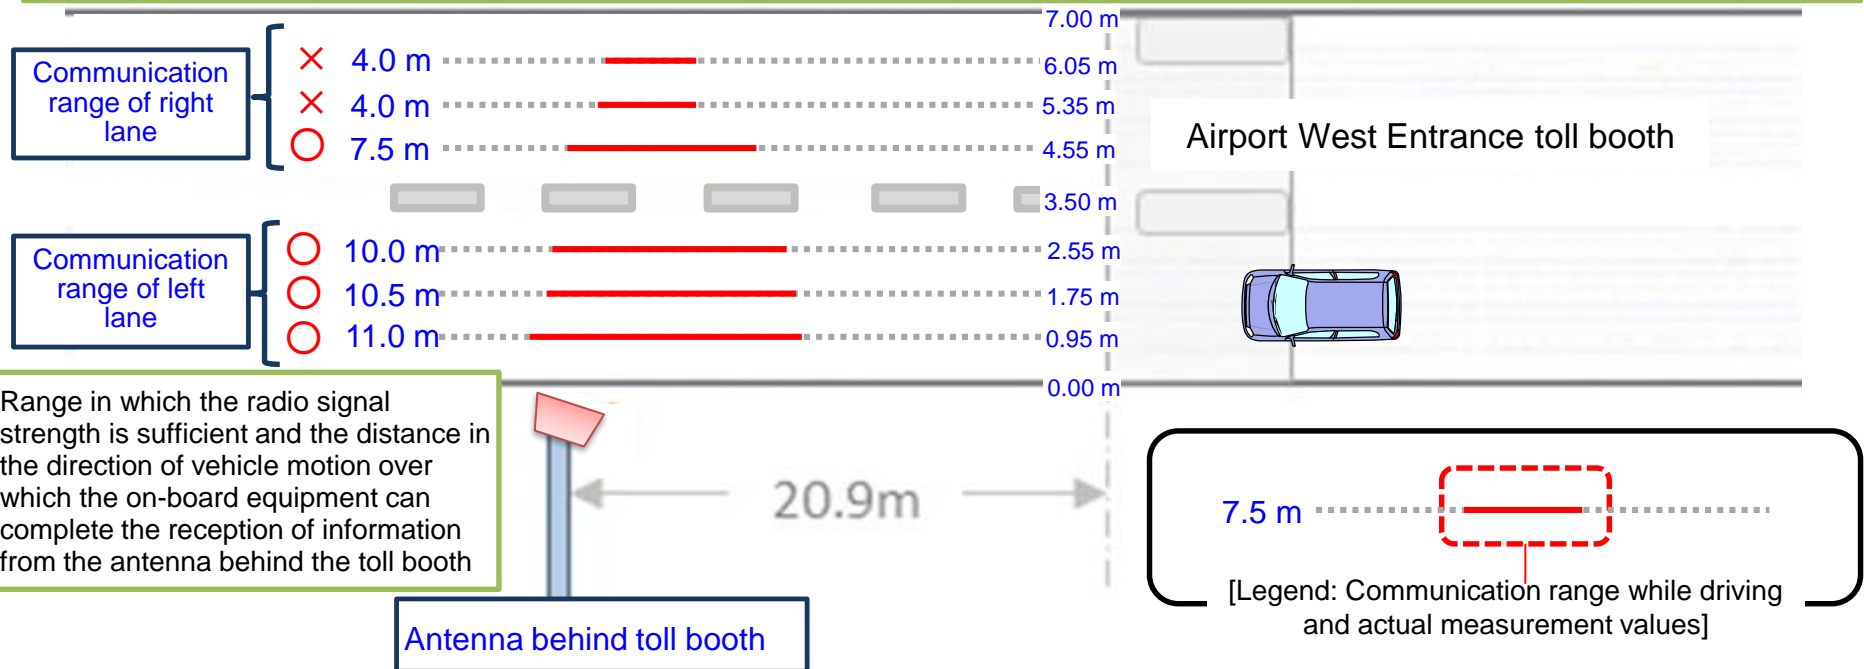
In the right lane, when passing the antenna at a speed of 30 to 39 km/h, the area in which radio signal strength and distance are sufficient for communications was confirmed to be within 1 m to 1.5 m of the center line.

Fig. Antenna behind toll booth - Range of possible communication range by location in lane [for envisioned speed of 30 km/h]

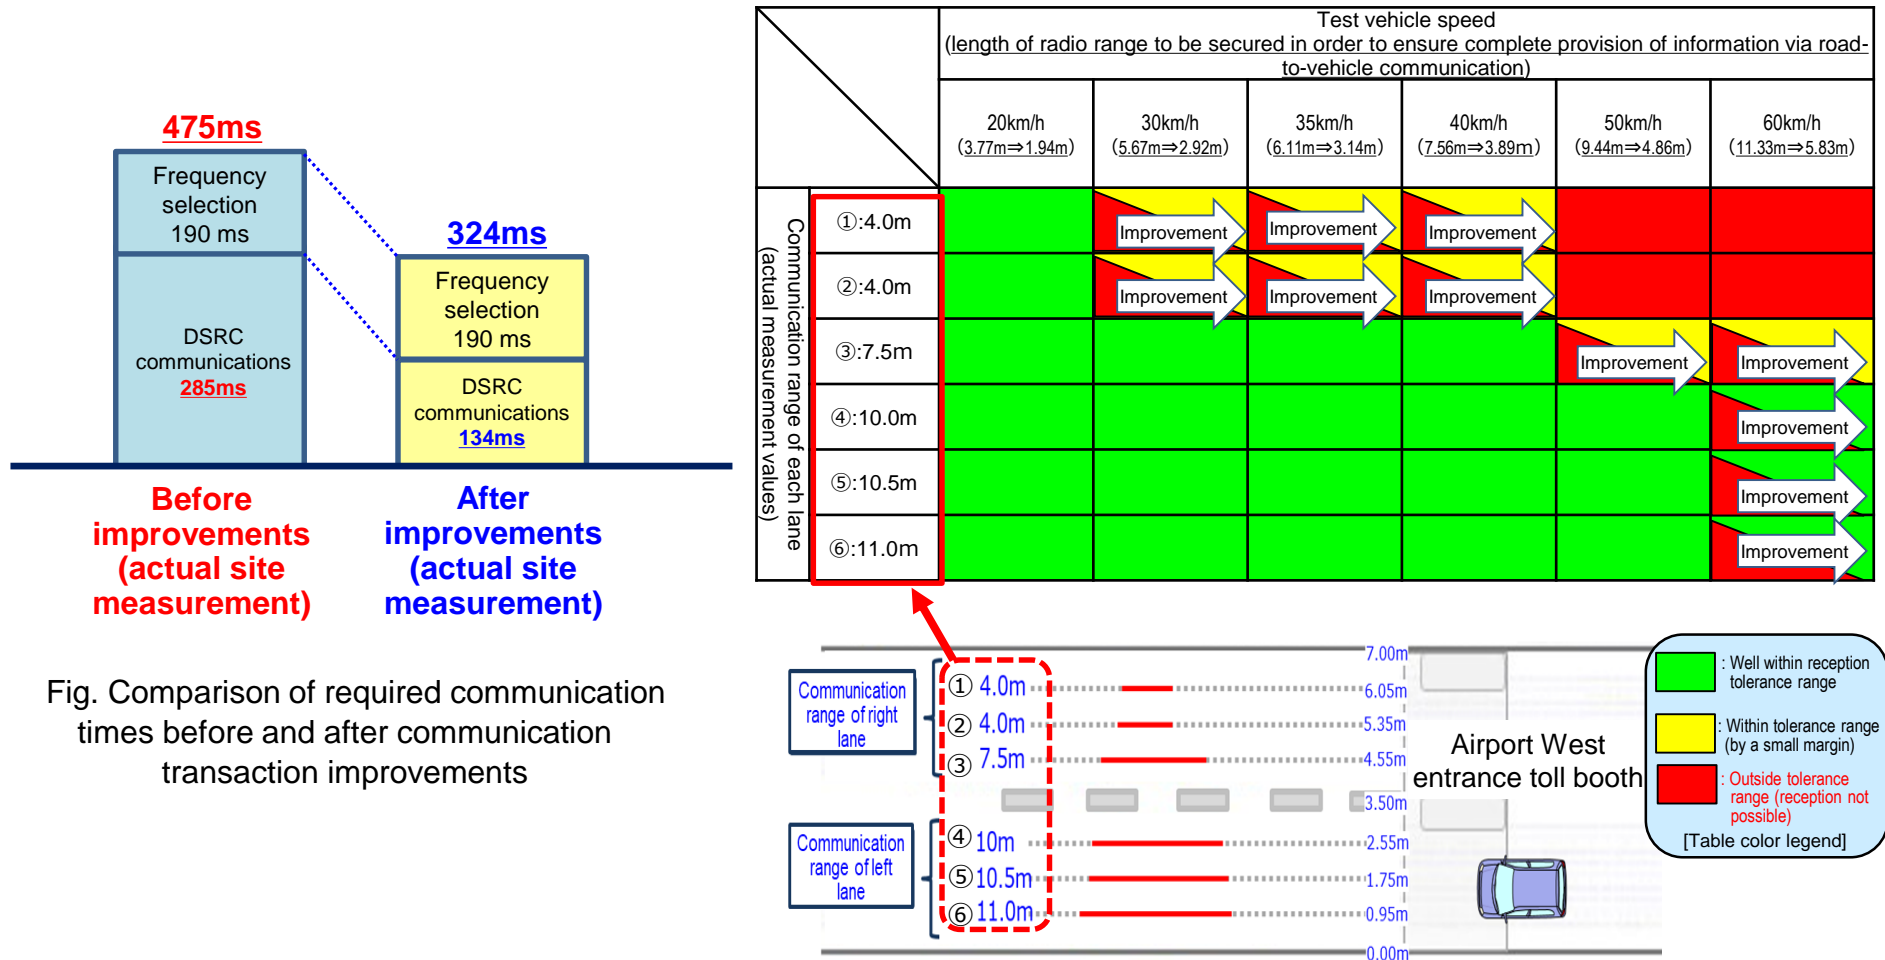
(Countermeasure) Shorten communication processing time. Specifically, in order to improve the reliability of completing road-to-vehicle communications, required communication times must be reduced by aggregating and streamlining communication processing. As shown below, we have confirmed that communication time has been reduced by roughly 60% (see figure below) and there are no cases in our test run after countermeasures of on-board equipment no receiving information.

Fig. Comparison of required communication times before and after communication transaction improvements

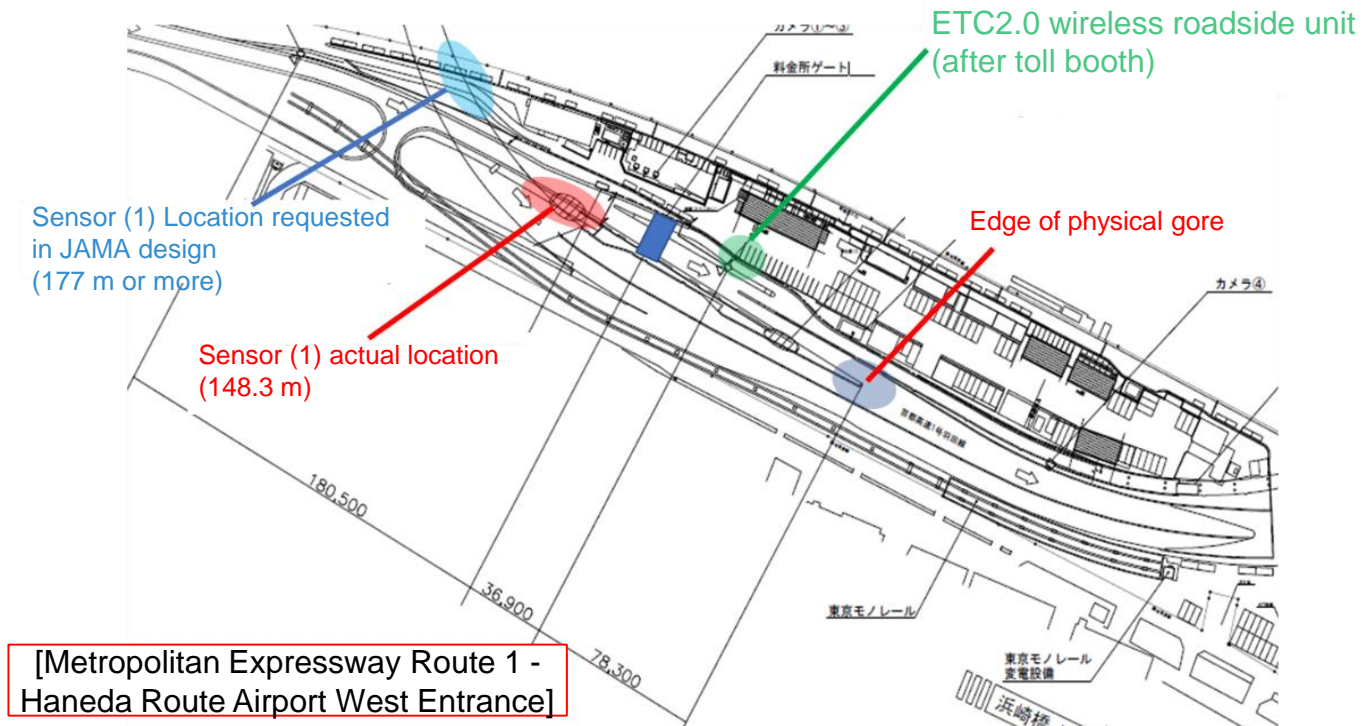
- (1) Space was secured to install mounts and poles for the roadside sensors supplied by five manufacturers
(The foundations for the total of six poles were large, which limited the number of possible installation locations)
- (2) The location at the JAMA-specified installation distance (177 meters or more) was a bridge area, and there was nowhere to build a foundation or erect scaffolding.
- (3) The roadside sensor mounting jigs and poles cannot be buried or mounted on highway balustrades (concrete walls) due to the risk of reinforcing bars being cut.

Fig. Comparison of roadside sensor locations requested in JAMA design and actual installation locations

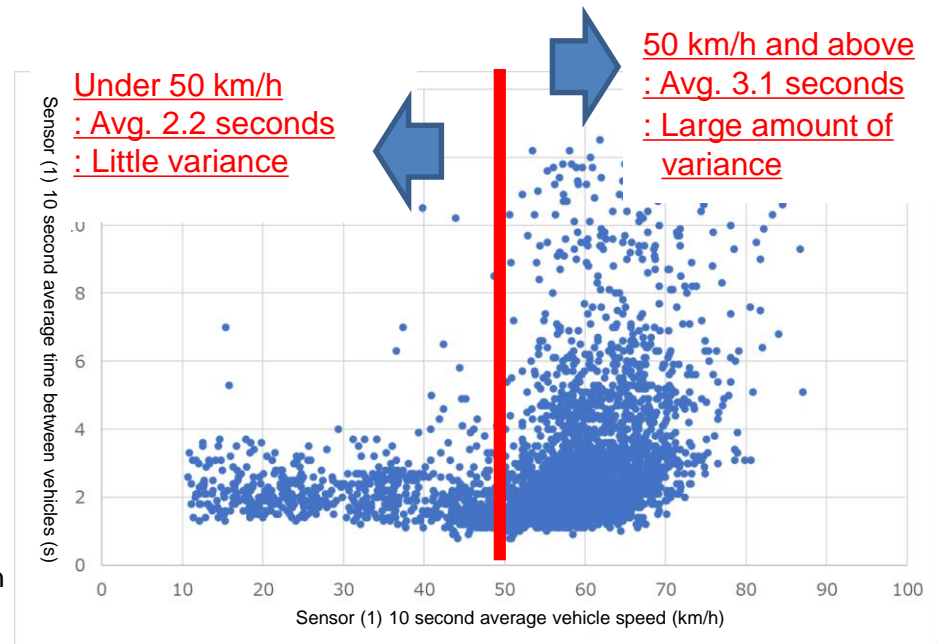
- The average time between vehicles was 2.2 seconds for vehicles traveling under 50 km/h and 3.1 seconds for vehicles traveling at 50 km/h or faster
- Most times between vehicle were between 1.5 and 3.5 seconds for vehicles traveling under 50 km/h
- At speeds above 50 km/h, the amount of variance in time between vehicles increased

* Average time between vehicle is a variable of up to 12.5 seconds (in units of 0.1 seconds), so analysis was performed on 3,269 samples after excluding 49 samples with times of 12.6 seconds or greater

Avg. vehicle speed	No. of samples	Average time between vehicles (s)				
		Avg.	Max.	Min.	Variance	Median
Under 50 km/h	662	2.2	10.5	0.8	1.2	2.0
50 km/h and above	2,607	3.1	12.5	0.8	3.3	2.4
All samples	3,269	2.9	12.5	0.8	3.8	2.2

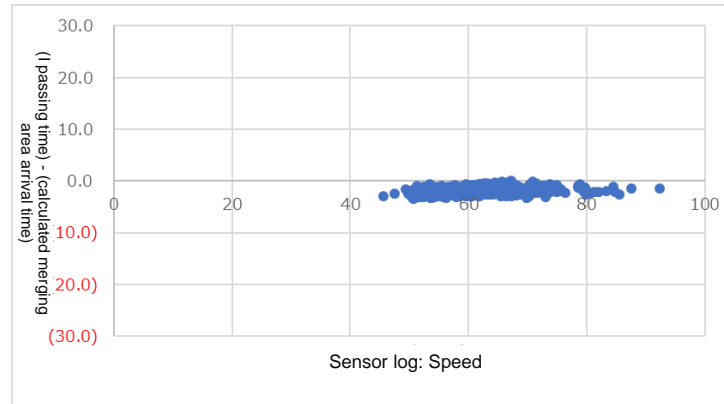
Uncongested
<3/30 12:35 to 13:05>

[Uncongested]

- The majority of vehicles drove at 50 to 75 km/h
- The average time deviation was roughly - 0.3 seconds (almost no deviation)

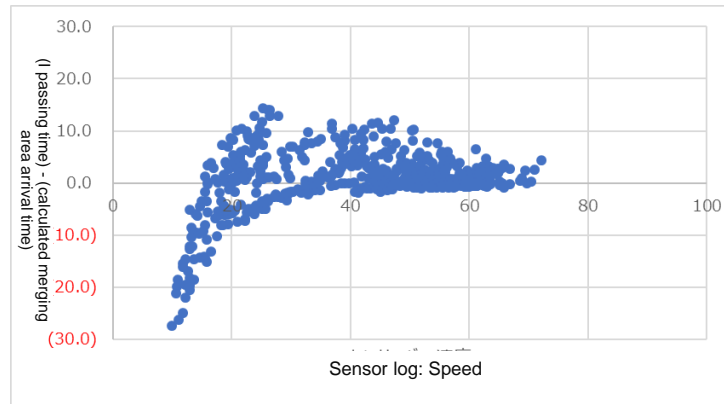
Critical
<3/24 6:25 to 6:55>

[Critical/traffic jam]

- There were vehicles driving between 10 and 40 km/h
→ Speeds slowed due to traffic jams
- There was a great amount of time deviation for slow vehicles

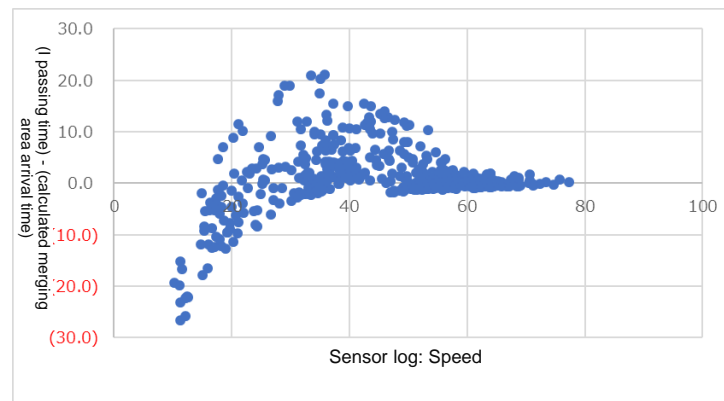
Traffic jam
<3/13 9:25 to 9:55>

- Even vehicles driving at 50 to 60 km/h had a greater amount of time deviation than vehicles driving when the road was uncongested
→ Traffic conditions had a major impact

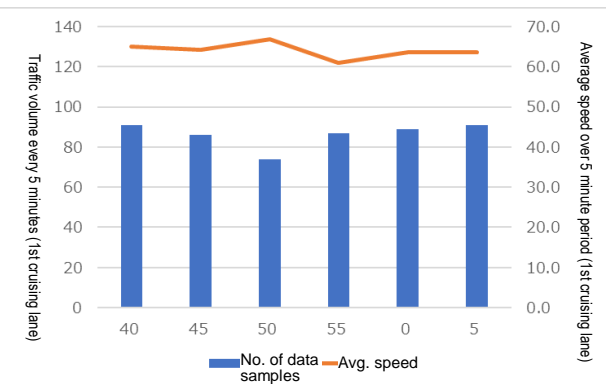
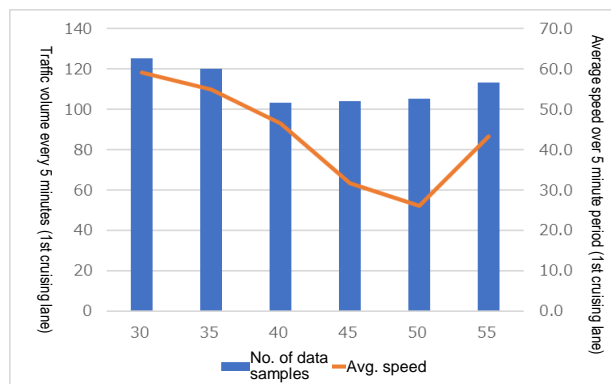
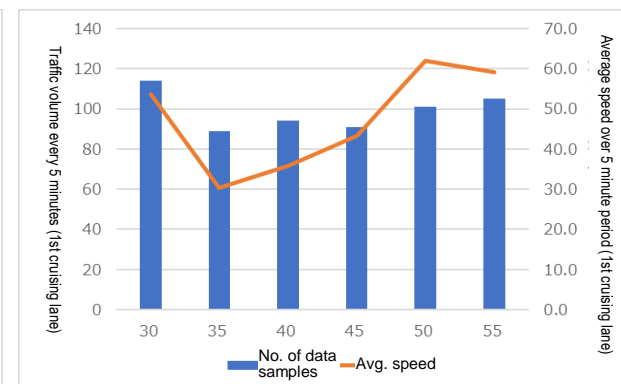
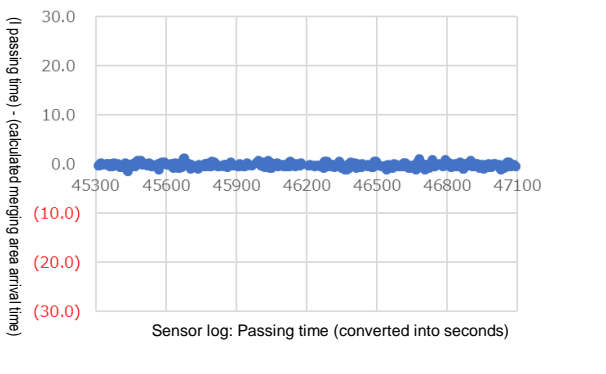
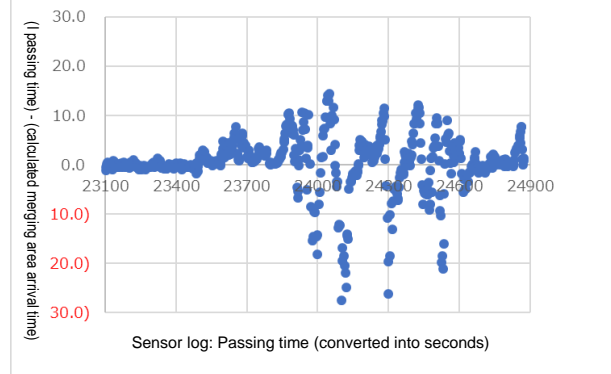
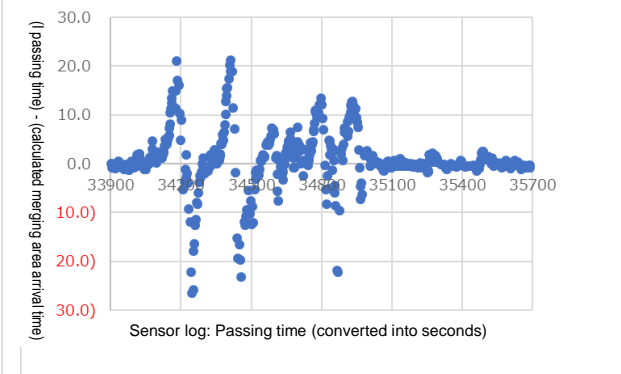
Comparison of traffic conditions and variance in arrival times every 5 minutes

→ When average speeds changed suddenly, deviations from calculated arrival times increased

Steady
Mar. 30 12:35 to 13:05

Critical
Mar. 24 6:25 to 6:55

Traffic jam
Mar. 13 9:25 to 9:55

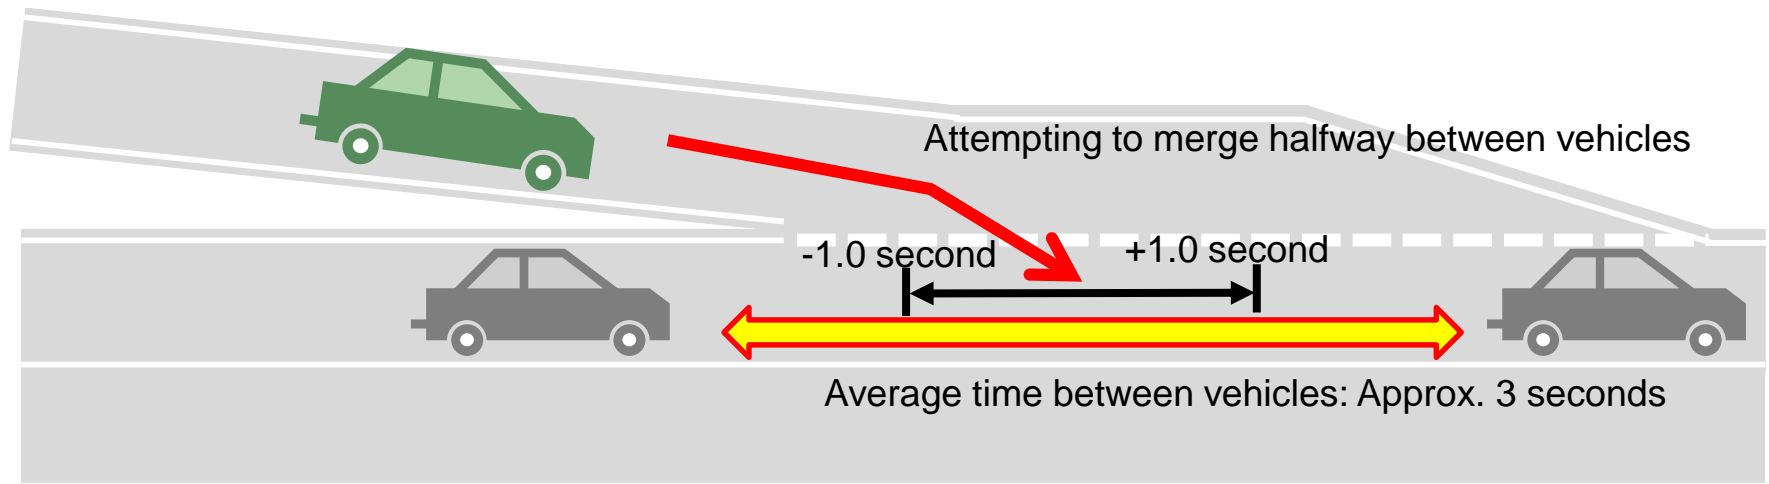
- The average time between vehicles driving in the cruising line near the No. 1 Haneda Route Airport West entrance was approx. 3 seconds.
- If, hypothetically, a test vehicle controlled its speed based on the calculated merging area arrival time in order to arrive halfway between vehicles in the cruising line, merging into the desired area would be assumed to be possible provided that the difference between the calculated and actual merging area arrival times was ± 1.0 seconds or less.

➔ The percentage of data for which the difference between the calculated merging area arrival time and the actual arrival time was ± 1.0 seconds or less was confirmed from the on-site data from the expressway infrastructure and used to perform evaluation.

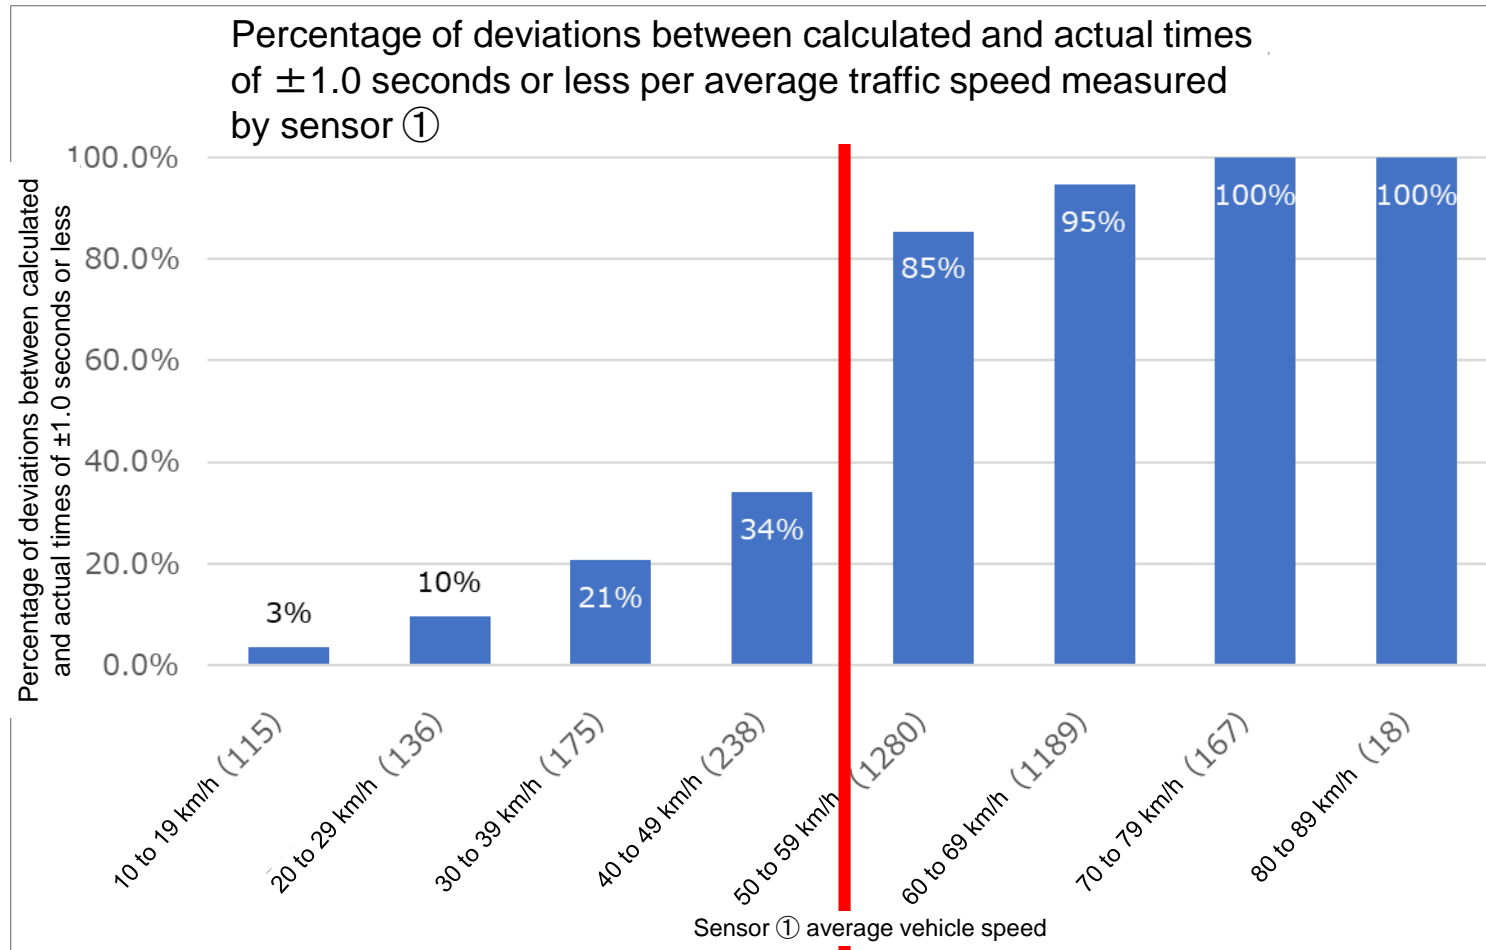
The deviation in merging end arrival time was large for traffic with average speeds of 50 km/h or less as detected by roadside sensor ① (installed upstream from the merging end)

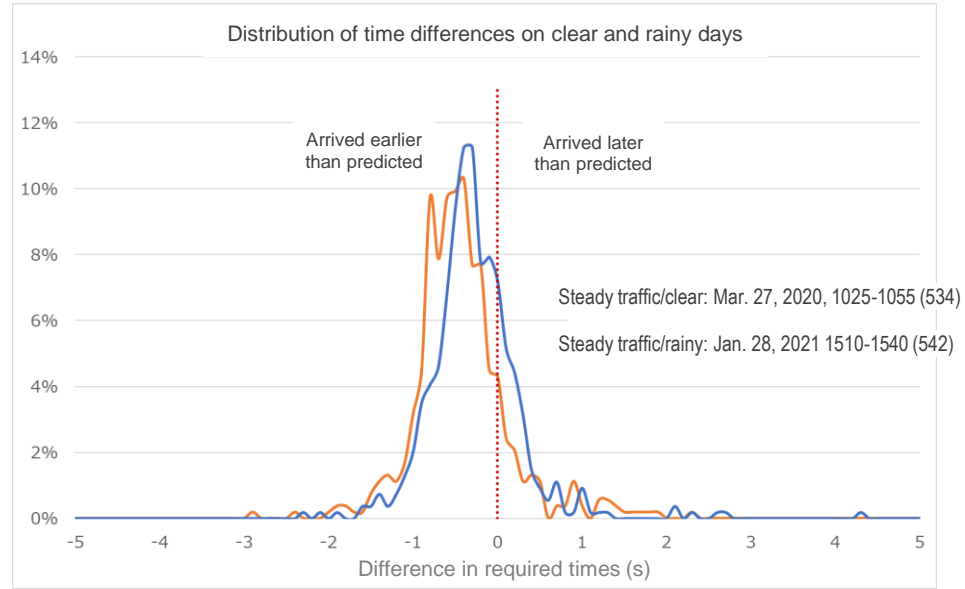
Under the same traffic flow conditions, we confirmed the difference between the calculated merge arrival time and the actual merge arrival time by weather (sunny / rainy), and confirmed that it was not affected by the weather..

Comparison of differences in times in measurements on a day with clear weather (Mar. 27) and a day with rain (Jan. 28) found little difference and equivalent distribution \Rightarrow It appears that rain has little impact on differences in calculated arrival times

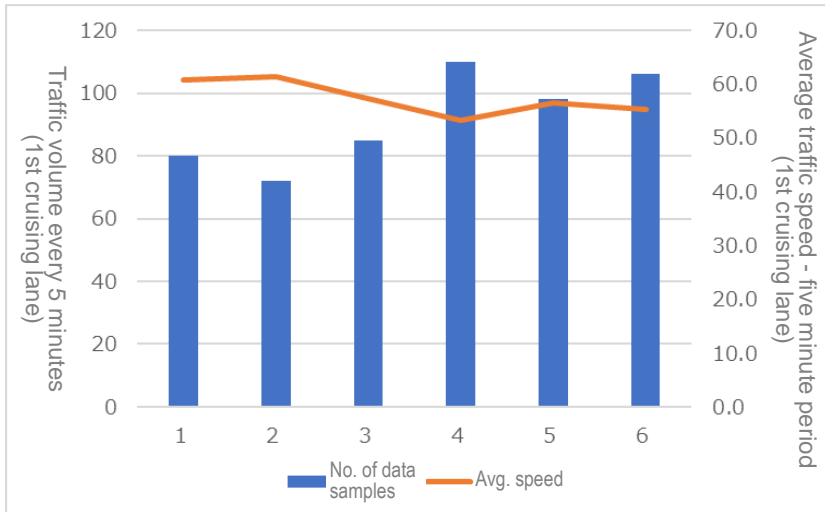
Jan. 28 Rain

Date/ time	Jan. 28 (Thu) 15:10 to 15:40	Mar. 27 (Fri) 10:25 to 10:55
Weather	Rain	Clear skies
Traffic conditions	Steady No. of vehicles in 1st cruising lane: 566 vehicles Total number of merging vehicles: 46 vehicles Average time between vehicles: 2.9 seconds	Steady No. of vehicles in 1st cruising lane: 518 Total number of merging vehicles: 70 Average time between vehicles: 2.8 seconds

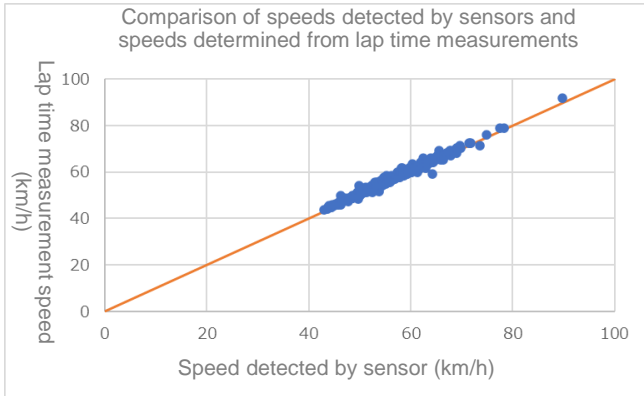
Negative: The vehicle was predicted to arrive after it actually passed the physical gore

No. of data samples	542
Average difference [seconds]	-0.275
Maximum difference [seconds]	4.333
Minimum difference [seconds]	-2.312
Variance	0.314

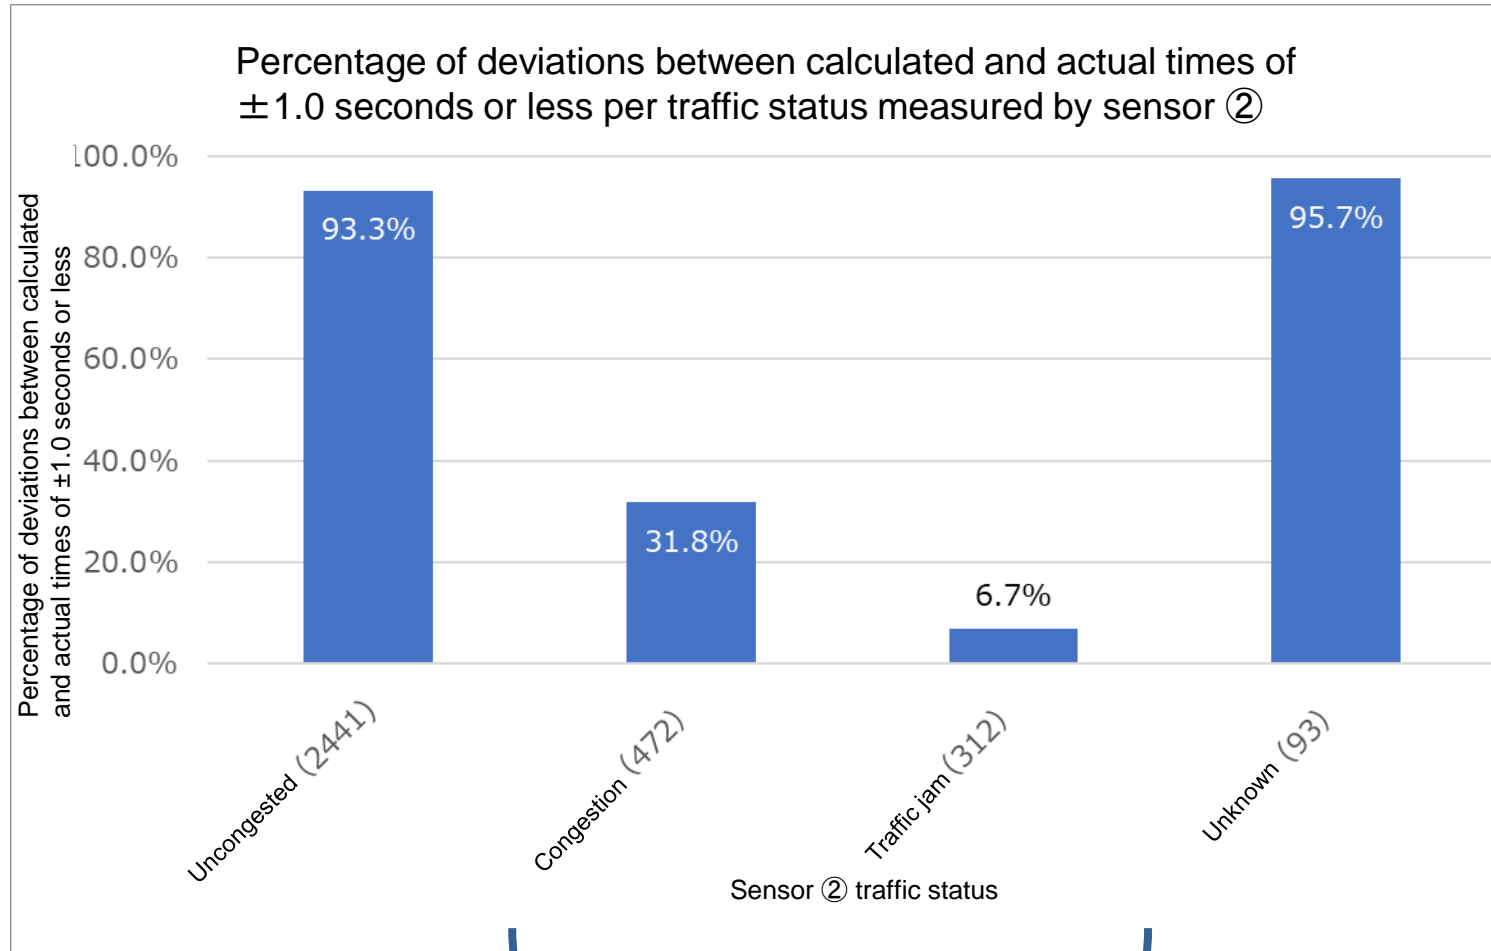
The deviation in merging end arrival time was large when roadside sensor ② (installed at the merging end) detected traffic conditions as “congestion” or “traffic jam”

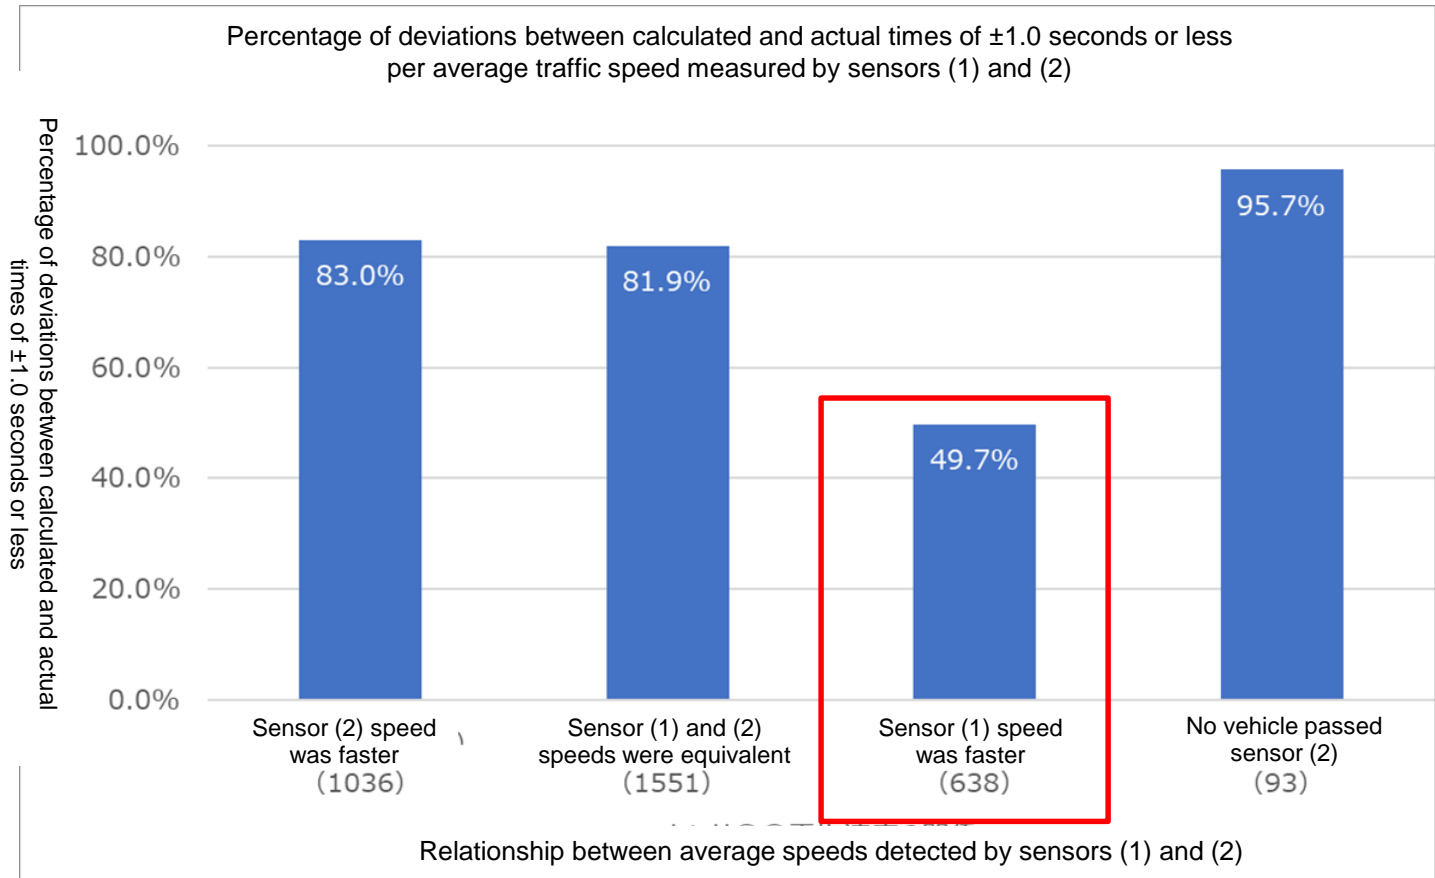
Average vehicle speeds measured by sensor (2) were assigned class values in 10 km/h increments, starting from 0 km/h → Average vehicle speeds measured by sensor (1) were also converted into class values, and data for identical class values was compared

* Average vehicle speeds were considered equivalent when class values were equal E.g.) Sensor (1) speed of 55 km/h and sensor (2) speed of 50 km/h to 59 km/h

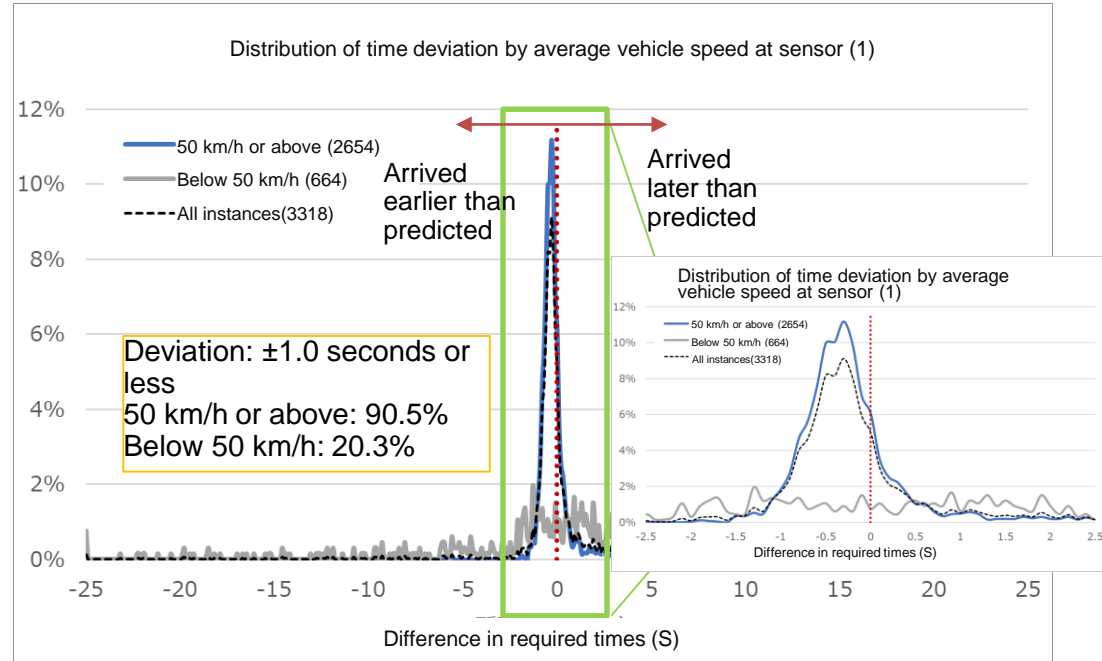
«2» By 10 second traffic average speed at cruising line sensor
(traffic condition information: sensor (1) average speed)

50 km/h or above	Below 50 km/h
No. of data	2654	664
Average deviation	-0.1	0.6
Median value	-0.3	0.9
Maximum deviation (positive)	12.4	21.1
Maximum deviation (negative)	-2.0	-27.5
Distribution	1.1	52.2
Peak by group	-0.3	-1.3
Peak group ratio	11.2%	2.0%

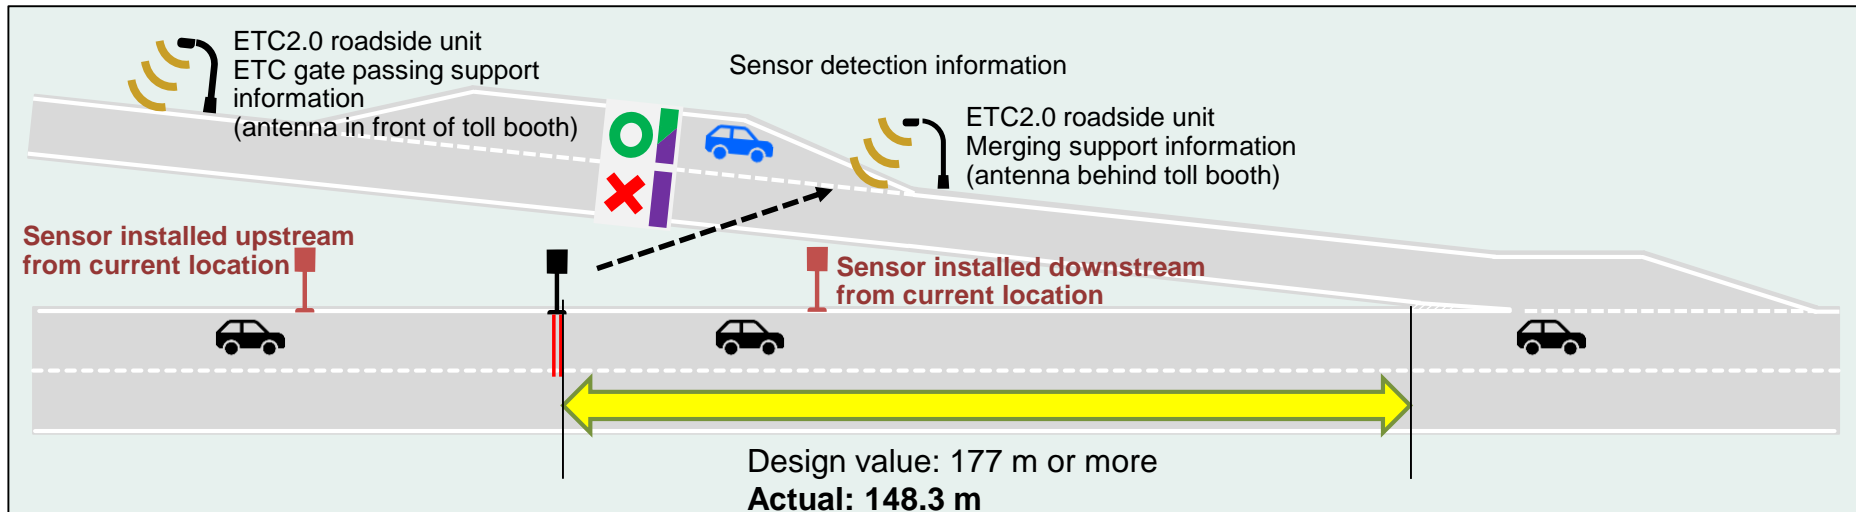
- The speeds determined at various points based on lap time measurement were used to calculate arrival times, and the difference between calculated and actual arrival times was calculated
- The distances between each point and the merging area were compared with the amount of variance in the deviation between the calculated and actual times to determine their degree of relation

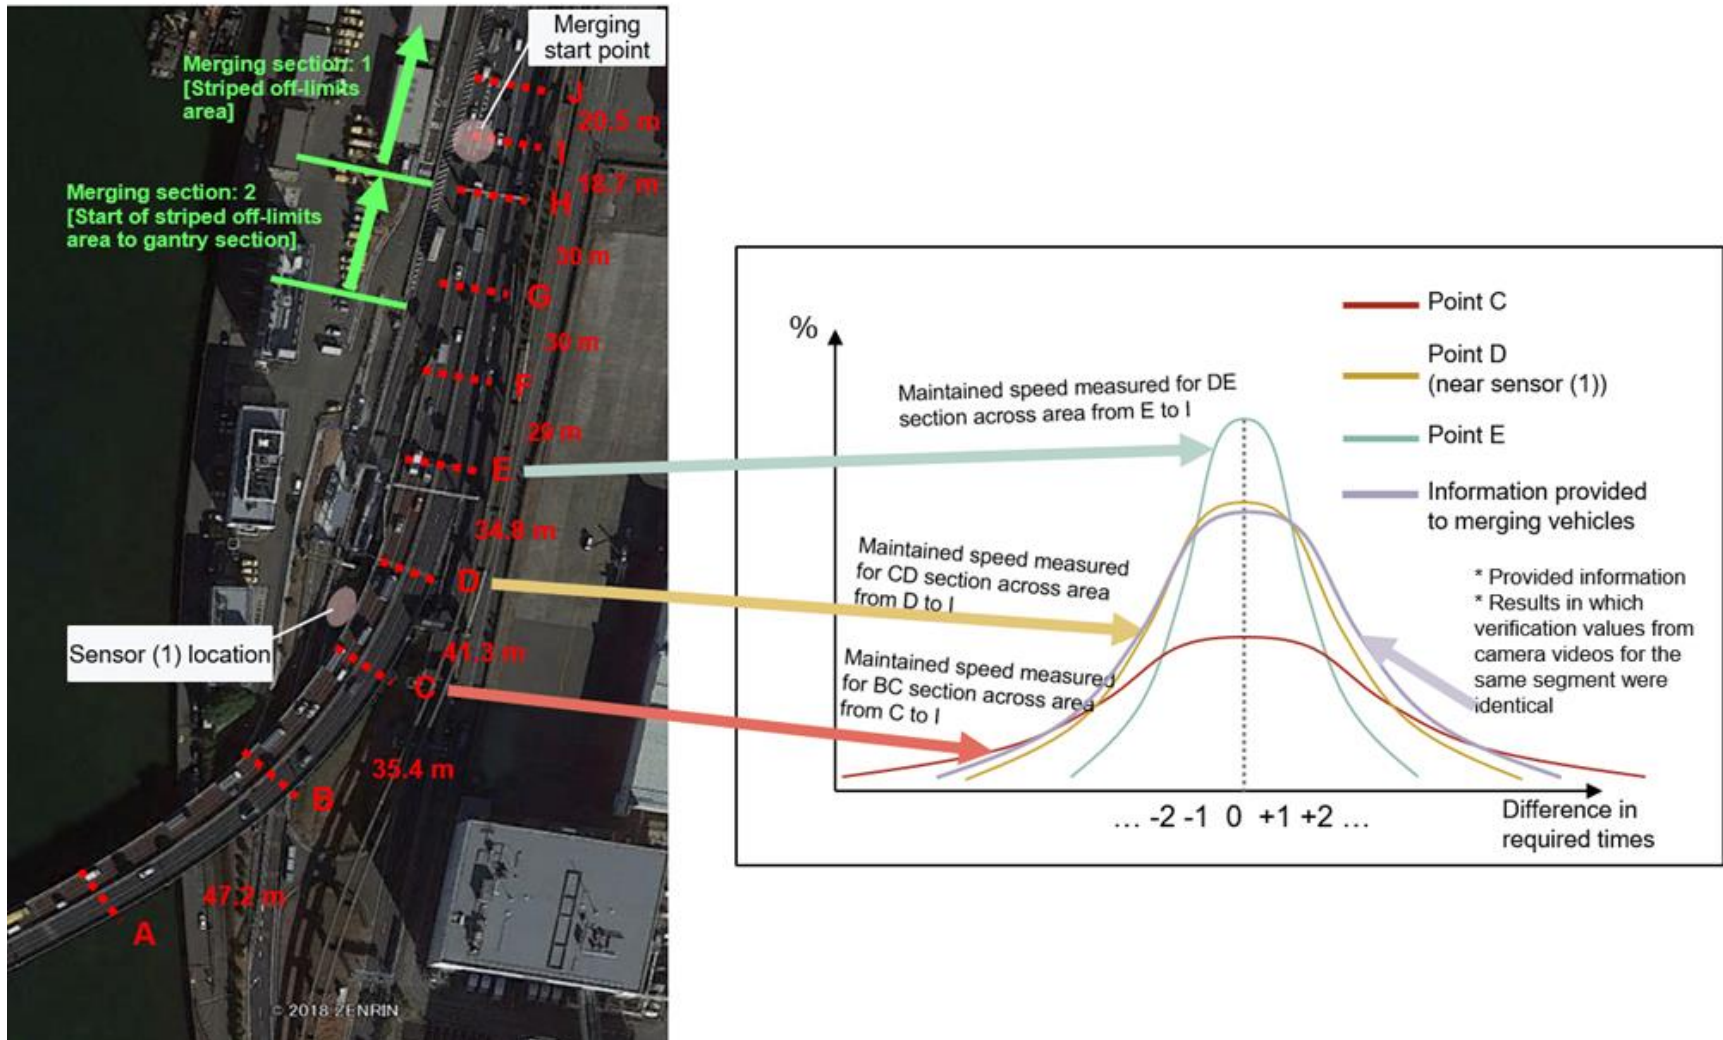
- Overview of lap time analysis performed to verify the validity of the position of the sensor used to provide merging support information

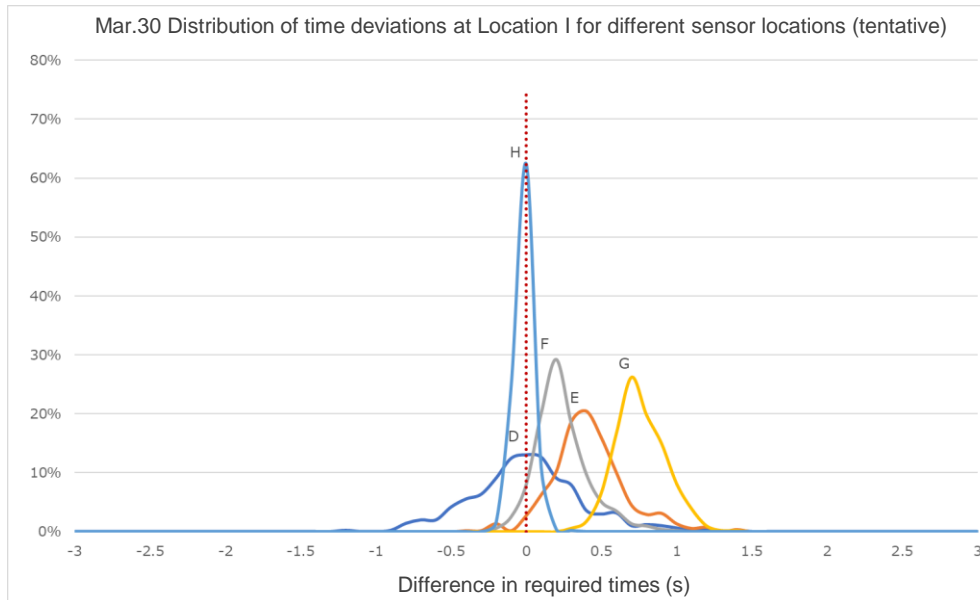
Positive: The vehicle was estimated to arrive before it actually passed the physical gore

Negative: The vehicle was estimated to arrive after it actually passed the physical gore

Sensor location	Speed assuming linear motion at a constant speed
D	CD segment speed
E	DE segment speed
F	EF segment speed
G	FG segment speed
H	GH segment speed

Installing the sensor in location G would tend to produce predictions of arrival earlier than the predictions that would be produced if the sensor were installed in other locations

The straight line to the merging area and the downward grade may cause speeds to increase in the FG segment

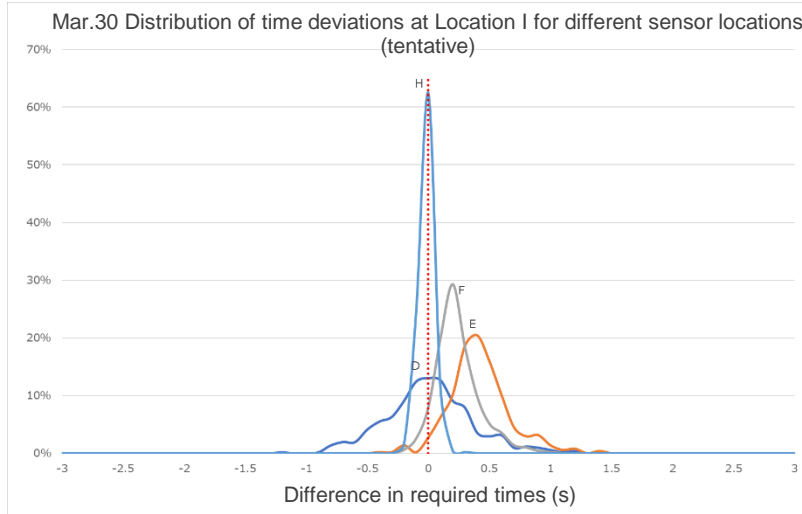
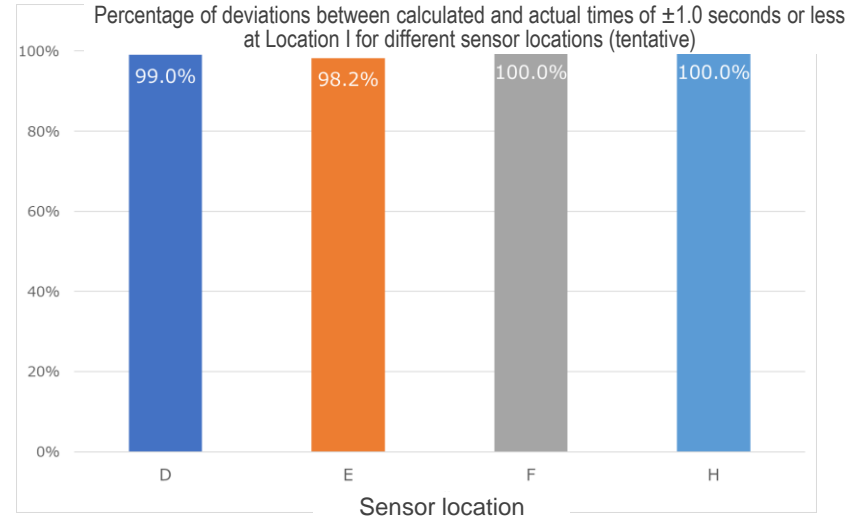
Mar. 30 12:35-13:05

Distribution of time differences when sensor was moved downstream

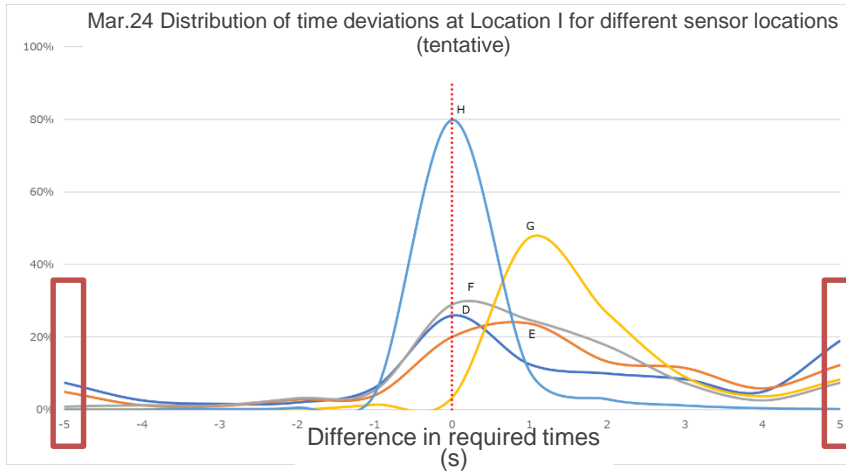
Mar. 24 06:25-06:55

Distribution of time differences when sensor was moved downstream
