Cross-ministerial Strategic Innovation Promotion Program (SIP) Phase Two/Automated Driving (Expansion of Systems and Services)/Infrastructure Preparation, Advance Verification, and Maintenance and Management for the Metropolitan Expressway Routes Connecting Haneda Airport and the Waterfront City Area, etc.

FY2019-2020 Report

Mitsubishi Electric Corporation

May 2021

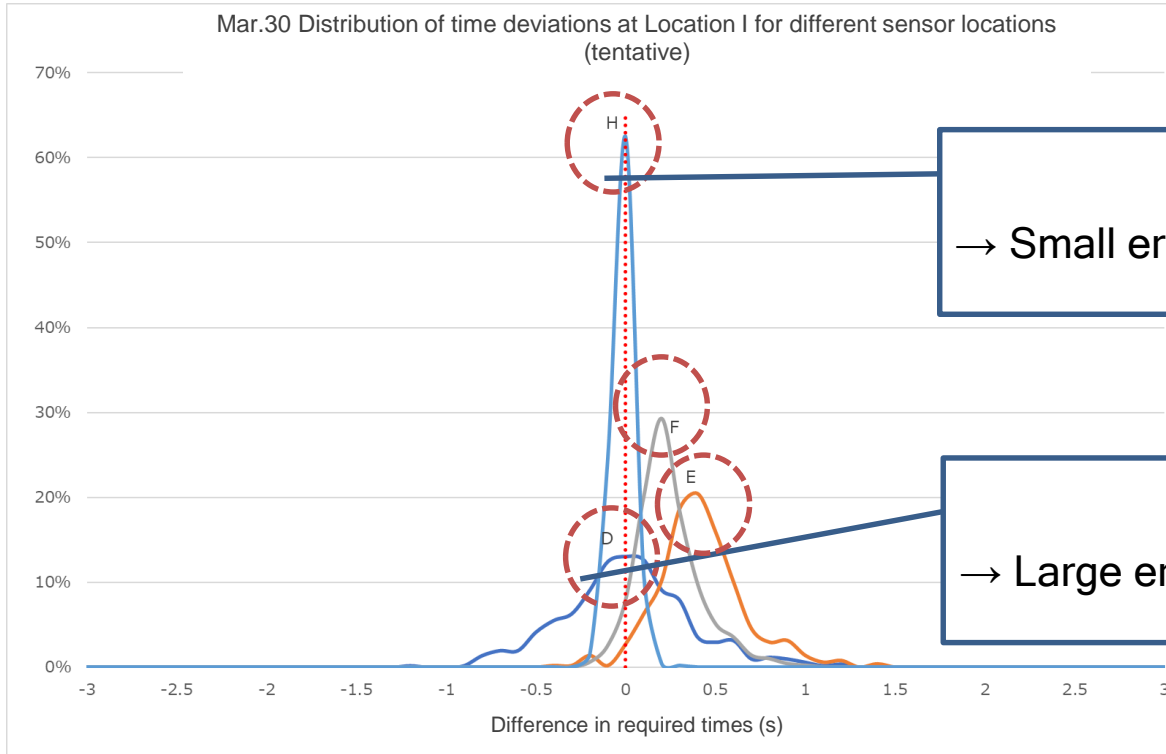
The distances between each point and the merging area were compared with the amount of deviation variance to determine their degree of relation

→ Comparison was performed using the mode ratio of the error distribution

Mode ratio: Large
→ Small error distribution, small variance

Mode ratio: Small
→ Large error distribution, large variance

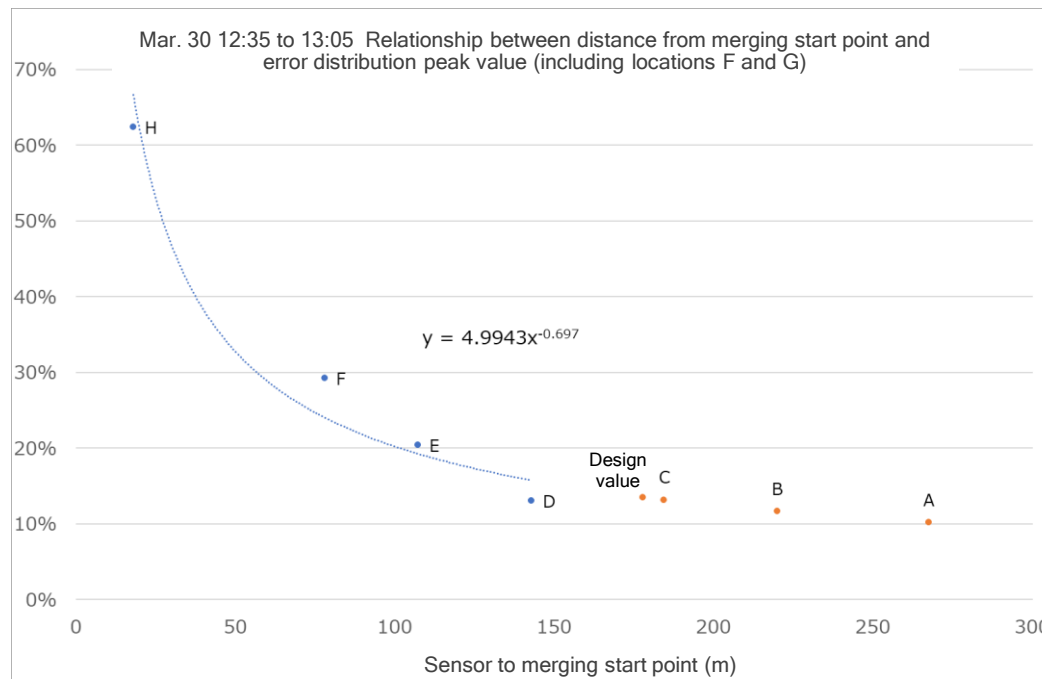
We calculated an approximate curve based on the relationship between lap time measurements (locations D, E, F, and H) and distances

We inferred peak values for locations outside the roadside camera range (locations A, B, and C) based on their distances

Distance from each location to the merging start point and corresponding peak values

H	F	E	D	C	B	A
Distance (m)	18.02	78.03	107.23	142.86	184.48	219.92	267.52
Peak value (%)	62%	29%	20%	13%	13%	11%	10%

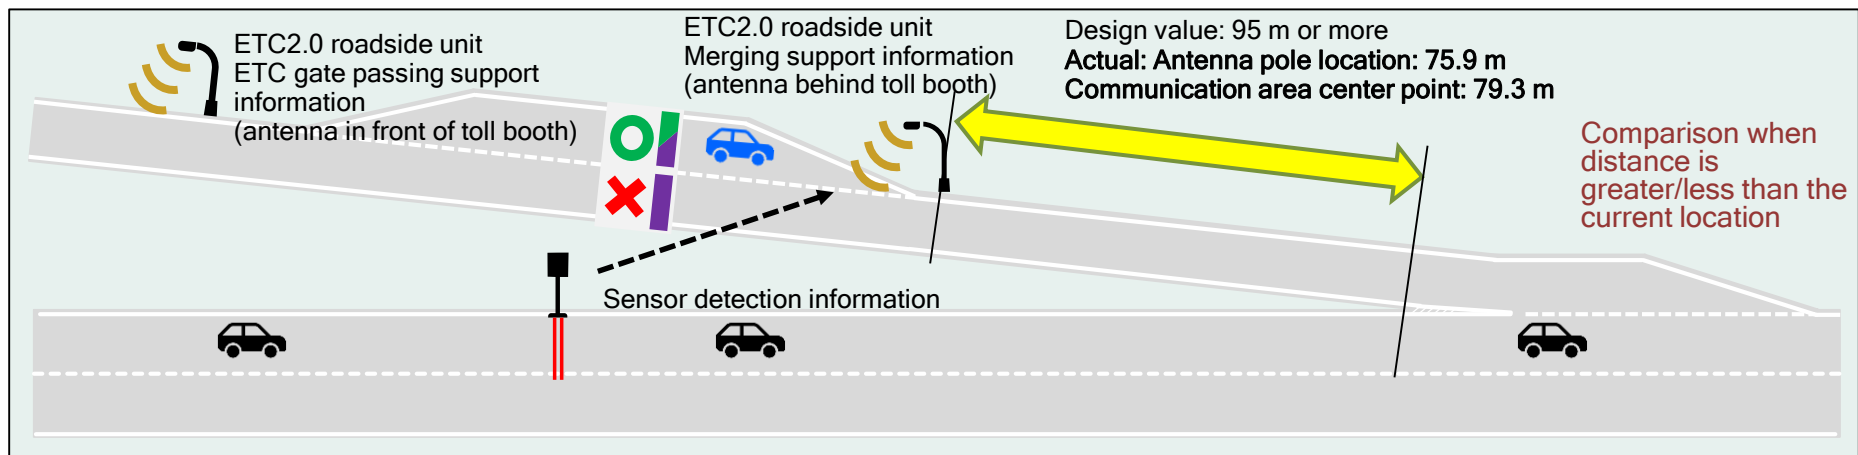
- The time required to arrive at the merging area was calculated based on the envisioned speed profiles (fastest and slowest profiles) of the merging vehicle after passing the ETC gate
- The distance between the antenna and the merging area was modified and the relationship between the antenna distance and the margin for making adjustments was derived
→ Verification was performed for each target speed

Airport West Entrance Location of antenna used to provide merging support information

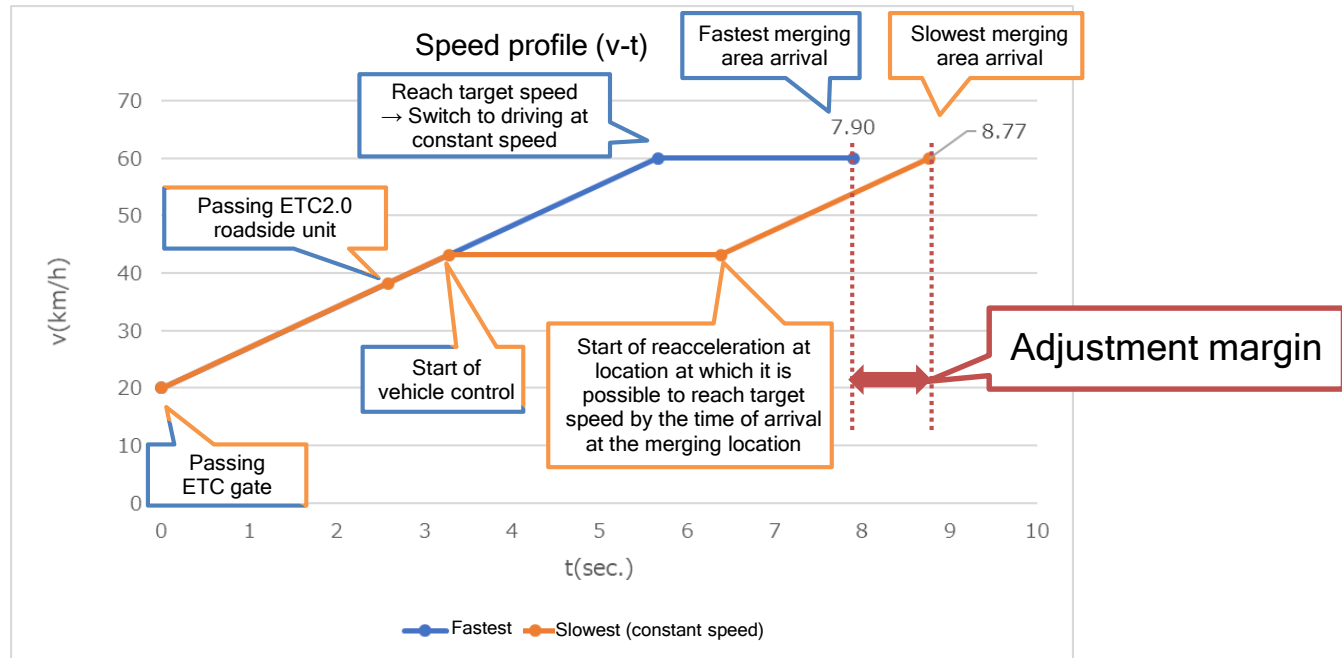
- The adjustment margin was calculated using the envisioned speed profile of the merging vehicle

(Adjustment margin) = (Required time for slowest profile) - (Required time for fastest profile)

[Variables] The input values in the graph above are as shown below

Target speed: 60 km/h

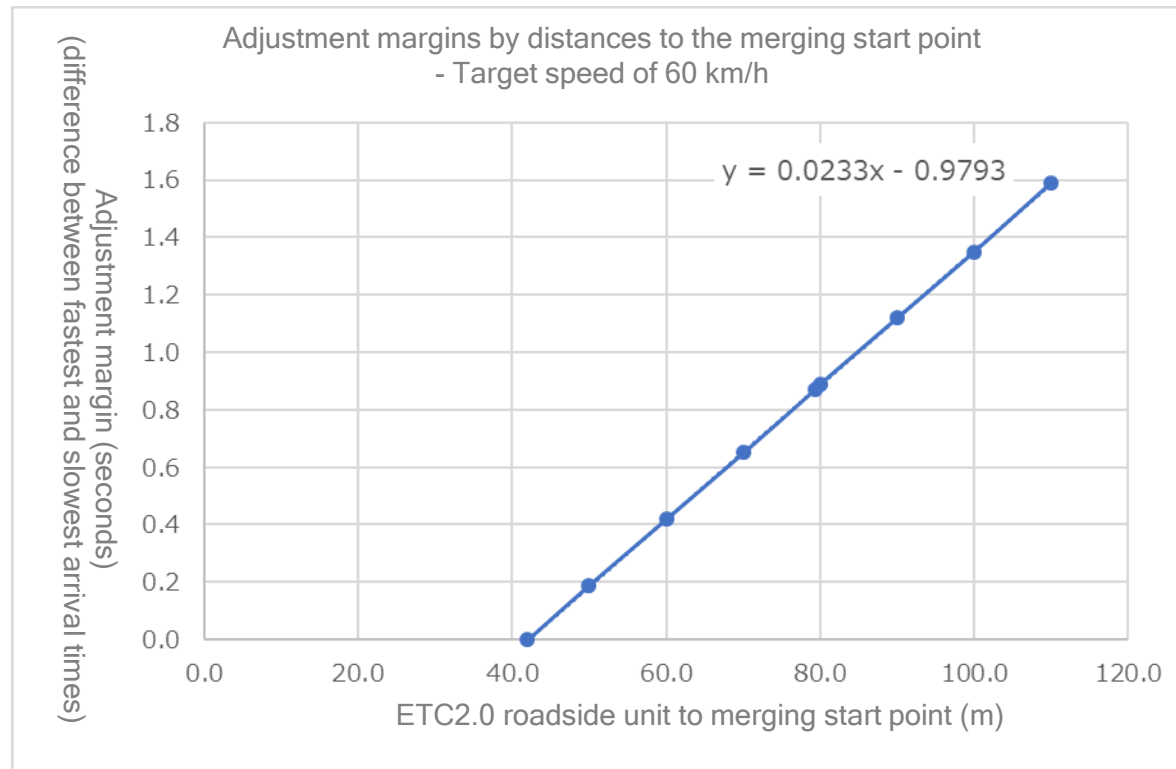
- When the distance between the ETC2.0 roadside unit and the merging area was less than 42 m, a speed of 60 km/h could not be reached by the time of arrival at the merging area
- The actual location of the roadside unit for Airport West was 79.3 m from the merging start point (distance to the center point of the communication area), and the adjustment margin was 0.78 seconds

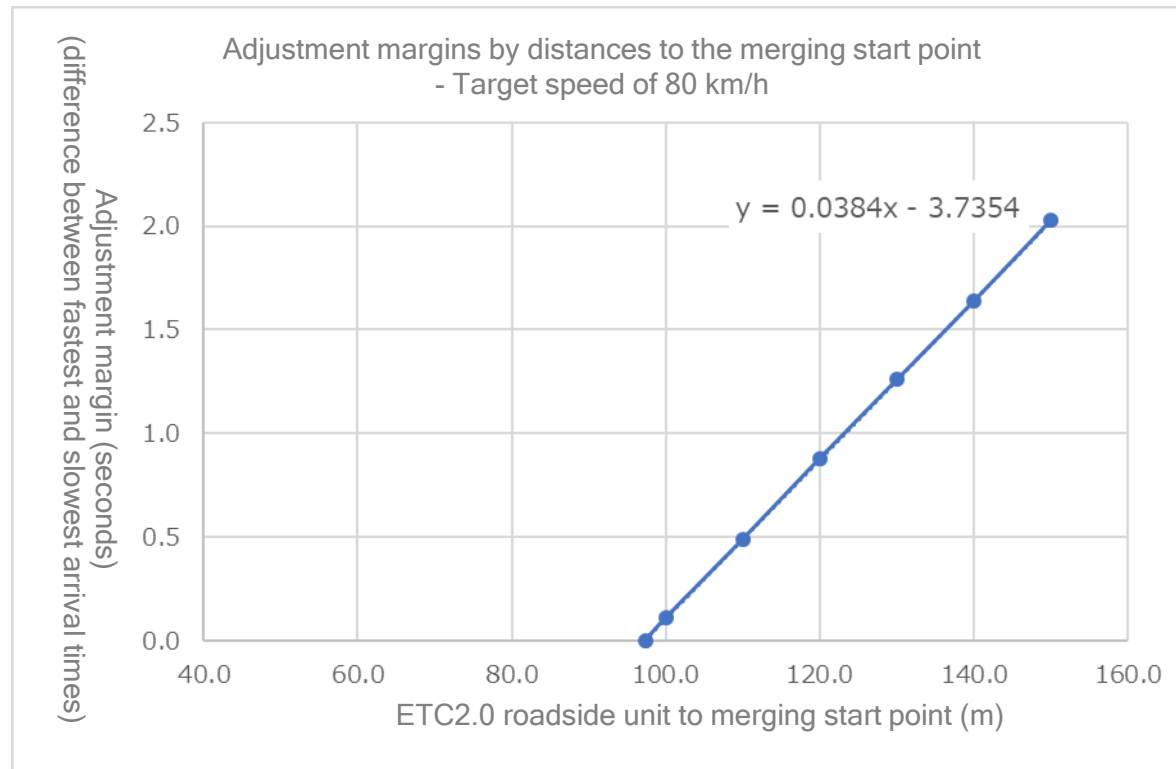
- When the distance between the ETC2.0 roadside unit and the merging area was less than 97.3 m, a speed of 80 km/h could not be reached by the time of arrival at the merging area
- The actual location of the roadside unit for Airport West was 79.3 m from the merging start point (distance to the center point of the communication area), so sufficient acceleration was not possible

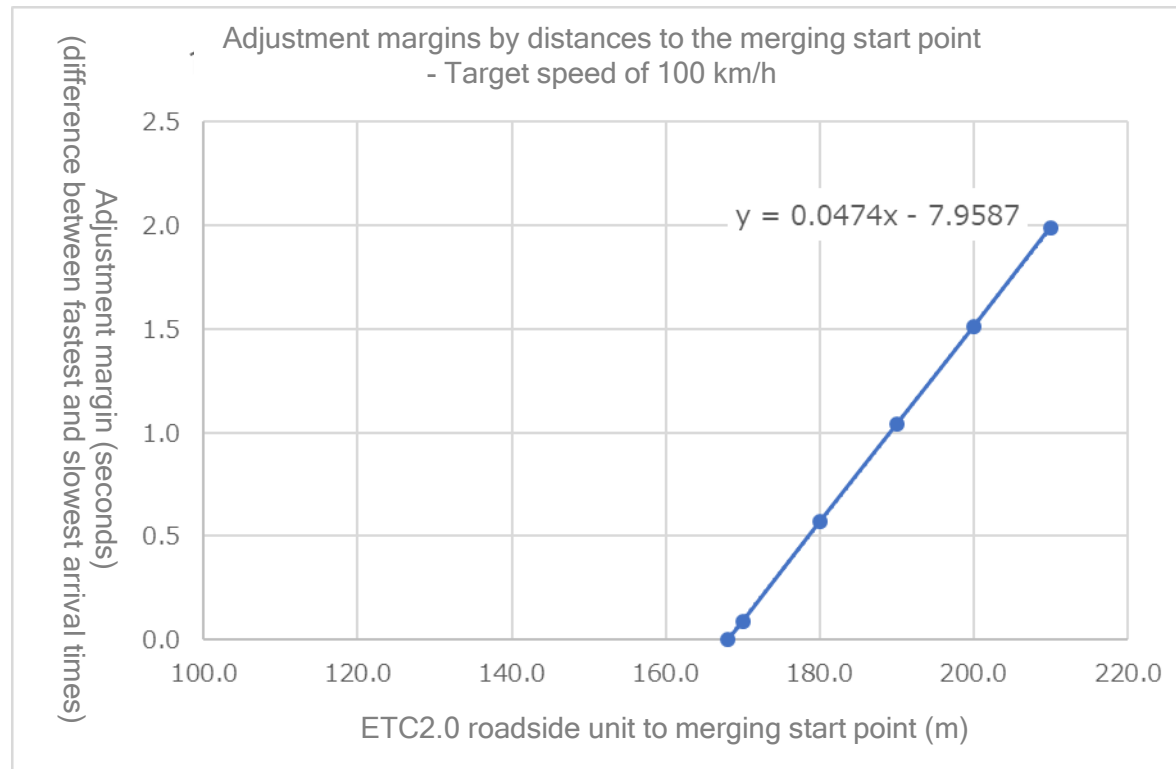
- When the distance between the ETC2.0 roadside unit and the merging area was less than 168.0 m, a speed of 100 km/h could not be reached by the time of arrival at the merging area
- For merging support on road sections with high cruising line speeds, such as intercity expressways, sufficient distance must be secured to accelerate after information is provided

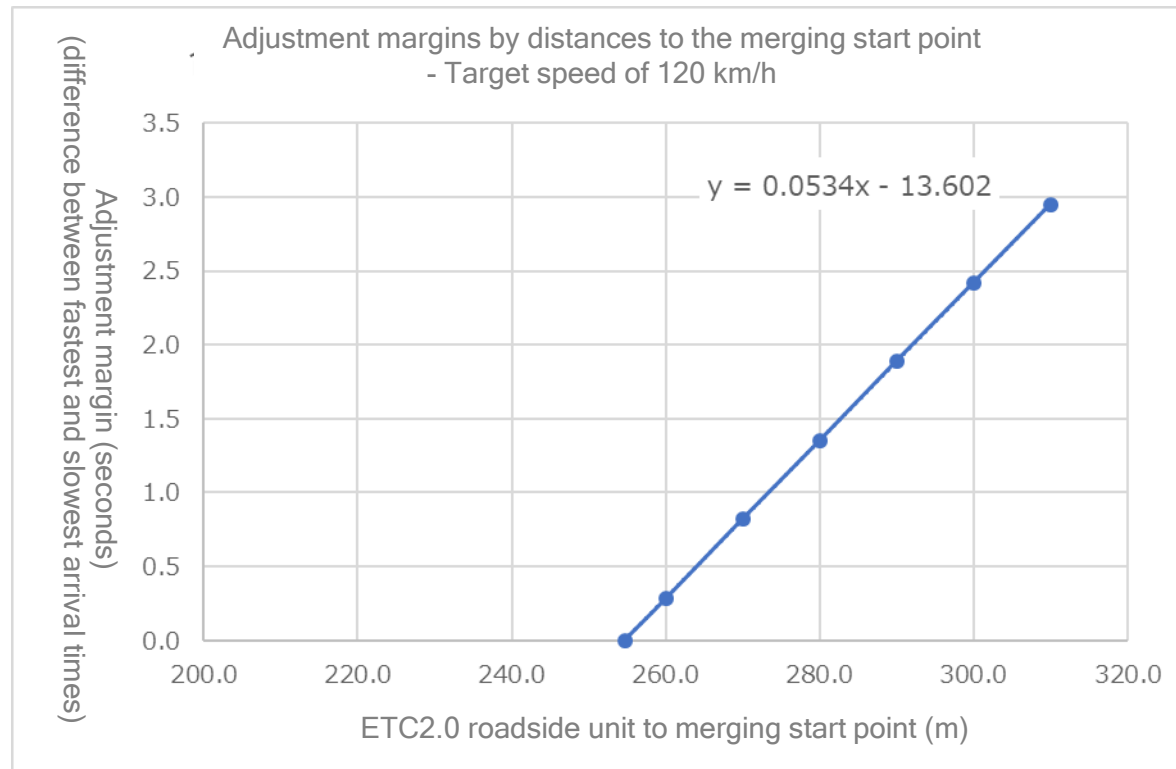
- When the distance between the ETC2.0 roadside unit and the merging area was less than 254.7 m, a speed of 120 km/h could not be reached by the time of arrival at the merging area
- For merging support on road sections with high cruising line speeds, such as intercity expressways, sufficient distance must be secured to accelerate after information is provided

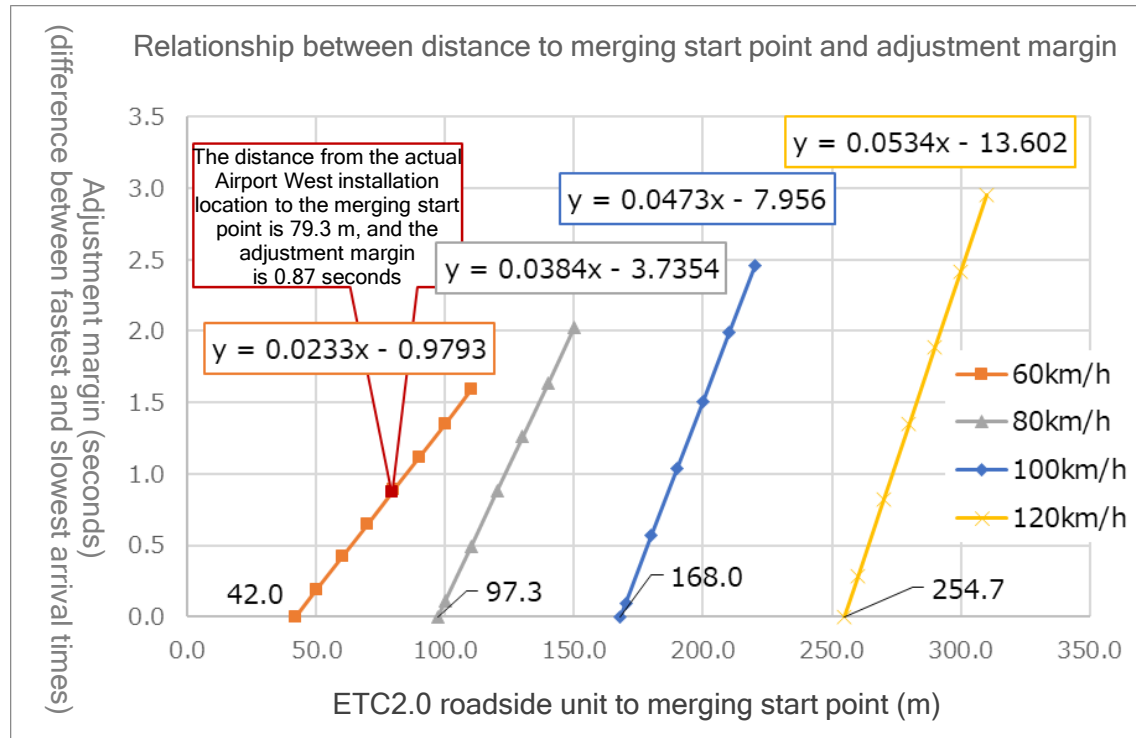
- Adjustment margin of 0 seconds \Rightarrow Distance needed to reach target speed under fastest profile
 \rightarrow The higher the target speed, the greater the distance necessary for acceleration
- The greater the distance between the ETC2.0 roadside unit and the merging area, the greater the adjustment margin
 \rightarrow Information provision locations should be defined based on the average following distance near the cruising line merging area in order to secure sufficient distance for the required adjustment margin

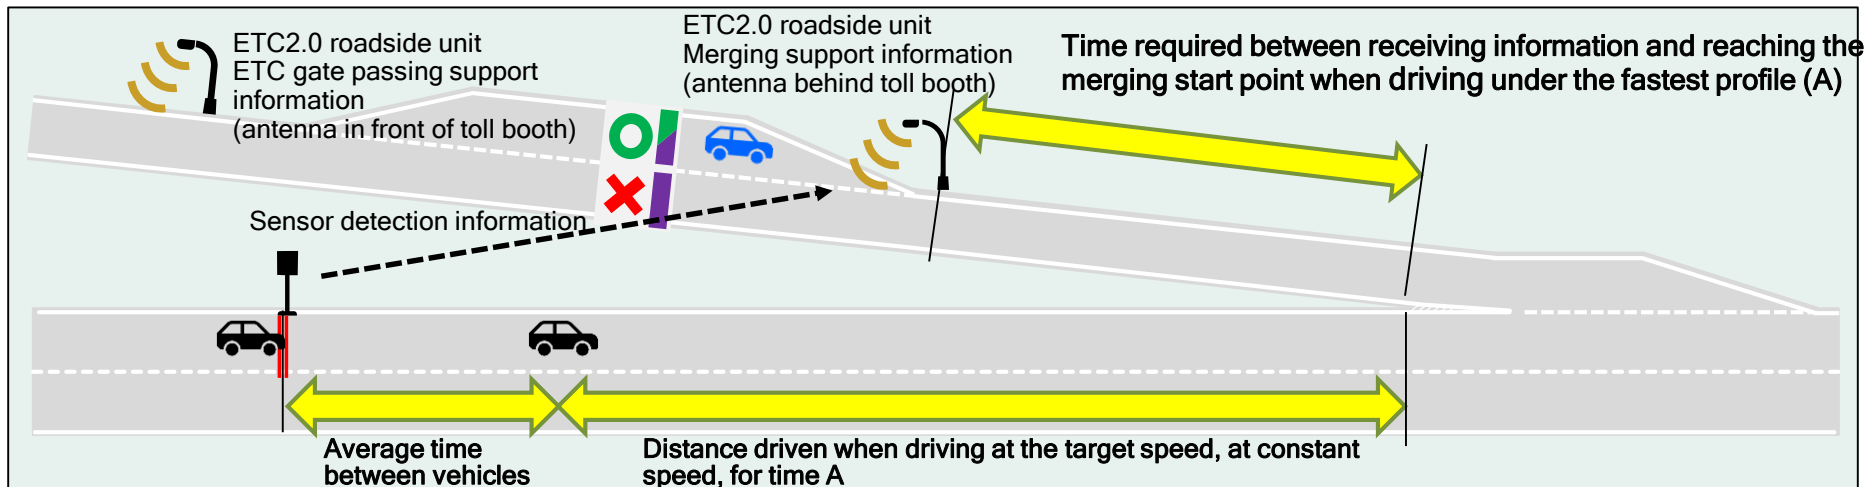
- Determine cruising line actual speed based on data acquired through the FOT (=target speed)
- We varied the distance between the information provision location and the merging area and calculated the required time under the fastest profile
- We calculated the distance (and sensor installation location), hypothesizing that vehicles on the cruising line travel at the target speed at a constant speed for the time required to reach the merging area + the average time between vehicles
- For each sensor installation location, we organized information regarding how much the accuracy of forecasts could be affected

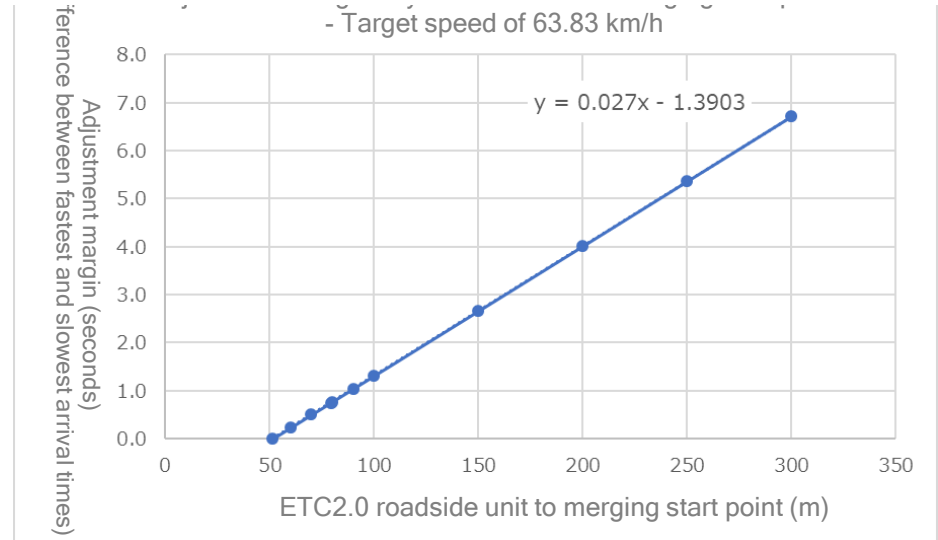
- Mar. 30 12:35-13:05 Lap time measurement found the average detected C-D over-all speed to be 63.83 km/h and the average time between vehicles to be 3.27 seconds

- For a target speed of 63.83 km/h, we calculated the required time for each distance between the information provision location and the merging area for both the fastest and slowest profiles
→ We then calculated the speed adjustment margins for merging vehicles

Information provision location to merging start point (m)	Speed adjustment margin for merging vehicles (s)
51.5	0.00
100.0	1.31
150.0	2.66
200.0	4.01
250.0	5.36
300.0	6.71

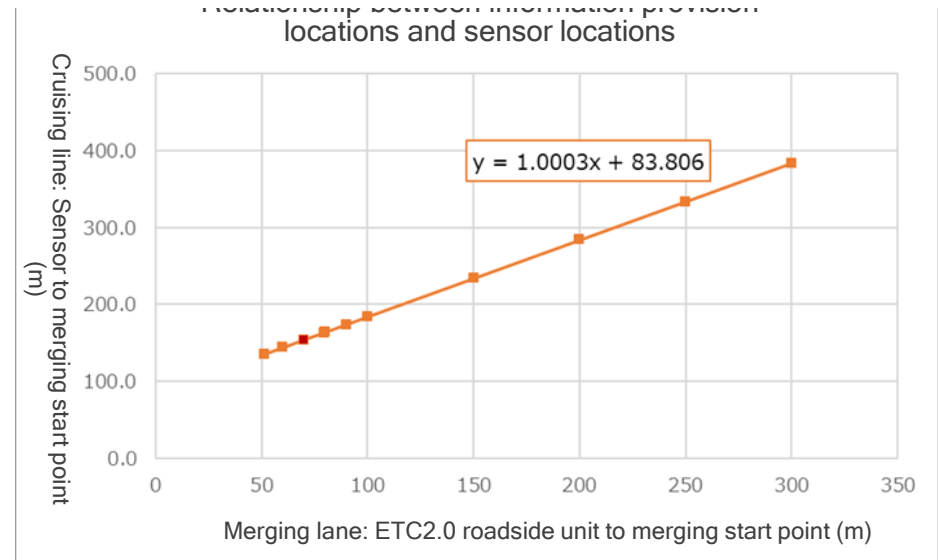
- For a target speed of 63.83 km/h, we calculated the required time for each distance between the information provision location and the merging area for the fastest profile
- We added 4.0 seconds to the required time for the fastest profile and calculated the sensor location

* By adding 4 seconds to the time of the fastest profile, we were able to include within the information provision range the vehicles following the vehicle in the cruising line that arrives at the merging start point at the same time as the merging vehicle

→ This makes it possible to determine the length of the gap to be merged into

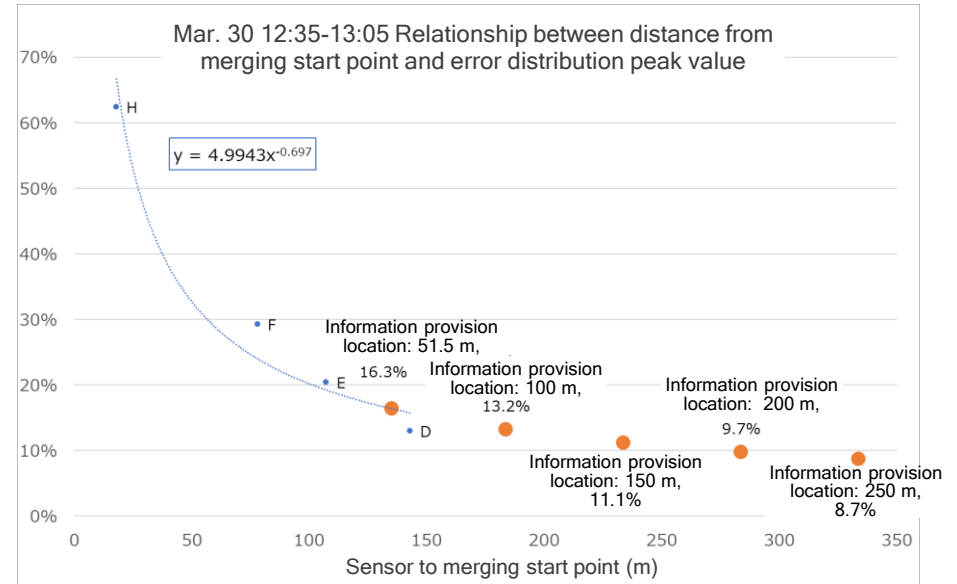
- We used the curve calculated in our sensor location analysis to infer the mode ratio of the error distribution for each distance between sensor location and merging start point given each information provision location
- Based on the lap time measurement results, we hypothesized an error distribution function and calculated data ratios that would produce deviations of ± 1 seconds or less and ± 0.5 seconds or less at each sensor location

Information provision location to merging start point (m)	Speed adjustment margin for merging vehicles (s)	Sensor to merging start point (m)	Deviation: ± 1.0 seconds or less	Deviation: ± 0.5 seconds or less
51.5	0.00	135.3	99.8%	93.7%
100.0	1.31	183.9	99.0%	86.8%
150.0	2.66	233.9	97.0%	79.4%
200.0	4.01	283.9	94.5%	73.3%
250.0	5.36	333.9	91.5%	67.7%
300.0	6.71	383.9	88.4%	63.2%

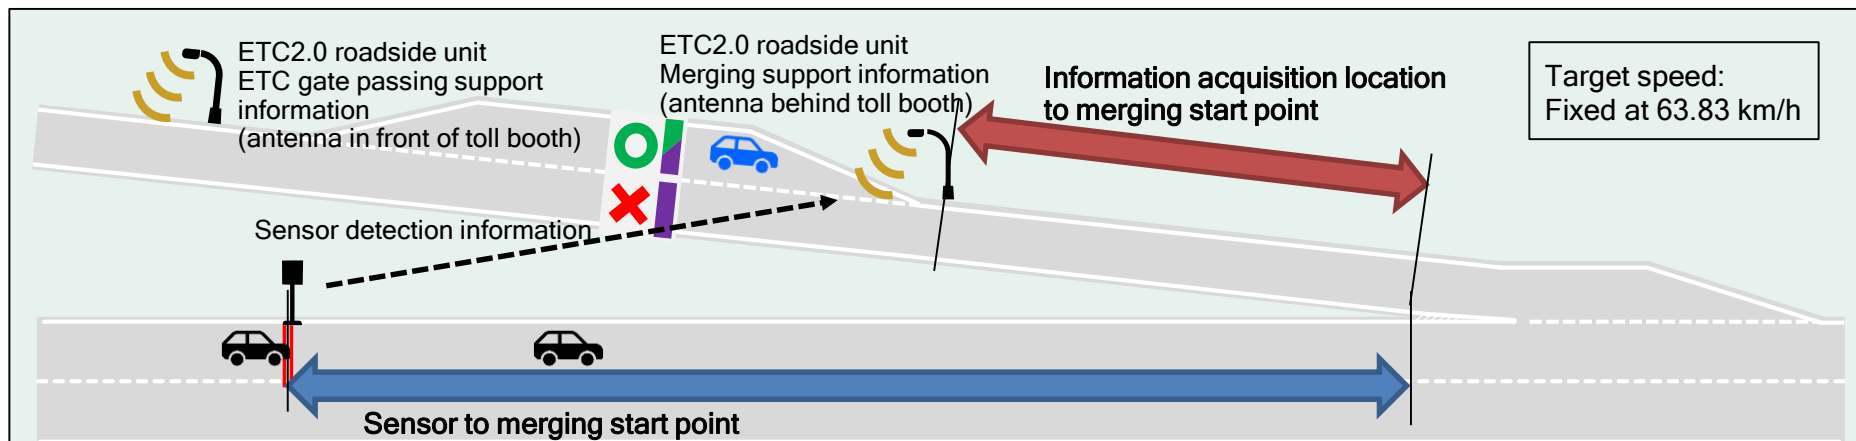
From the table below, it was confirmed that the location of the infrastructure equipment installed this time is optimal under the restrictions of the road environment.

Information provision location to merging start point (m)	Speed adjustment margin for merging vehicles (s) Difference in required times for merging vehicles under fastest and slowest profiles	Sensor to merging start point (m) Distance driven when driving at the target speed at constant speed for the required time under the merging vehicle's fastest profile + 4 seconds	Deviation: ± 1.0 seconds or less	Deviation: ± 0.5 seconds or less
51.5	0.00	135.3	99.8%	93.7%
(Current location) 79.8	0.75	163.1	99.4%	89.7%
(JAMA request) 95.0	1.18	178.9	99.1%	87.3%
100.0	1.31	183.9	99.0%	86.8%
150.0	2.66	233.9	97.0%	79.4%
200.0	4.01	283.9	94.5%	73.3%
250.0	5.36	333.9	91.5%	67.7%
300.0	6.71	383.9	88.4%	63.2%

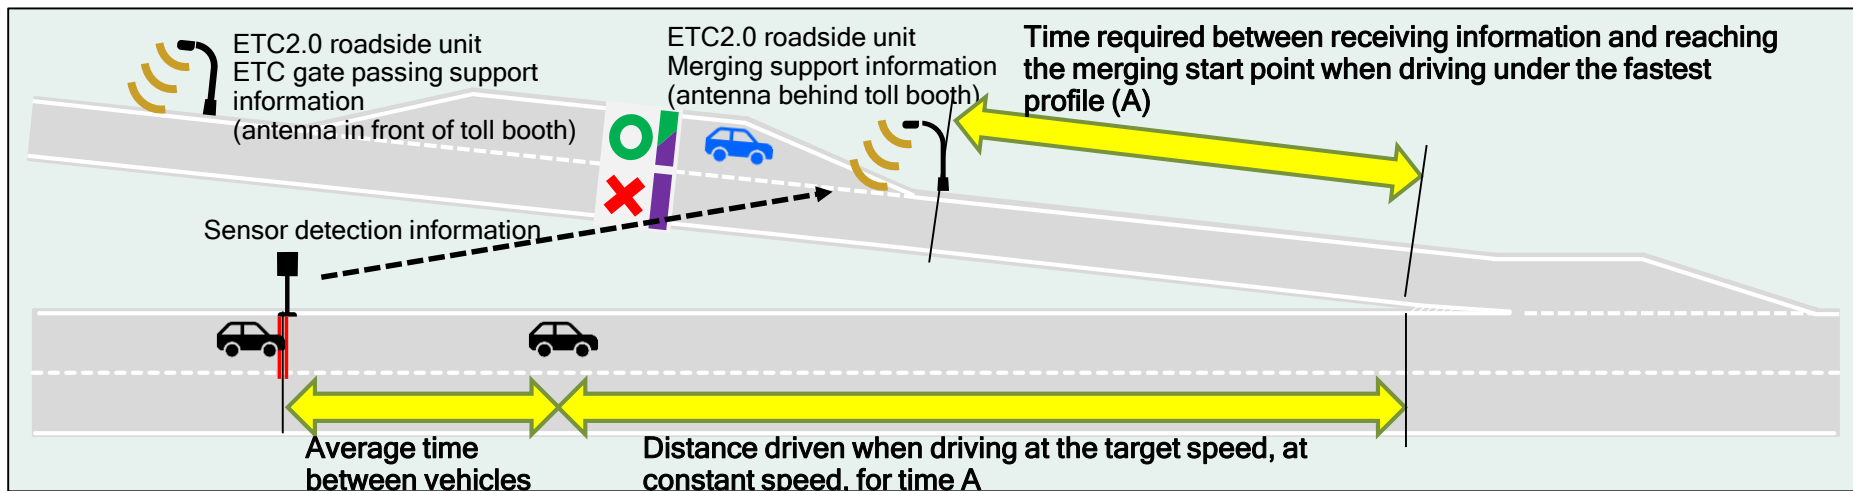
[Verification method]

- We calculated the distance between the information provision location and the merging area based on the time required to ensure a 1 second adjustment margin under the fastest profile for different target speeds
- We calculated the distance (and sensor installation location), hypothesizing that vehicles on the cruising line travel at the target speed at a constant speed for the time required to reach the merging area + the average time between vehicles

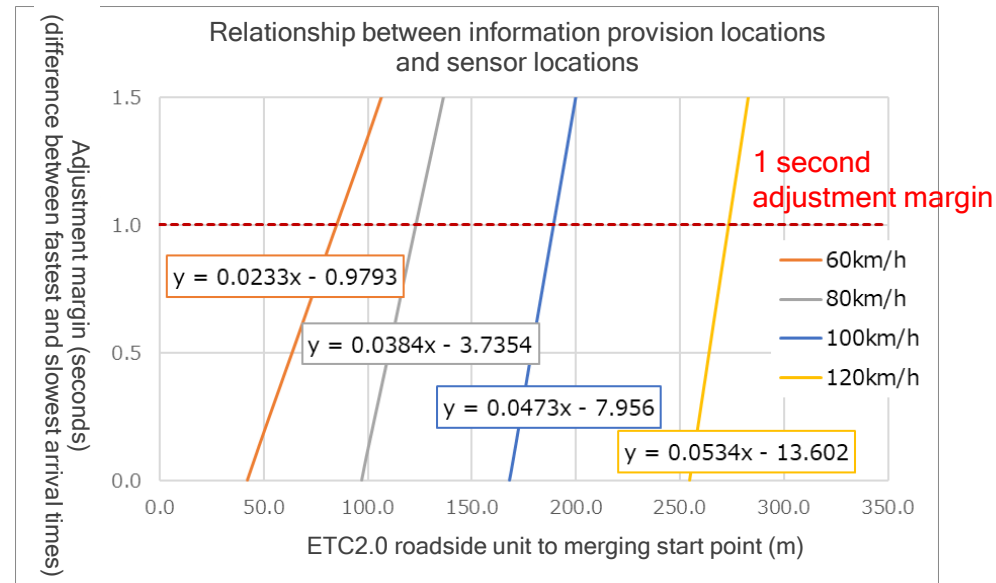
- We calculated the required time for merging vehicle fastest profiles based on the target speed and information provision location
- We added 4.0 seconds to the required time for the fastest profile and calculated the sensor location

* On expressways, following distances are usually linked to speeds, so by adding 4 seconds, we were able to include the vehicles following the vehicle in the cruising line within the information provision range

Target speed (km/h)	Information provision location to merging start point (m)	Sensor to merging start point (m)
60	84.9	161.0
80	123.3	246.4
100	189.0	375.3
120	273.4	528.3

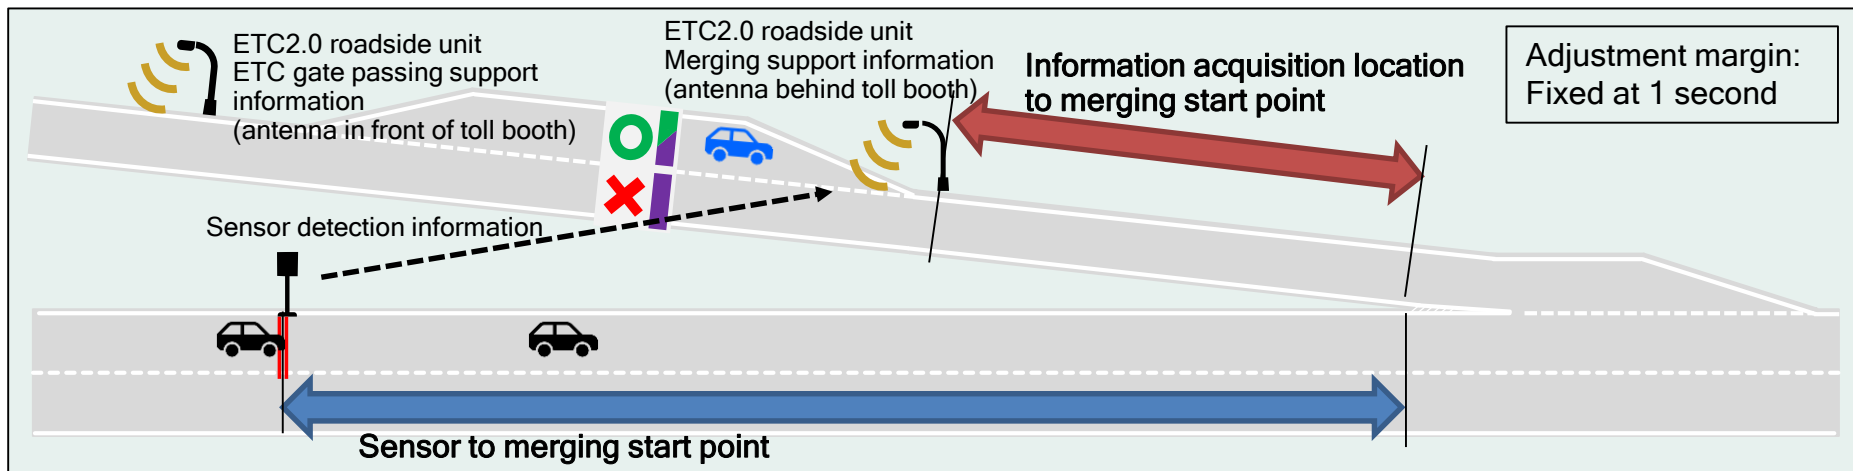
- The faster the target speed (=cruising line speed), the greater the distance between the information provision point and the merging area required to secure an adjustment margin of 1 second, and the greater the distance between the sensor and the merging start point

Target speed (km/h)	Information provision location to merging start point (m) Distance required to ensure 1 second of difference in required times for merging vehicles between fastest and slowest profiles	Sensor to merging start point (m) Distance driven when driving at the cruising line speed at constant speed for the required time under the merging vehicle's fastest profile + 4 seconds
60	84.9	161.0
80	123.3	246.4
100	189.0	375.3
120	273.4	528.3

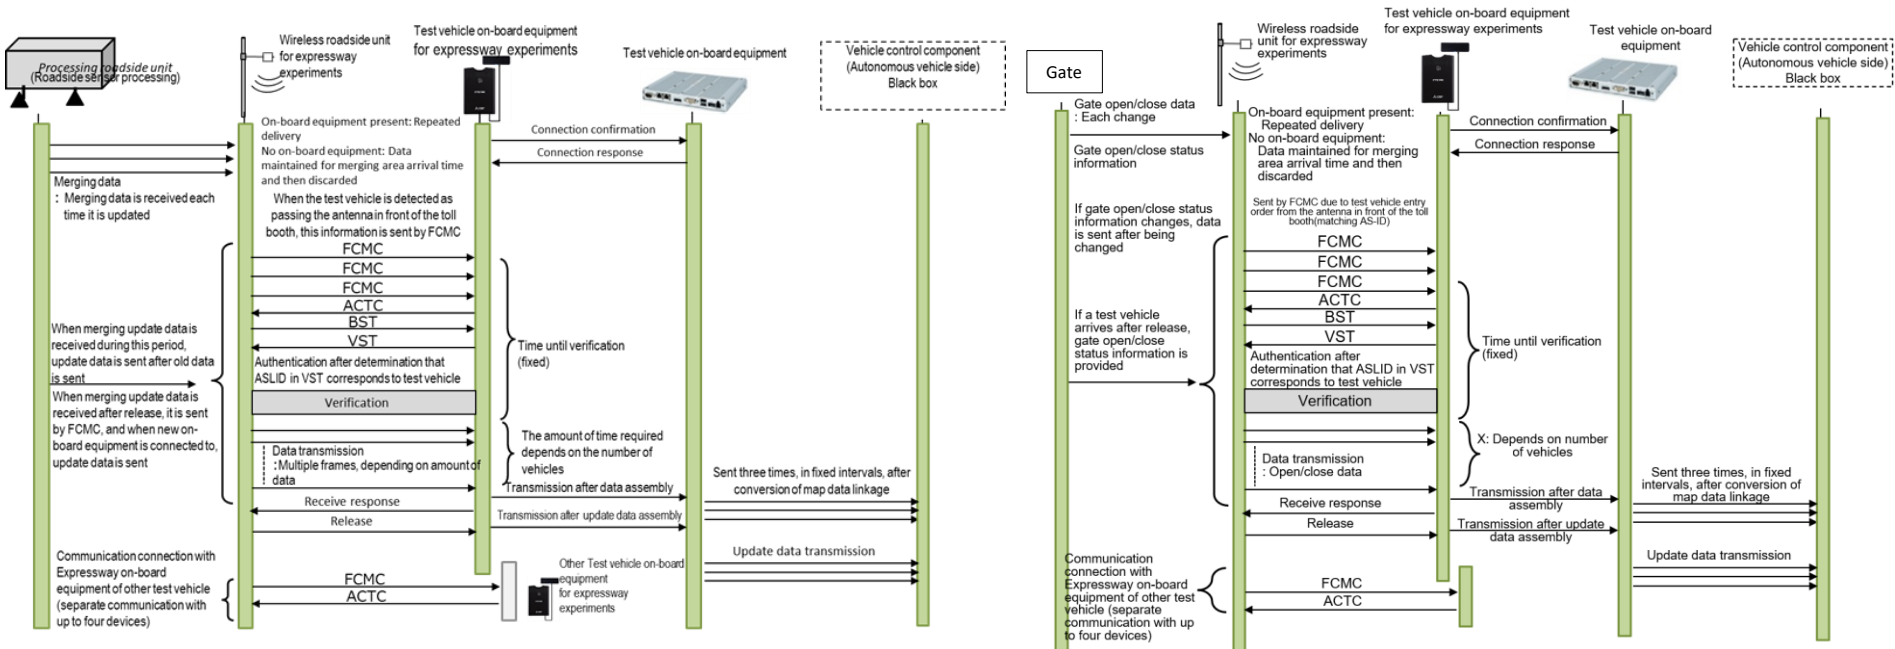
Fig. Transmission sequence between units when providing merging support

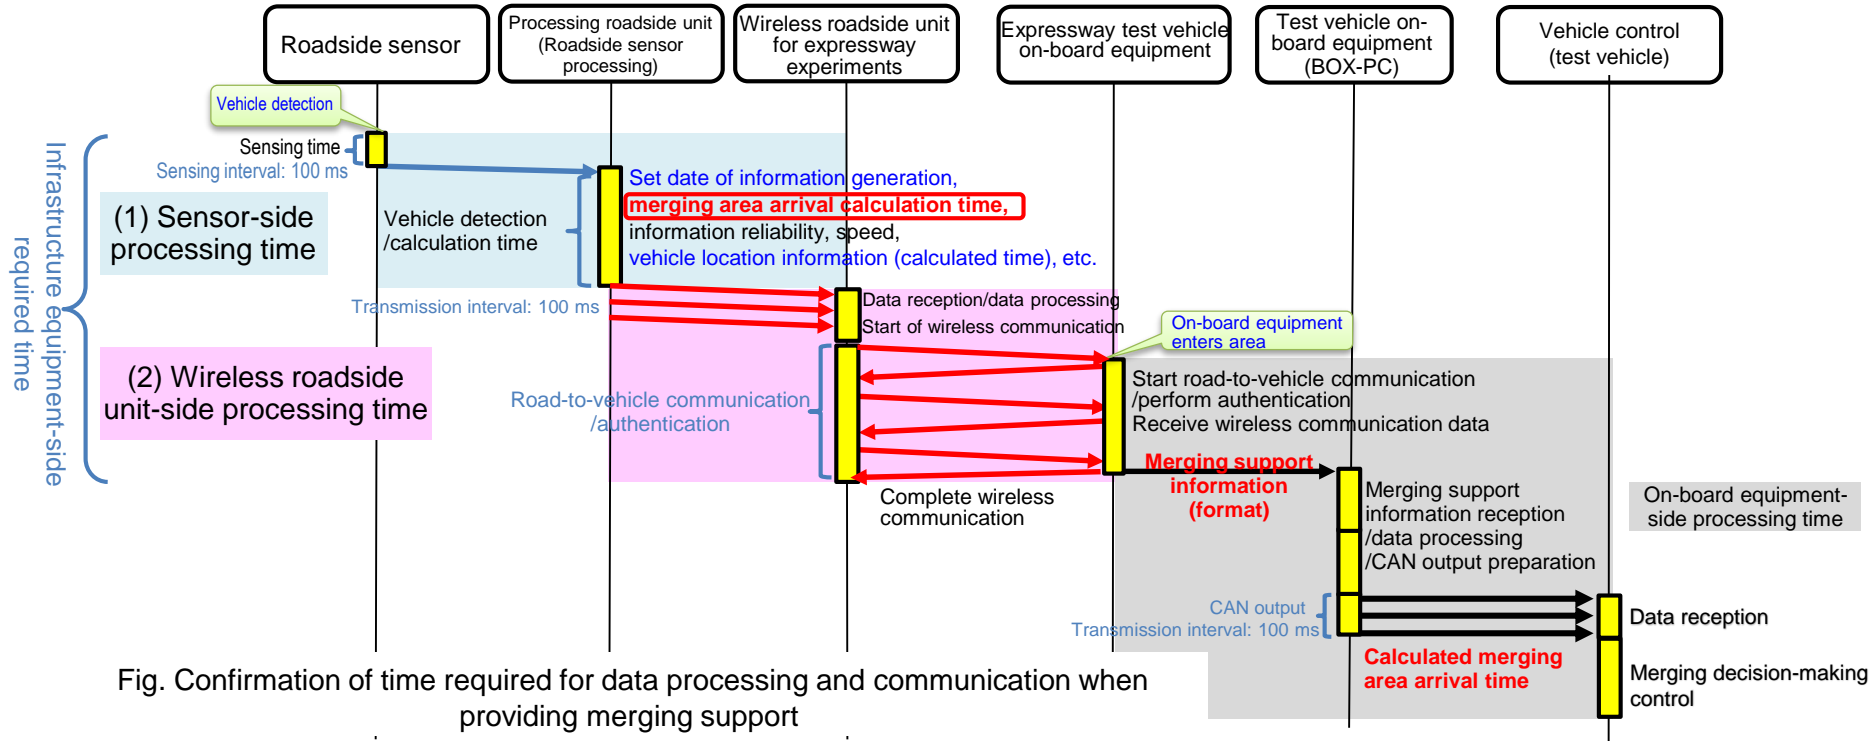
Fig. Confirmation of time required for data processing and communication when providing merging support

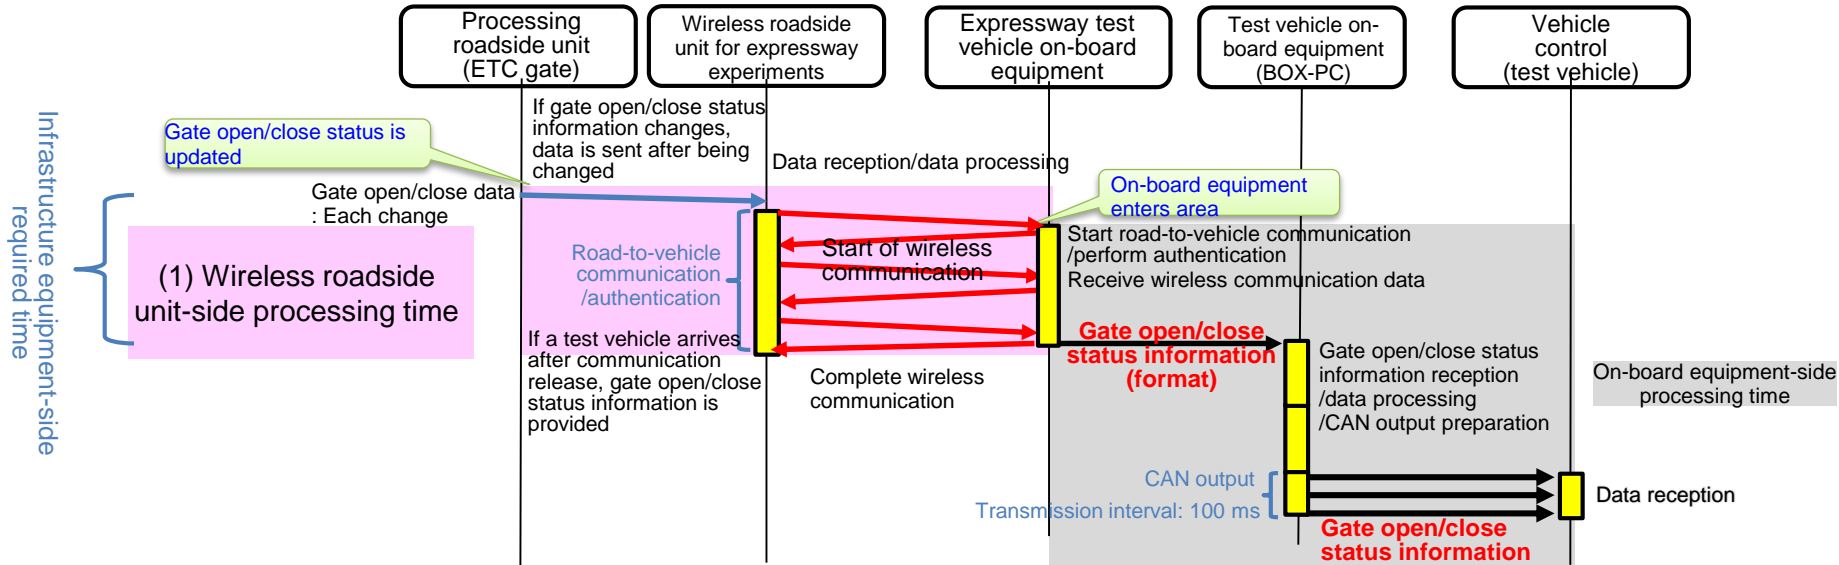
Fig. Confirmation of time required for data processing and communication when providing ETC gate passing support

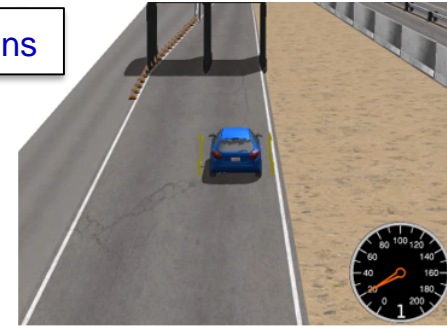
- The road structure of the Airport West Entrance and the congestion conditions of the cruising line (steady traffic/congestion/traffic jam) were reflected in the simulator
- We generated merging vehicles in the simulation and verified the merging success rates when using merging support information, depending on the location of the infrastructure (roadside units/sensors) used to provide the merging support information.

Merging simulation

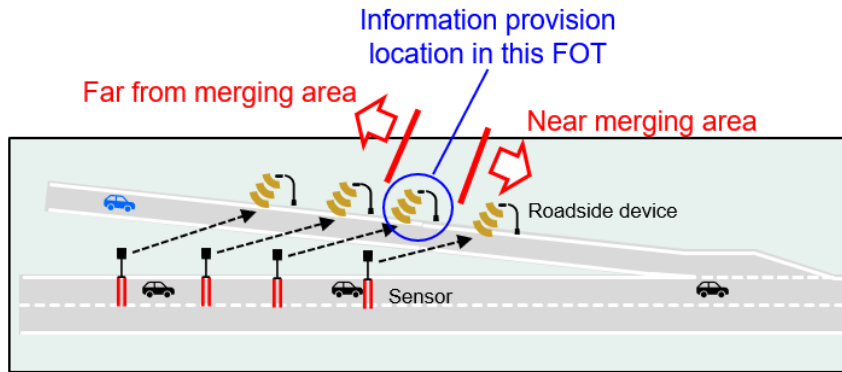
Relationship between roadside unit location and sensor location

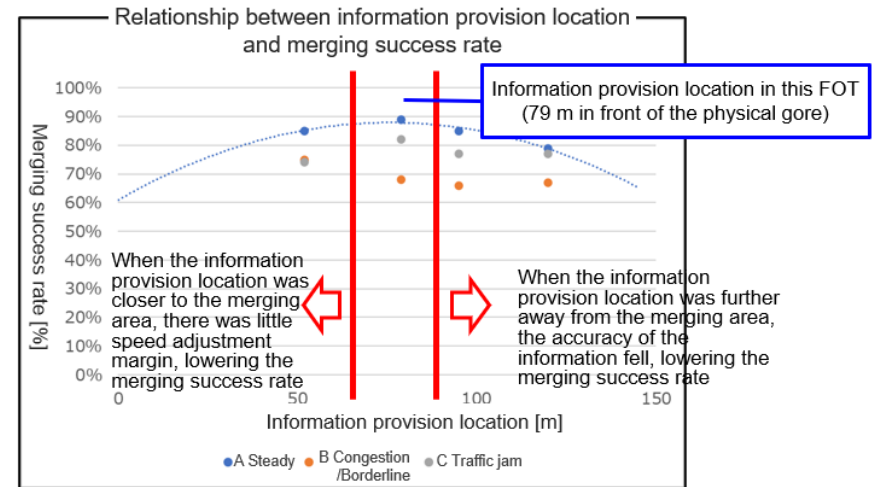
Merging success rates by roadside unit, sensor location, and cruising line traffic conditions
