“Cross-ministerial Strategic Innovation Promotion Program (SIP)
Phase Two - Automated Driving (Expansion of Systems and Services)
/Implementation of FOTs in the Tokyo Waterfront Area”
- 2020 Results Report Overview (Attachment A) -

FOTs in the Tokyo Waterfront Area Consortium

May 2021

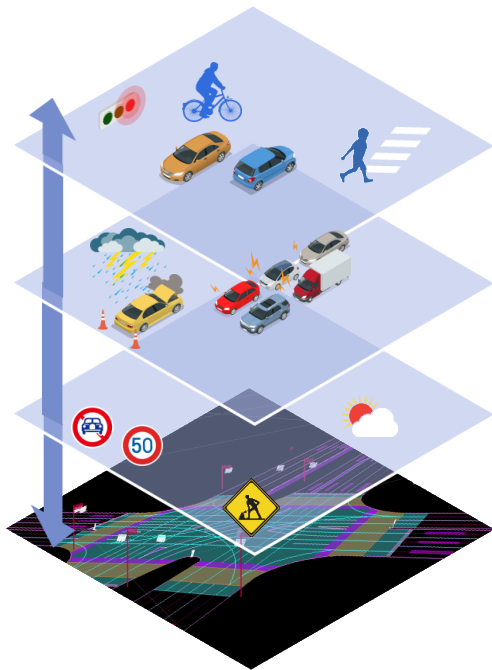
- The data used in the FOTs, based on the four levels dynamic map structure, is as shown below.

Dynamic map structure
(Defined in SIP Phase 1)

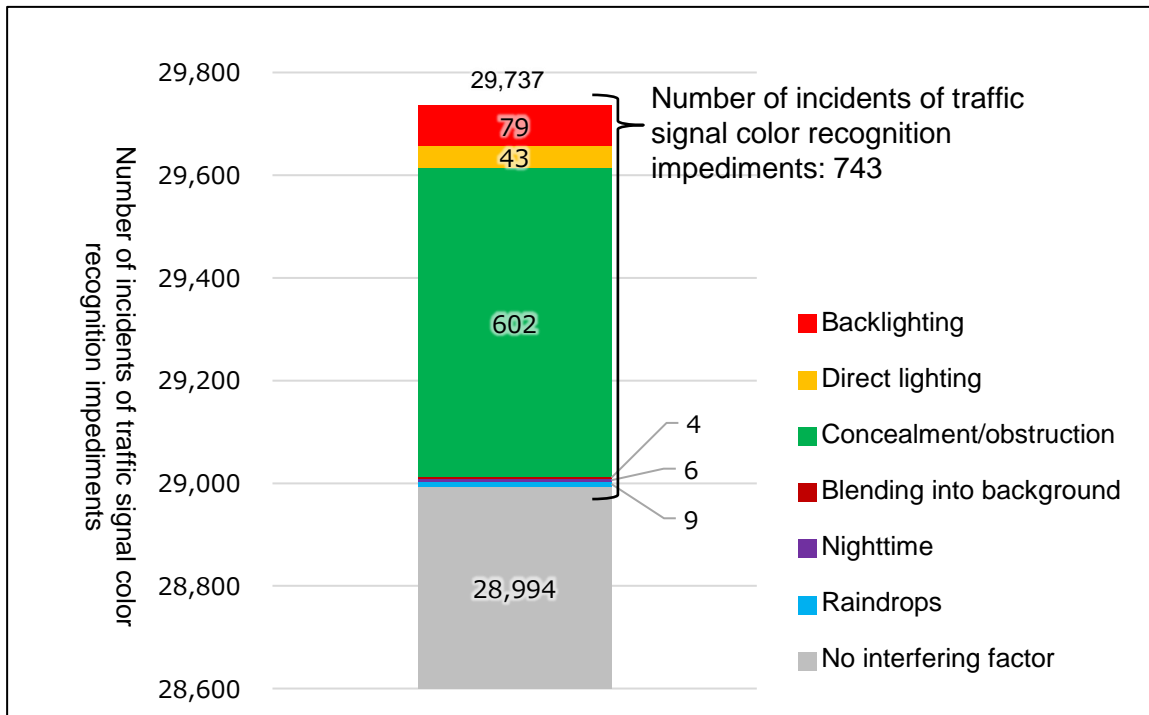
Of the 29,728 total intersection traversals*, the number of cases of backlighting, direct lighting, concealment/obstruction, blending into the background, nighttime, and raindrops were confirmed

Number of incidents of each type of traffic signal color recognition impediment in all traversals of intersections during the FOTs in the Tokyo Waterfront area

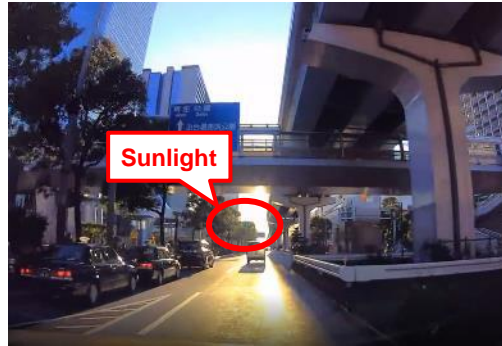
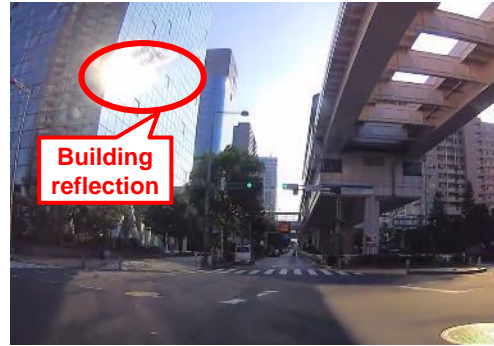
1) Effectiveness of traffic signal color information when there is backlighting

- Backlighting made it difficult to recognize traffic signal colors at times, so having traffic signal information was valuable
- The amount of time that recognition accuracy fell was extremely short, so traffic signal colors immediately before and after were identified by on-board cameras and traffic signal colors were identified throughout driving

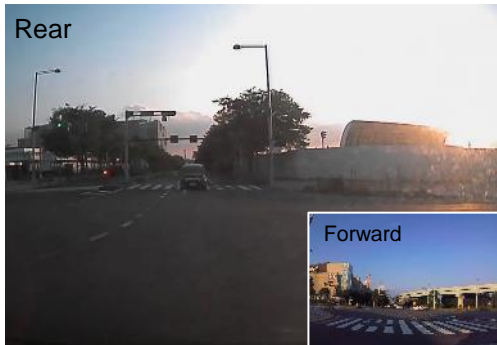
<2020/8/25 17:23 Aomi 1-chome>

2) Effectiveness of traffic signal color information when there is direct lighting

- The traffic signal color recognition accuracy of the camera dropped slightly for just a moment
- The drop in the traffic signal color recognition accuracy of the camera was only momentary, so it had no impact on intersection traversal decision-making

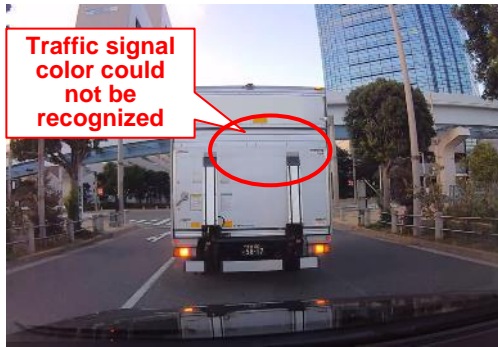
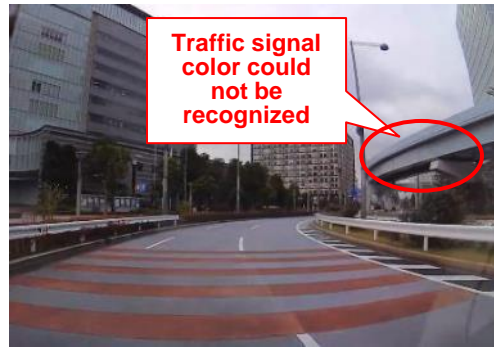
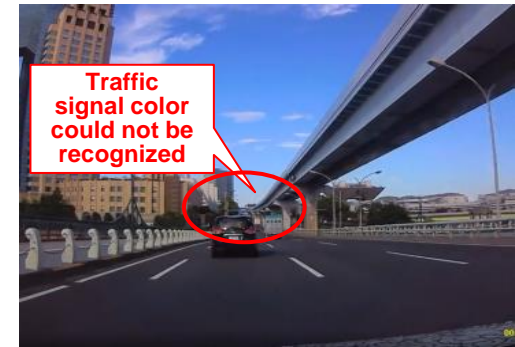
- A large truck concealed the traffic light, so when the traffic signal color changed to green, the vehicle did not recognize the change for four seconds. Using the traffic signal remaining seconds information made it possible to prepare to move forward even before the traffic signal color could be seen
- Traffic signal information was received before reaching the traffic signal, which made it possible to perform appropriate vehicle control, such as preliminary deceleration.

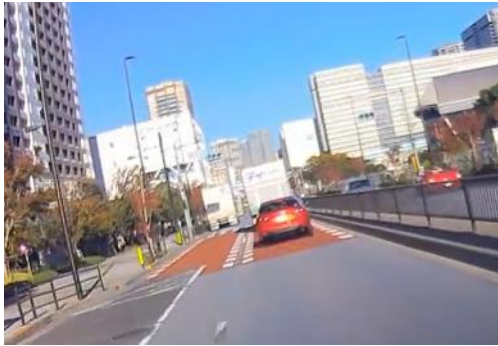
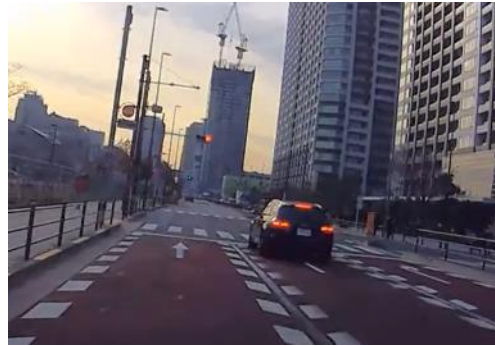
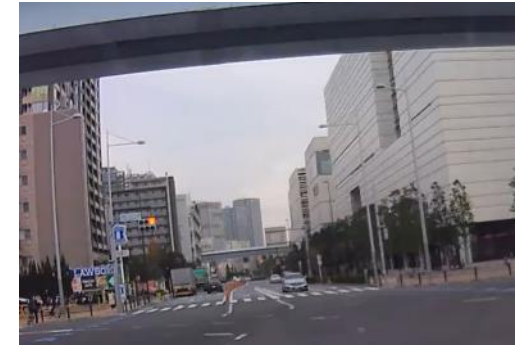
- The color of the traffic signal could be determined, but the traffic signal's outline, etc. blended in with the building behind it or other background elements, reducing the reliability of traffic signal detection.

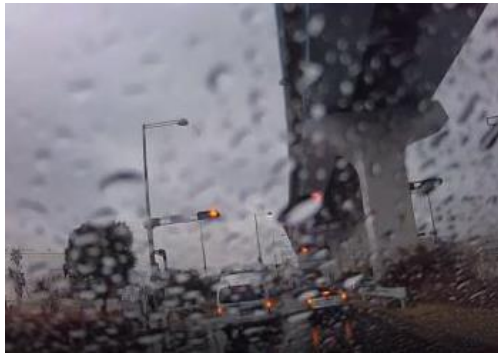
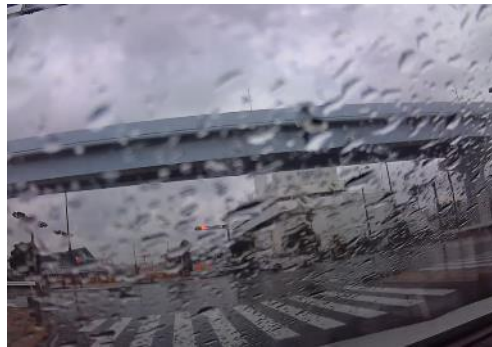
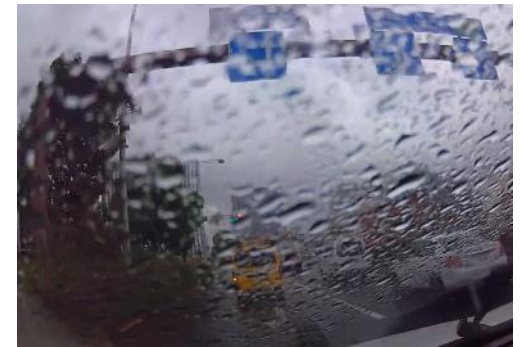
- Sometimes, rain fell on the front camera, making traffic signal color recognition difficult.

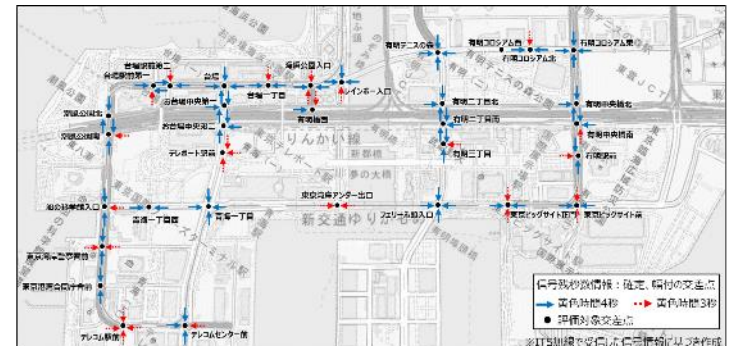
(II) Speed limits in the Waterfront City area

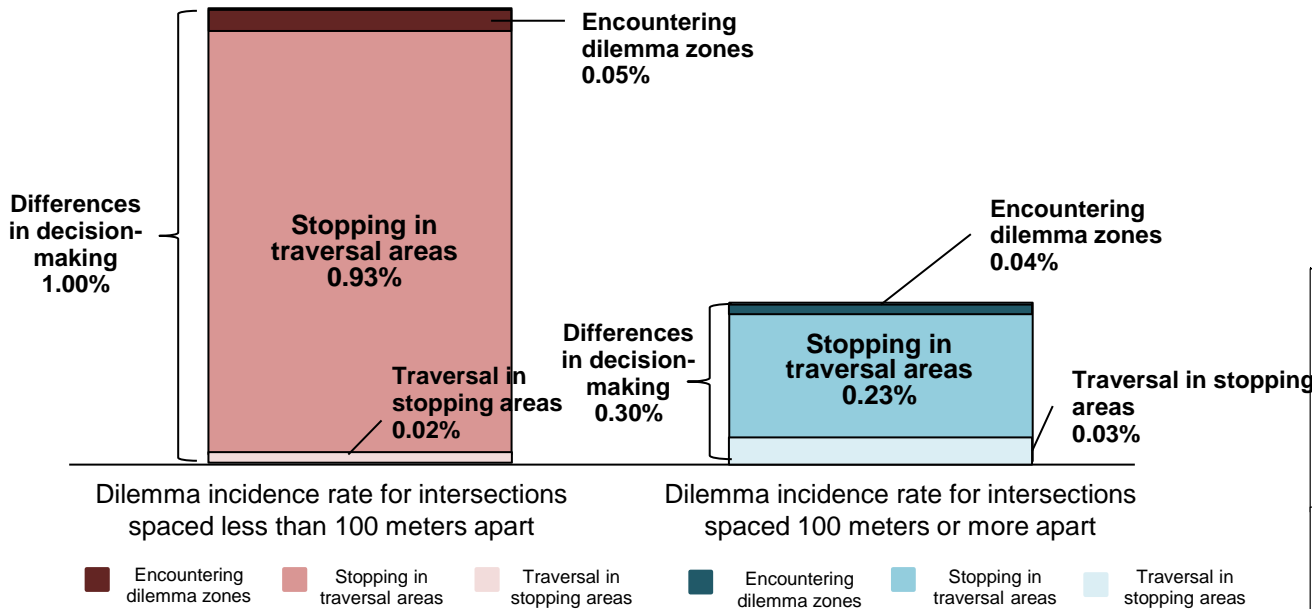
➔ Traffic signal information reaches 100 meters or further, so "following intersection" traversal/stopping decisions can be made in advance

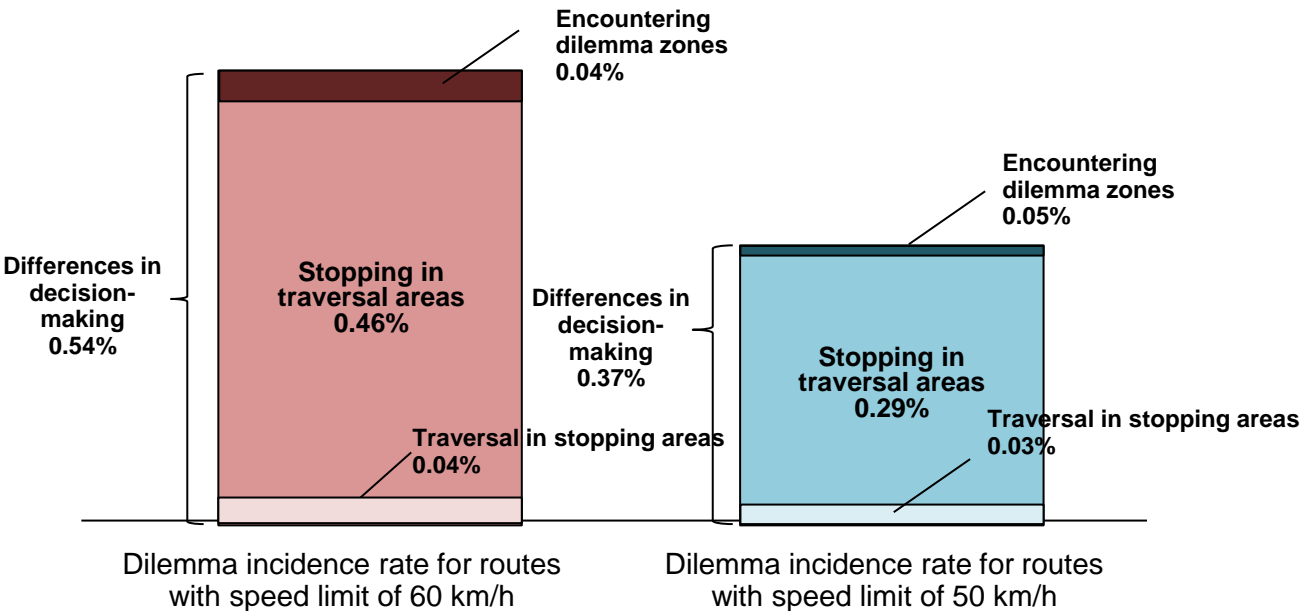
The number of cases of stopping in traversal areas was high for routes with 60 km/h speed limits.

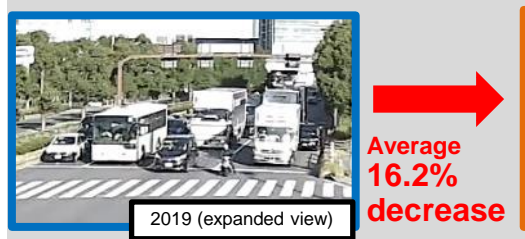
Through observation of traffic volume on three weekdays at selected measurement times, it was confirmed that **overall traffic volume decreased**

→ Average 16.2% decrease

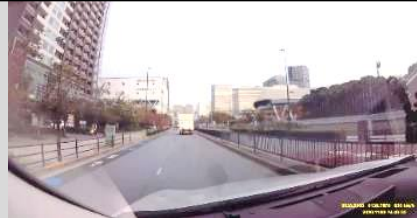
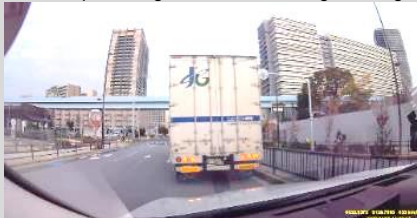
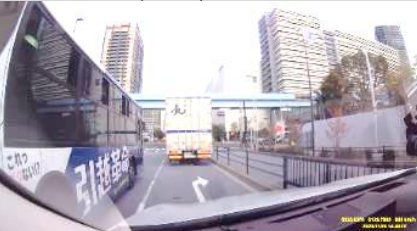
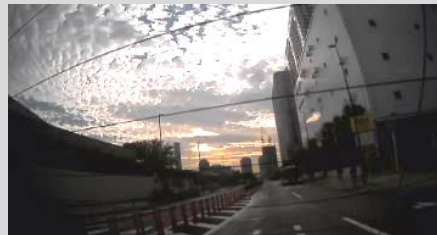
* In preparation to turn right, the test vehicle followed the large vehicle in the second lane.

The test vehicle entered the right turn lane and rapidly approached the stopped large vehicle. Rapid braking and stop

The test vehicle followed the large vehicle in the second lane at the legal speed (approx. 50 km/h). The preceding vehicle drove straight through the intersection.

The test vehicle entered the right turn lane, rapidly approached the stopped large vehicle, and rapidly braked (-0.56G)

When the right turn arrow turned green, driving resumed (the vehicle stopped without passing through during a single signal cycle), and there was no impact on following vehicles.

Analysis: When the vehicle in front of a test vehicle is a large vehicle, it makes it difficult to determine conditions in front of the vehicle (traffic signal status, right turn queue, etc.), which results in rapid braking.

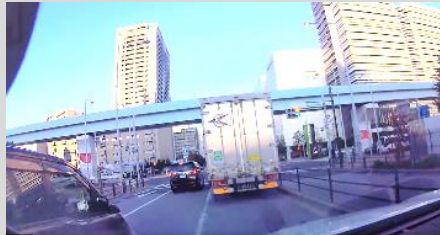
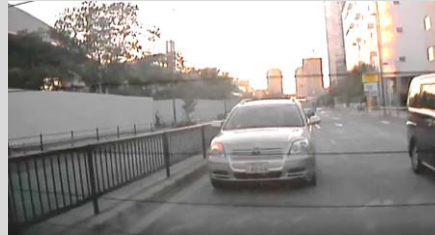
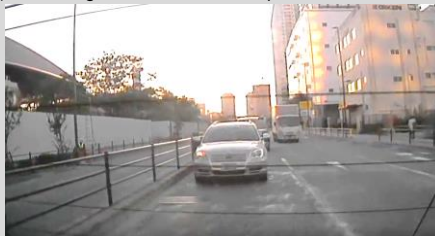
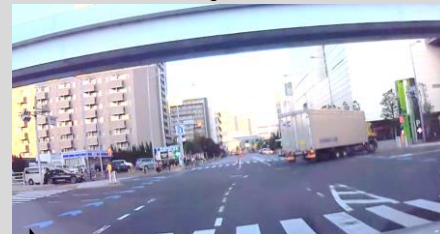
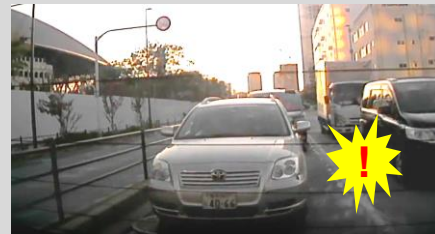
■ Behavior of automated driving when the traffic signal changes when driving straight forward, etc. (right turn) ID: 16161

* Case of an autonomous vehicle entering a queue of vehicles waiting to turn right and the traffic signal changing from yellow to red. The following vehicle intended to pass through the intersection, but the autonomous vehicle in front of it stopped, resulting in the risk of a rear-end collision

A group of cars was waiting to turn right. The right turn traffic signal turned green and vehicles accelerated (following timing was somewhat slow). Following vehicles also lined up.

The traffic signal arrow turned yellow, so the test vehicle rapidly braked. The following vehicle intended to turn right, so it accelerated.

Because the test vehicle stopped, the following vehicle suddenly stopped with a small amount of knocking. It was a close call.

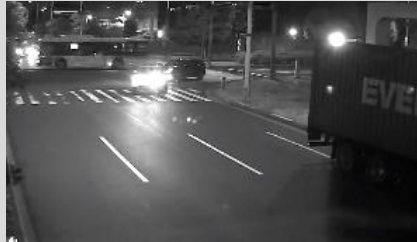
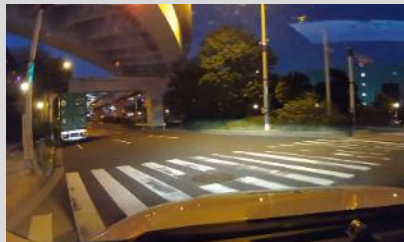
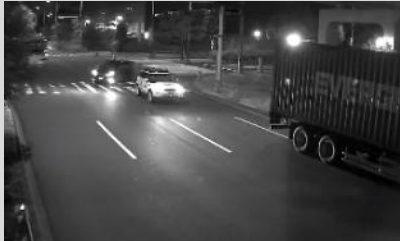
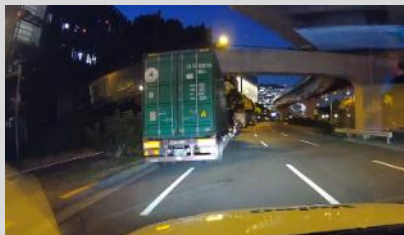
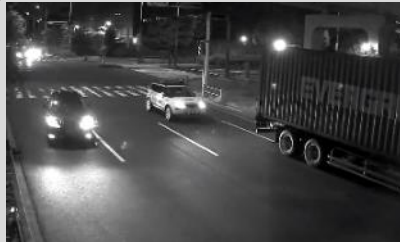
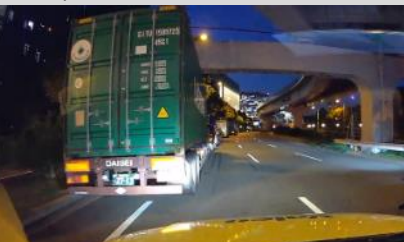
Vehicle travel route

Turning left at an intersection.

After the vehicle turned left, it detected a vehicle parked on the street and decelerated.

After decelerating, it was passed by the vehicle that was following it.

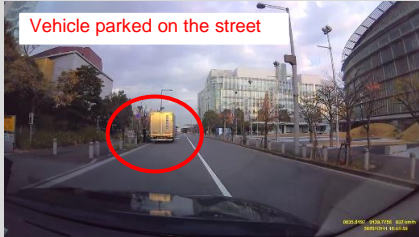
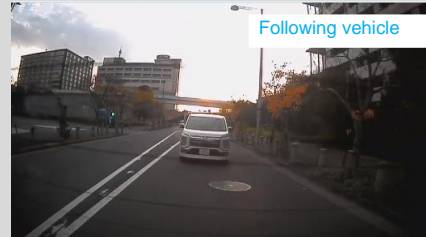
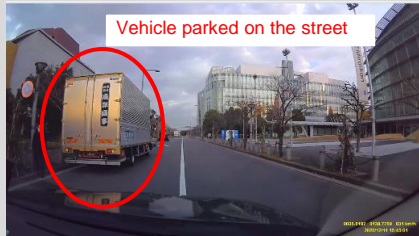
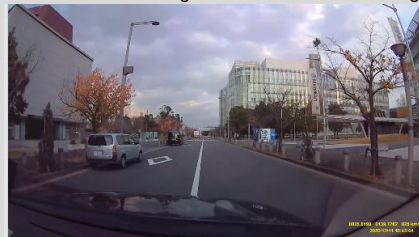
ID: 36314

* We confirmed congestion involving a following vehicle when test vehicles engaged in avoidance behavior when encountering a vehicle parked on the street

A following vehicle was present when the test vehicle encountered a vehicle parked on the street

When the test vehicle engaged in avoidance behavior, it caused congestion involving a following vehicle. The test vehicle began avoidance behavior roughly 30 to 10 meters before reaching the parked vehicle

The test vehicle engaged in avoidance behavior and passed the parked vehicle. There were three parked vehicles in a row, so the test vehicle engaged in avoidance driving for a long distance.

Analysis: We confirmed a situation in which congestion involving nearby vehicles (following vehicles) was caused when a test vehicle encountered a vehicle parked on the street

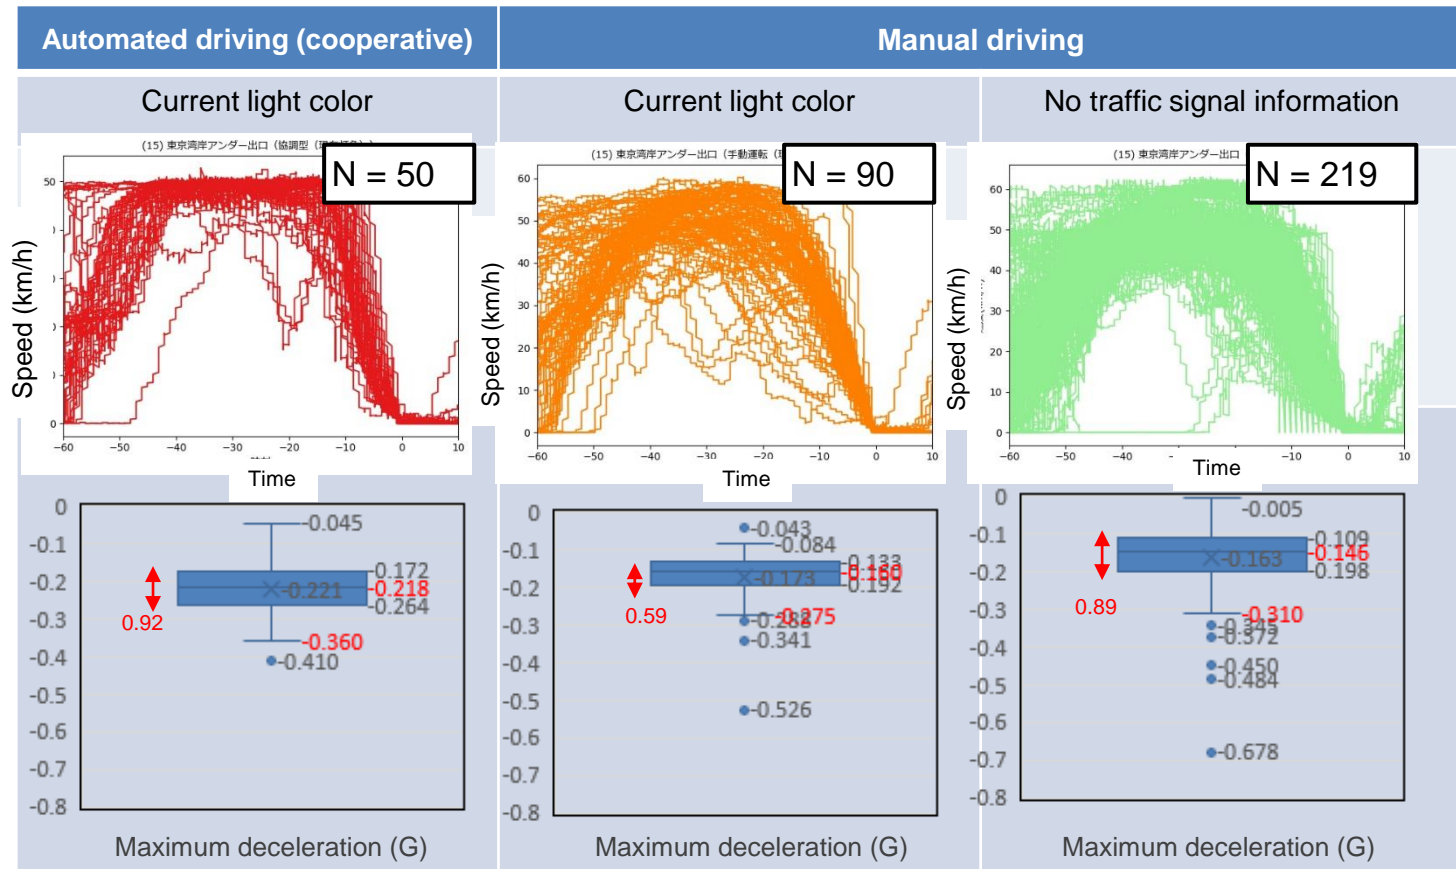
2-2) Results - Target intersection:(15) Tokyo Wangan Underpass Exit **[Current light color information only]**

- Cooperative driving (current light color) had the largest average maximum deceleration, largest maximum deceleration, and largest quartile range
- This indicates that current color information alone may be insufficient for modifying red traffic light deceleration behavior

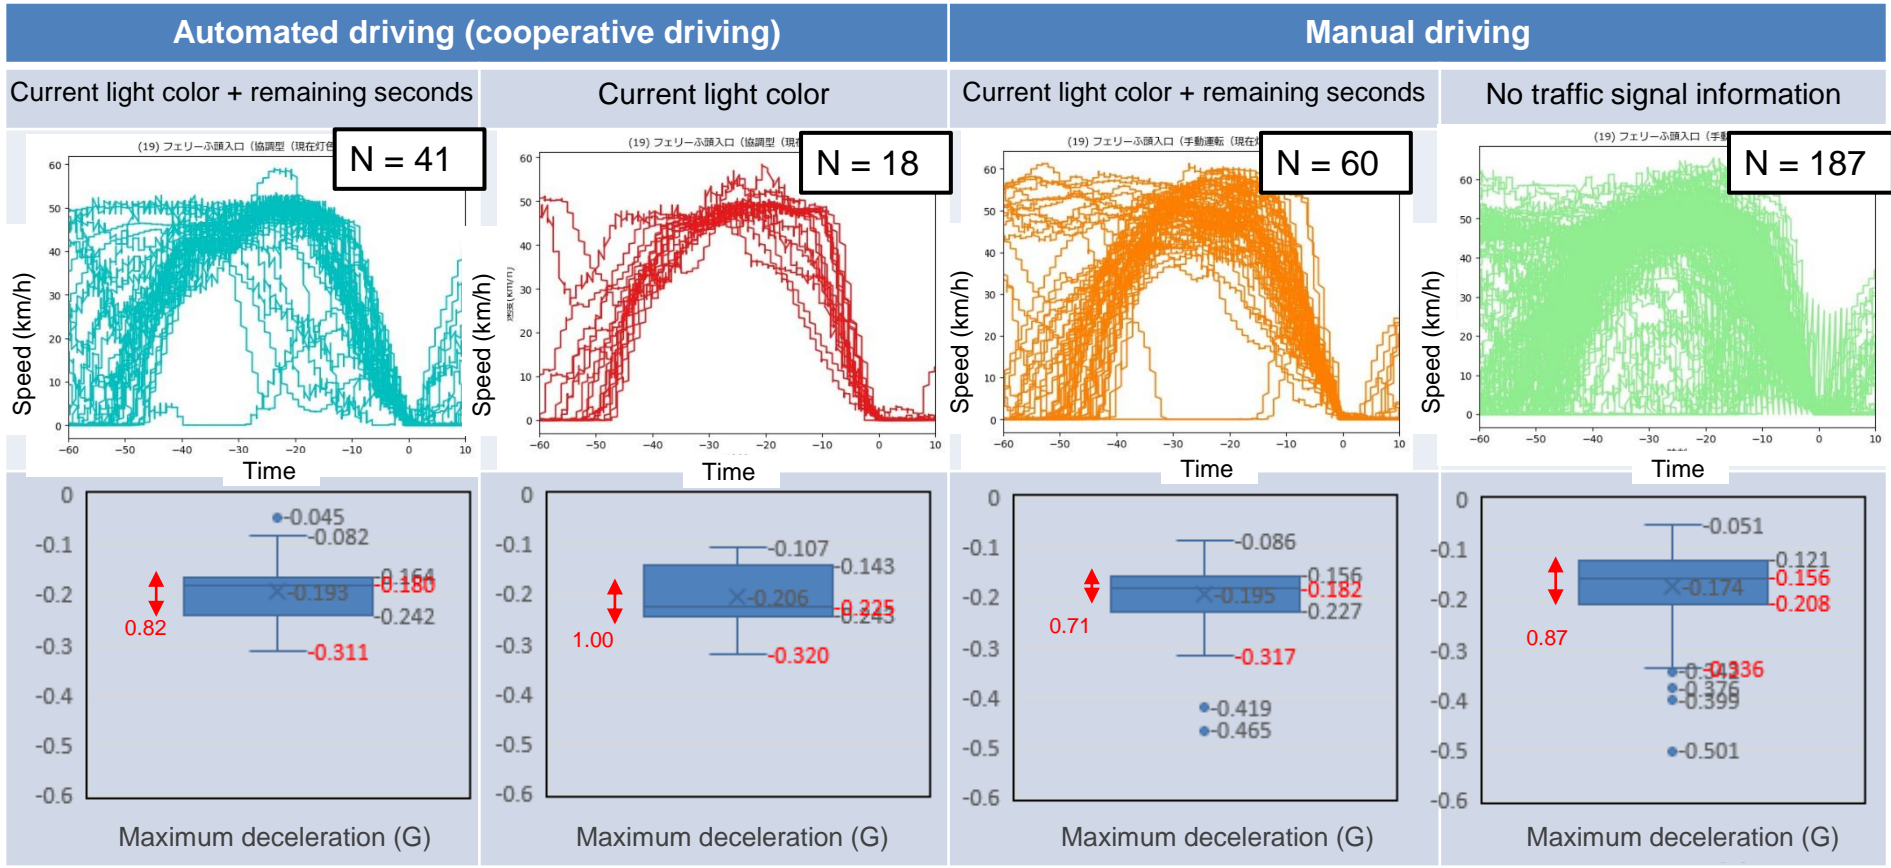
2-2) Results - Target intersection: (19) Ferry Terminal Entrance **[Current light color + remaining seconds information (w/ margin)]**

* Providing remaining seconds information was somewhat effective in improving the maximum deceleration.
 → Providing remaining seconds information (w/ margin) is believed to have contributed to more stable driving

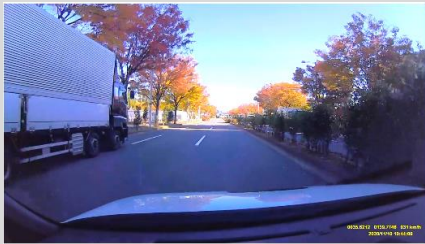
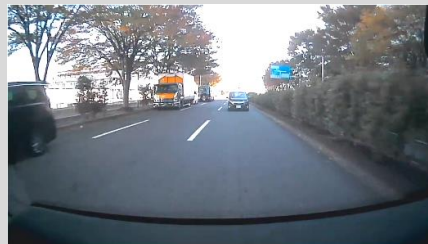
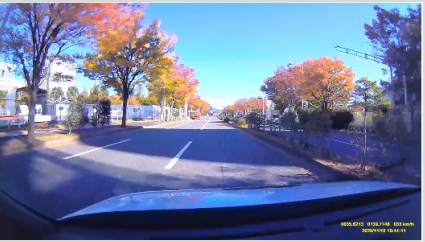
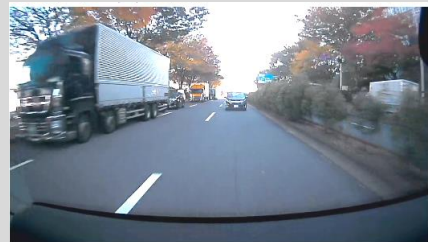
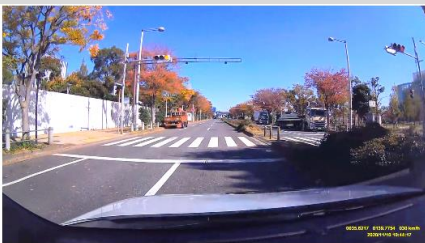
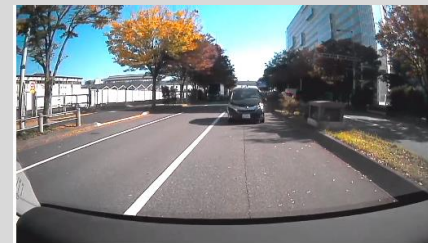
ID: 31268

* Situation when stopping at a red light when driving straight forward.

The vehicle was driving at 37 km/h.

Immediately after the light turned yellow, the vehicle began decelerating.

The vehicle stopped with some degree of leeway. There was no congestion with following vehicles

Analysis: Confirmation of the effectiveness of infrastructure information (current light color, remaining seconds information)

- * There was no congestion with following vehicles.
- * The vehicle engaged in safe stopping behavior using the current light color and remaining seconds information (confirmed)

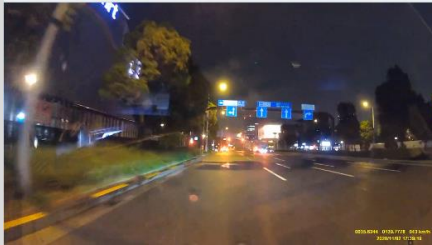
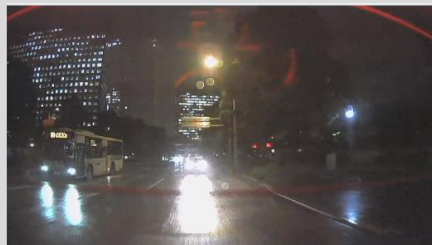
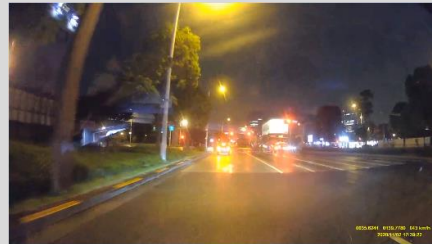
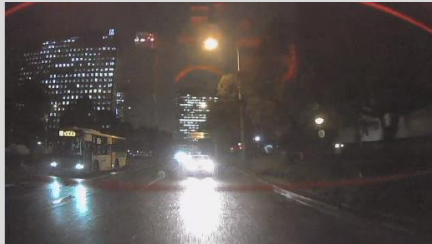
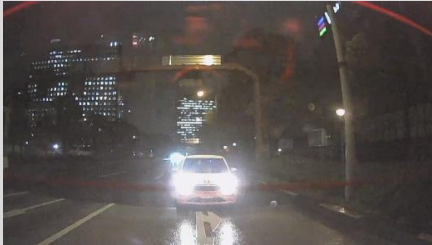
ID: 27105

■ Behavior of automated vehicle when stopping at a red light while driving straight
 · [Cooperative (current traffic light color + remaining seconds)] Situation in which there was preliminary deceleration and a gradual stop

Infrastructure information was received and the test vehicle began preliminary deceleration in advance (98 meters before reaching the stop line)

The test vehicle detected a vehicle waiting at the intersection, and began further deceleration

The vehicle stopped. There was no sudden deceleration and no congestion involving the preceding vehicle.

Analysis: Safe stopping behavior was achieved using preliminary deceleration + spatial monitoring

- * Infrastructure information (current light color information) was used to perform preliminary deceleration
- * Even when a preceding vehicle was encountered, spatial monitoring made safe stopping possible.

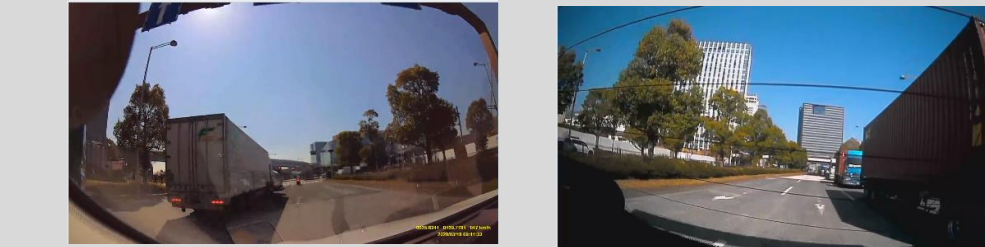
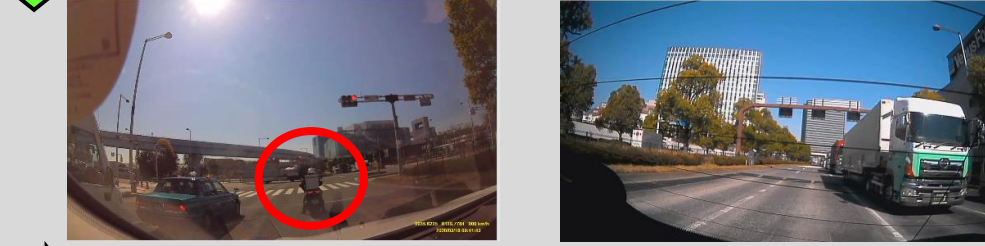
■ Behavior of automated vehicle when stopping at a red light while driving straight
 ***[Autonomous]** Situations involving sudden deceleration near an intersection and the possibility of a close call involving the preceding vehicle

↓ The test vehicle detected a traffic light and a preceding vehicle (motorcycle) and began decelerating (72 meters before the stop line)

↓ The test vehicle was close to the intersection, so it decelerated rapidly (-0.3G)

→ The test vehicle stopped after decelerating suddenly, and there was the potential for congestion involving the preceding vehicle

Analysis: Stopping based on spatial monitoring appears to be insufficient for carrying out safe driving

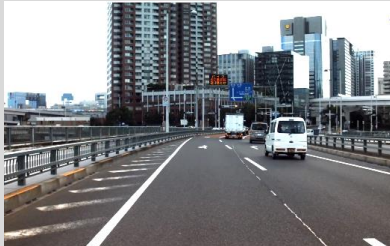
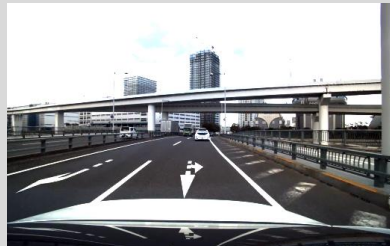
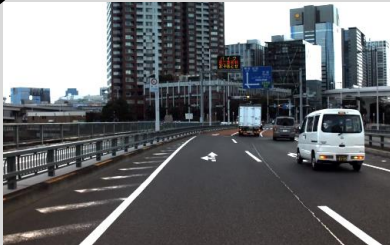
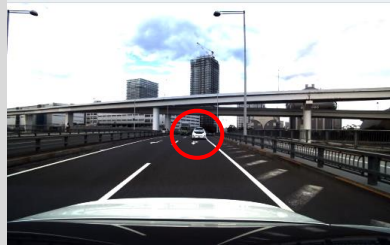
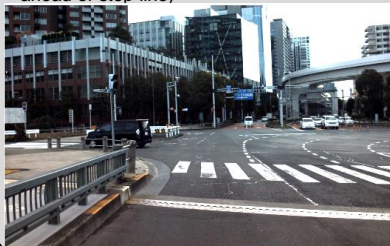
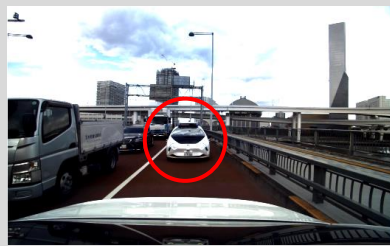
ID: 42358

* Current traffic light color + remaining seconds information alone were used to perform deceleration, and there was no congestion involving a following vehicle

The test vehicle was driving at 45 km/h, and there was a vehicle behind it

The test vehicle decelerated due to a red traffic light (-0.2G) (Deceleration start point: 82 meters ahead of stop line)

There was no congestion involving the vehicle following the test vehicle

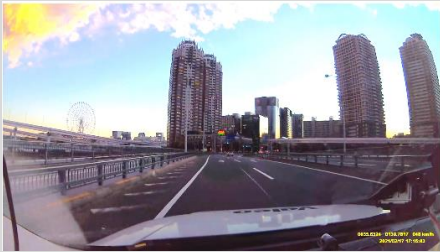
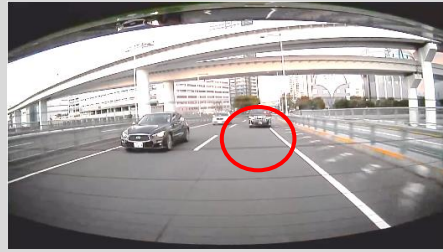
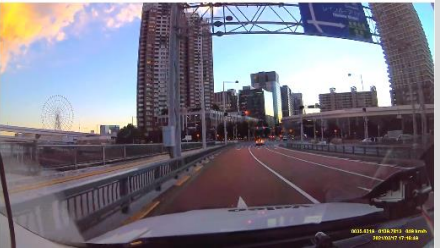
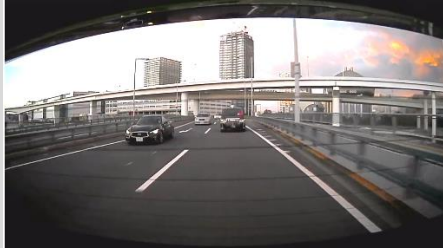
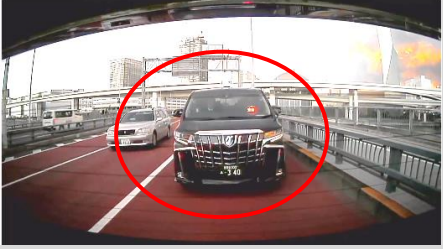
ID: 38831

* Situation in which deceleration was performed using current light color information alone and there was congestion involving a following vehicle

➡ The test vehicle was driving at 50 km/h, and there was a vehicle behind it

➡ The test vehicle decelerated somewhat suddenly due to a red traffic light (-0.24G) (Deceleration start point: 48 meters ahead of stop line)

➡ There was congestion involving the vehicle following the test vehicle

Analysis: We confirmed the importance of remaining seconds information

- This situation appears to have occurred because no remaining seconds information was used, so there was no preliminary deceleration and the test vehicle suddenly decelerated

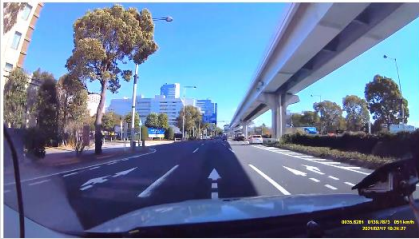
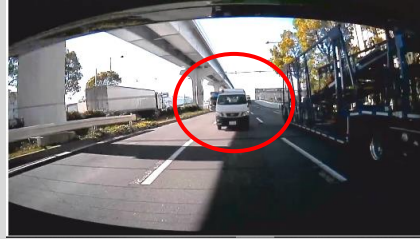
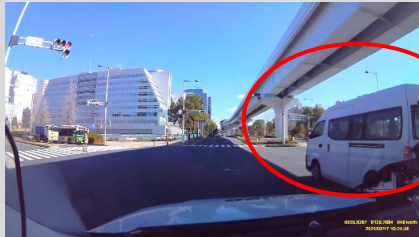
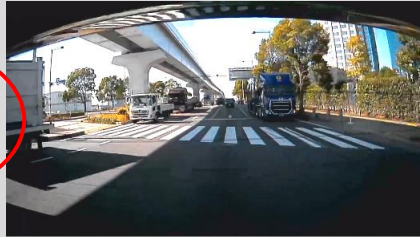
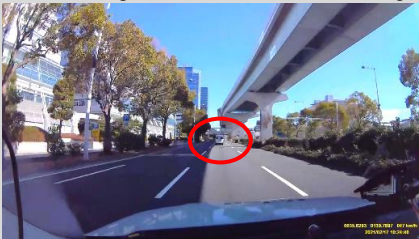
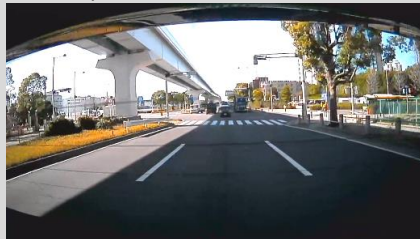
ID: 39016

* In situations in which speed deviations resulted in test vehicles driving straight forward being passed by ordinary vehicles, we observed no cases of test vehicle behavior (such as deceleration) which affected surrounding vehicles

→ The test vehicle was driving at 50 km/h, observing the speed limit

→ The following vehicle, circled in red, changed lanes and passed the test vehicle

→ Even when the test vehicle was passed, it was not observed to engage in any behavior that affected surrounding vehicles, such as deceleration

Analysis: Even when passing occurred, test vehicles were not observed to have an impact on surrounding vehicles

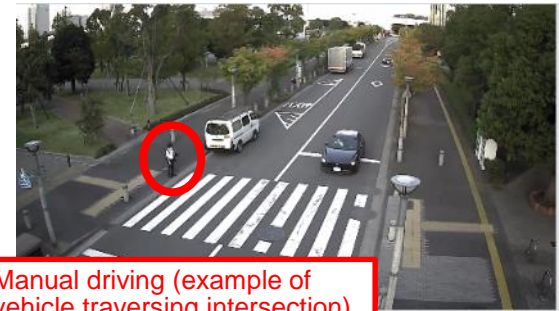
Manual driving (example of vehicle traversing intersection)

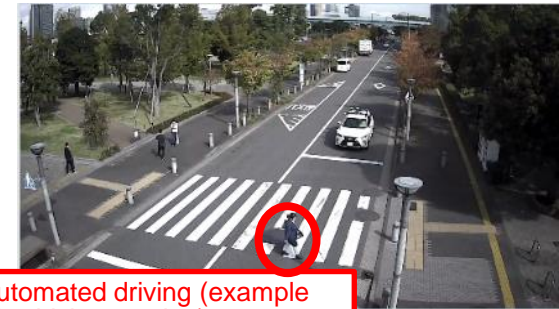
Automated driving (example of vehicle stopping)

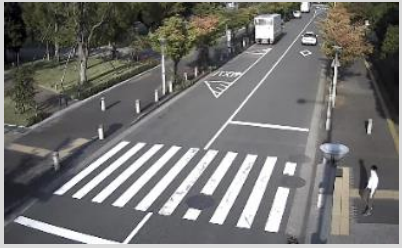
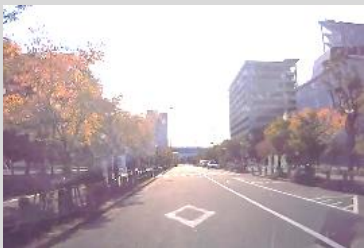
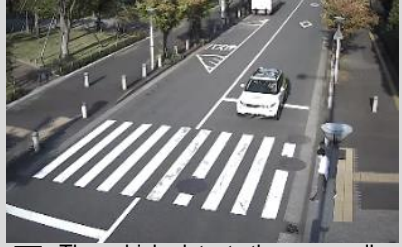
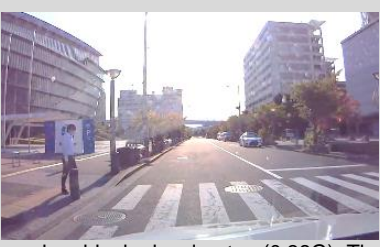
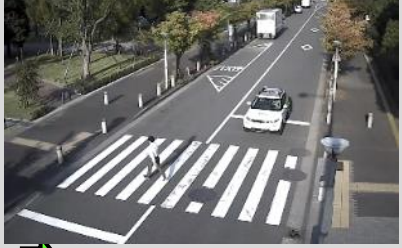
■ Behavior of autonomous vehicles when driving straight and encountering crosswalk pedestrians ID: 16057
 * Case of an encounter with a crosswalk pedestrian on a basic road section (with no traffic signal). The vehicle was slow to detect the crosswalk pedestrian, so it crossed the stop line by a large amount and drew near the pedestrian.

↓ The vehicle approaches the pedestrian crossing. It has not yet detected the presence of the crosswalk pedestrian.

↓ The vehicle detects the crosswalk pedestrian and suddenly decelerates (0.38G). The vehicle crosses the stop line by a large amount and draws near the pedestrian.

↓ After confirming that the pedestrian has crossed, the vehicle pulls forward.

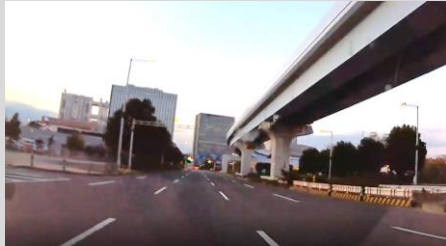
ID: 15645

* While driving at low speed (30km/h), a motorcycle cut in from the passing lane. The autonomous vehicle detected this, applied sudden braking, and stopped momentarily. Because this occurred in a basic road section, the following vehicle approached and there was a rear-end collision close call.

The vehicle was driving slowly (approx. 30km/h) in the second cruising lane (the speed limit was 50km/h)

Analysis: The autonomous vehicle was passed and cut in by a motorcycle behind it, partly due to its driving at slow speed. This caused sudden braking and resulted in a close call.

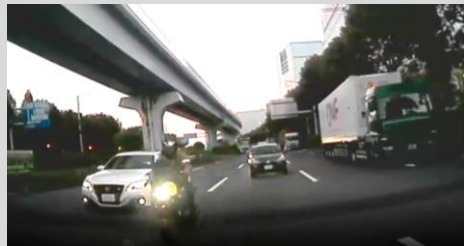
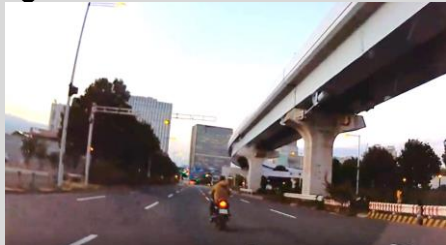
A motorcycle passed from the rear right and cut in. The vehicle detected this and applied sudden braking.

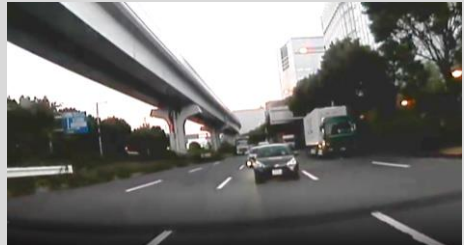
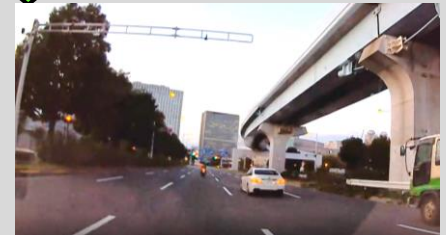
After sudden braking, the vehicle stopped momentarily. This surprised the following vehicle, which applied sudden braking (close call).

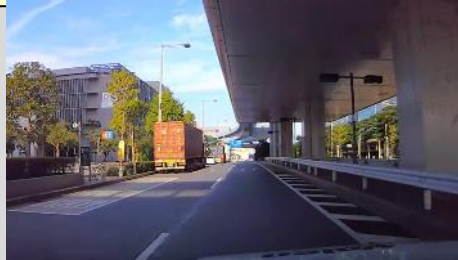
ID:16059

* While driving in the second cruising lane, the test vehicle encountered a bicycle and applied sudden braking. No impact on the following vehicle was observed.

The vehicle was driving in the second cruising lane.

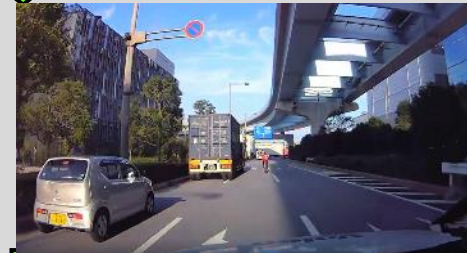
It detected a sports-type bicycle in front and applied sudden braking (approx. -0.44G).

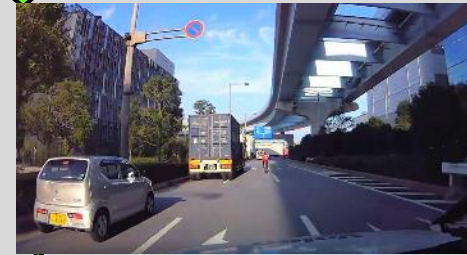
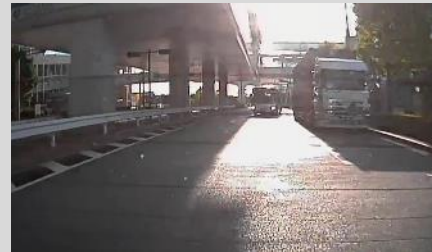
There was no impact on the following vehicle.

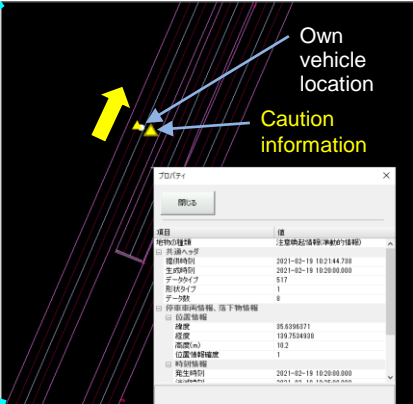
The tail end of the traffic jam was further back than the location indicated in the caution information

There was already a traffic jam at the data location.
Approx. 10:22:30 Speed: 23 km/h

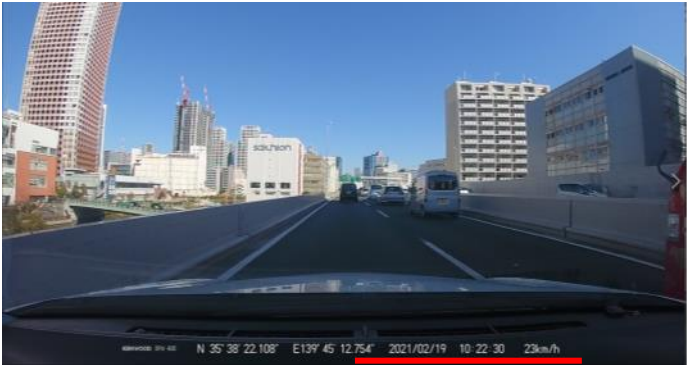
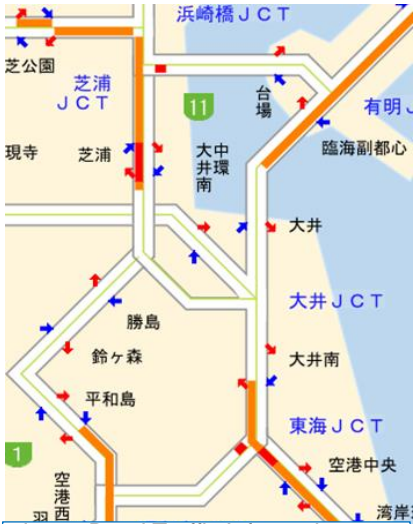
Japan Road Traffic Information Center website screen Feb. 19, 10:20 a.m.

The speed of the traffic slowed (to 30 km/h or less) approximately 4 1/2 minutes earlier (approx. 1.3 km ahead of the location in the caution information. 10:17:55 Speed: 30 km/h or less The right lane slowed approximately 10 seconds earlier.

The traffic jam was growing, so the situation is believed to have occurred because of the time lag between when the data was generated and when the location was reached.

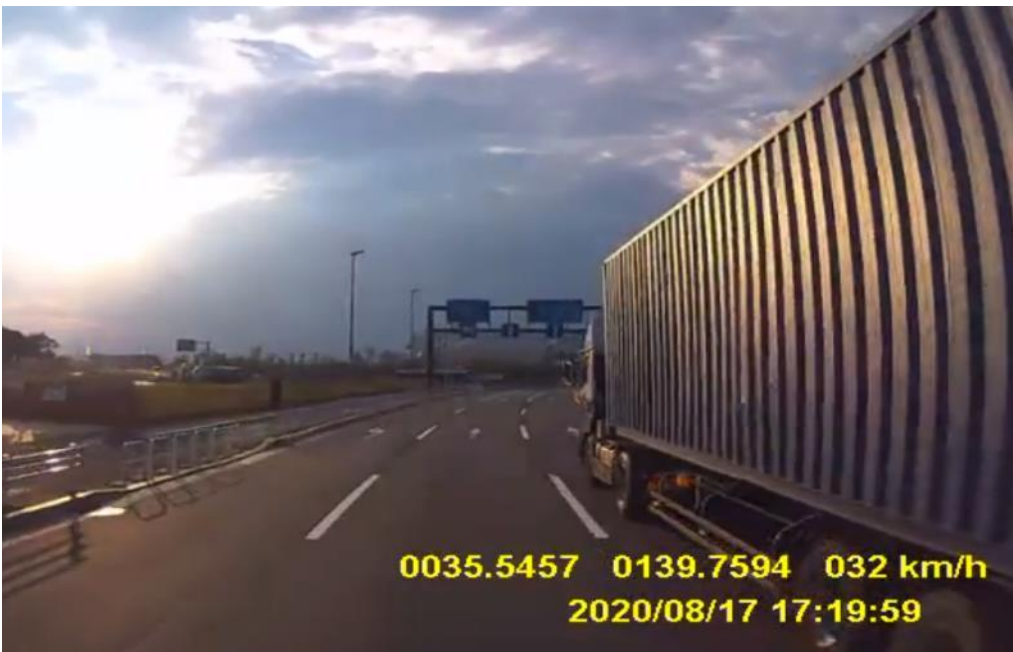
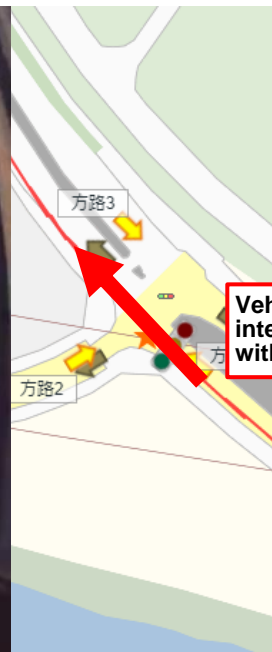
Identification of situations involving signal recognition difficulty

Name of intersection	Speed when obstruction occurred	Speed when traversing intersection	Issue
Haneda Airport 2-chome West	32 km/h	36 km/h	Obstruction of traffic signal by large vehicle

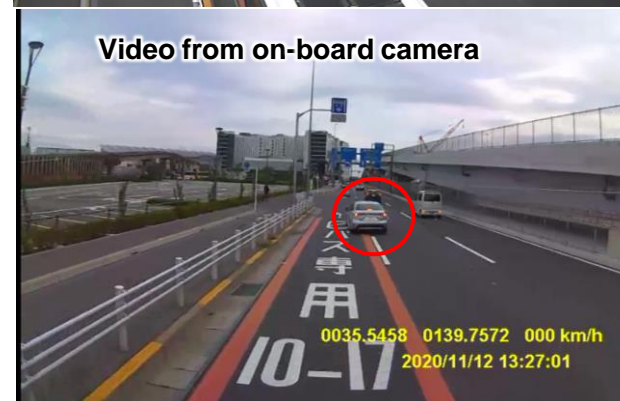
Definition of “conflict”:

Situations in which the distance between ordinary vehicles and autonomous buses narrows due to ordinary vehicle lane changes, etc., affecting the behavior (speed/acceleration) of either of the vehicles
