"Cross-ministerial Strategic Innovation Promotion Program (SIP)  
Phase Two - Automated Driving (Expansion of Systems and Services)  
/Implementation of FOTs in the Tokyo Waterfront Area"  
**- FY2021 Results Report Overview -**  
**Appendix**

FOTs in the Tokyo Waterfront Area Consortium  
Mitsubishi Electric Corporation (representative)

March 2022

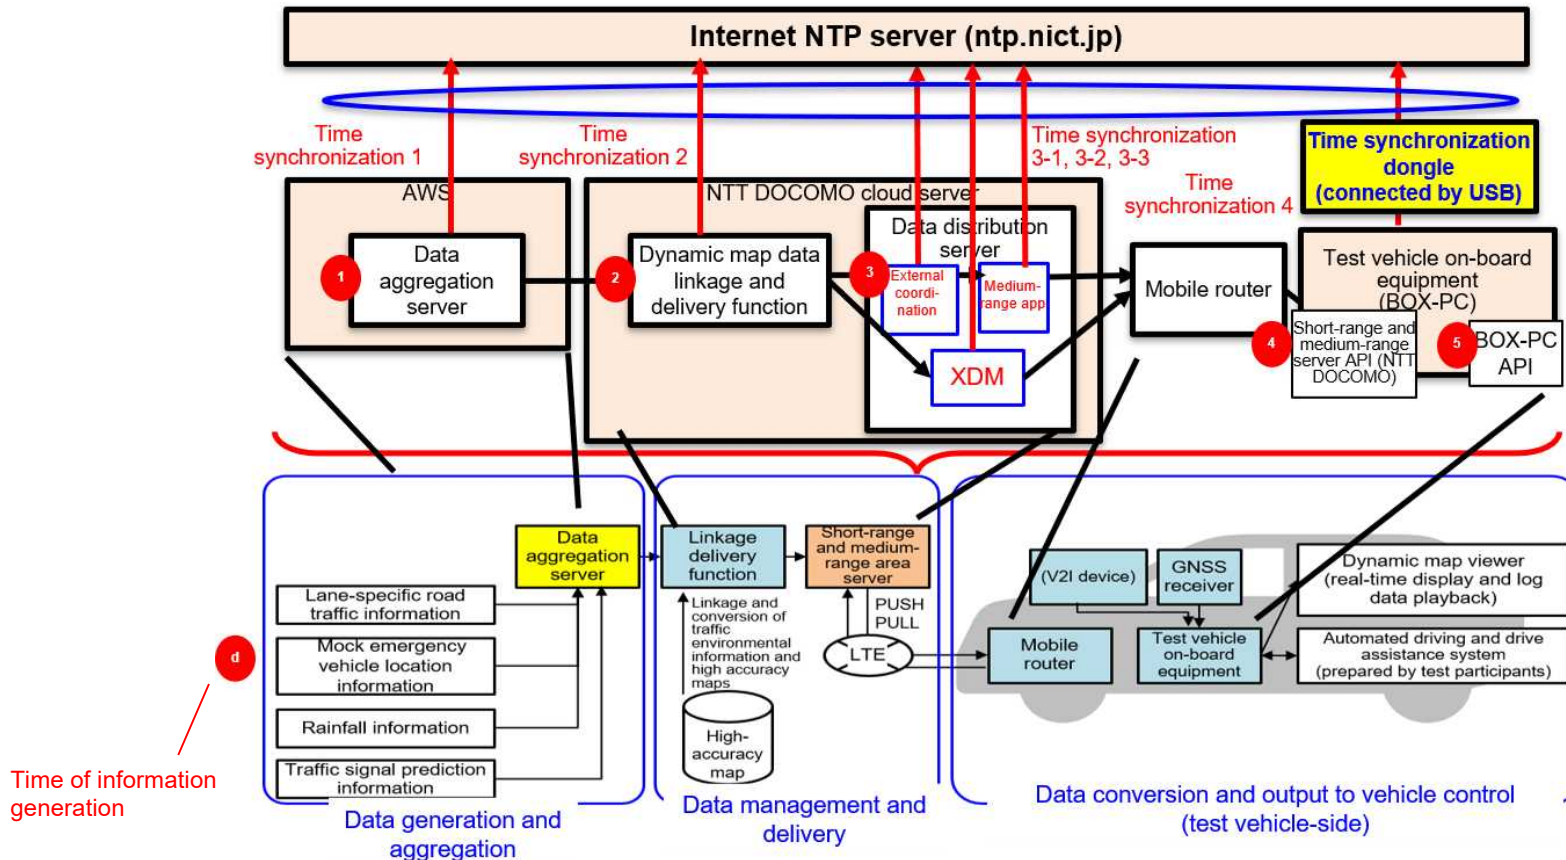
- Assess amount of time required for delivery between devices, based on the time taken to transmit data between the data aggregation server and the test vehicle on-board equipment

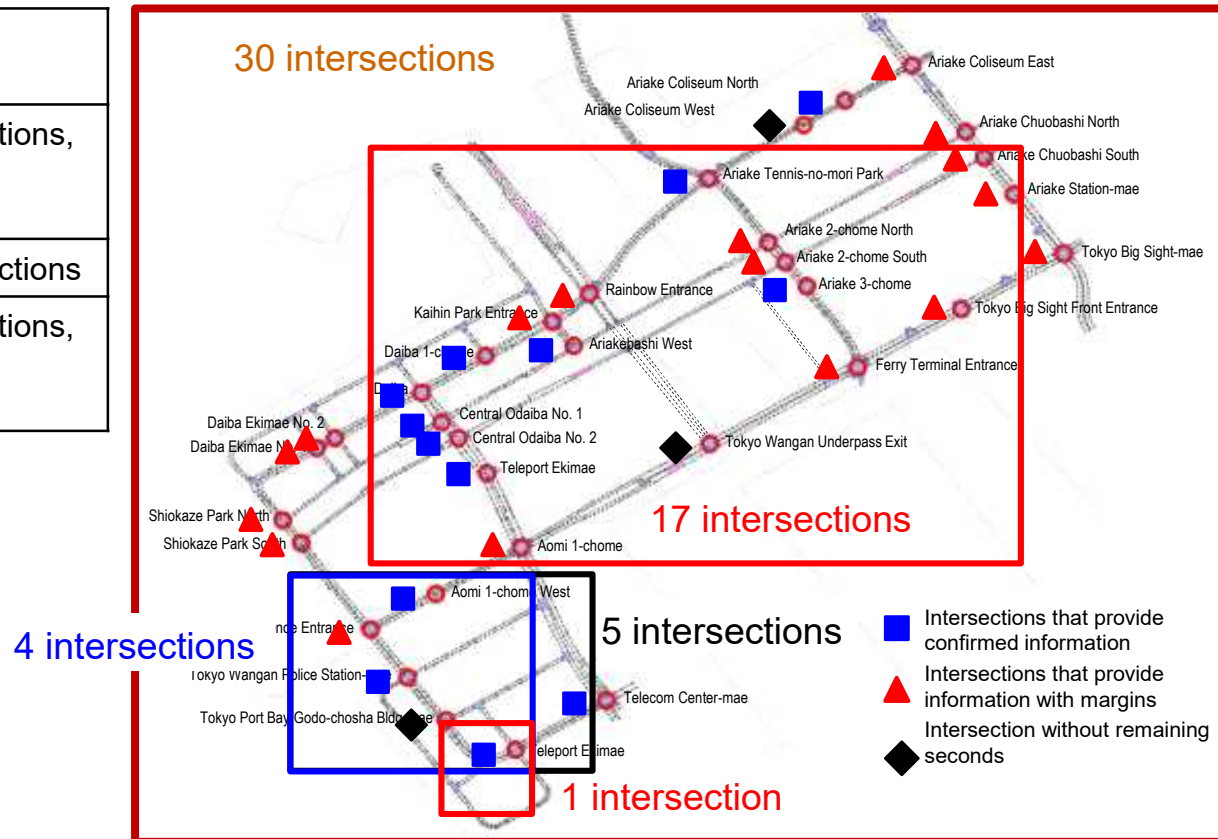
- Testing was performed using the three methods of the specified distance PUSH method, the PULL method, and the specified intersection PUSH method.

Delivery method	Test pattern
Specified distance PUSH method	1 intersection, 4 intersections, 17 intersections, 30 intersections
PULL method	5 intersections, 7 intersections
Specified intersection PUSH method	1 intersection, 5 intersections, 17 intersections, 30 intersections

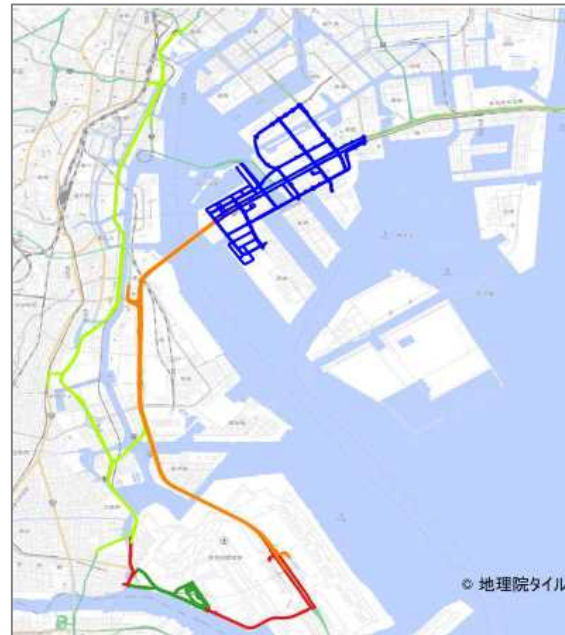
Fig. Overview of areas A., B., and C.

**Area A** **Blue lines** (Waterfront City - updated)

**Area B** **Orange lines** (Metropolitan Expressway; Bayshore Route - updated)

**Lime green lines** (Metropolitan Expressway: Haneda Route - updated)

**Red lines** (General roads - not updated)

**Area C** **Green lines** (Haneda Airport area - not updated)

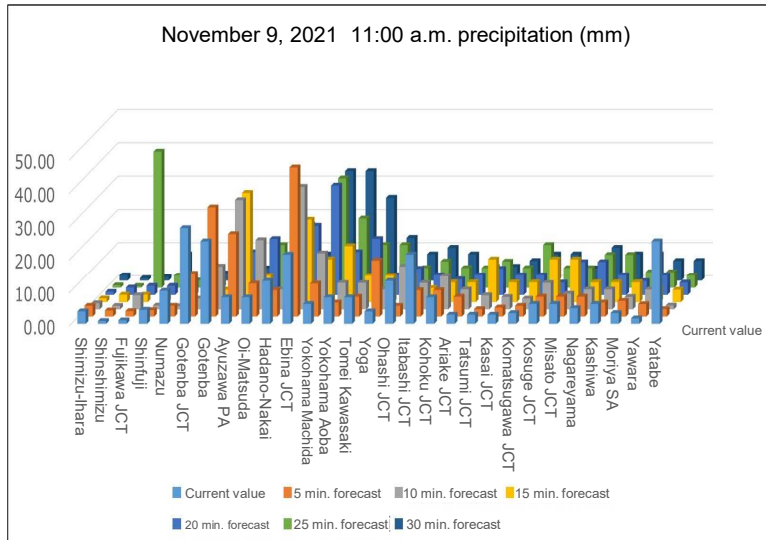
- We confirmed that rainfall information generated by the Japan Meteorological Business Support Center was delivered correctly via V2N

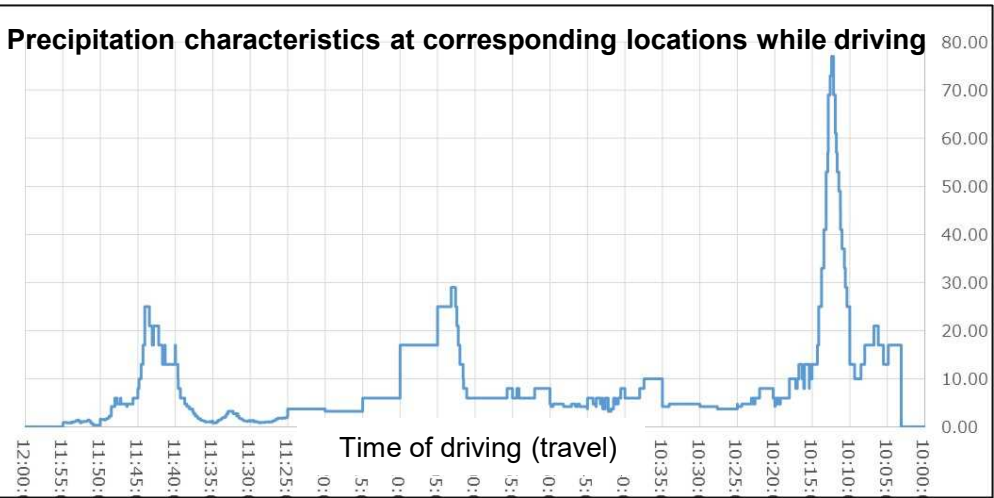
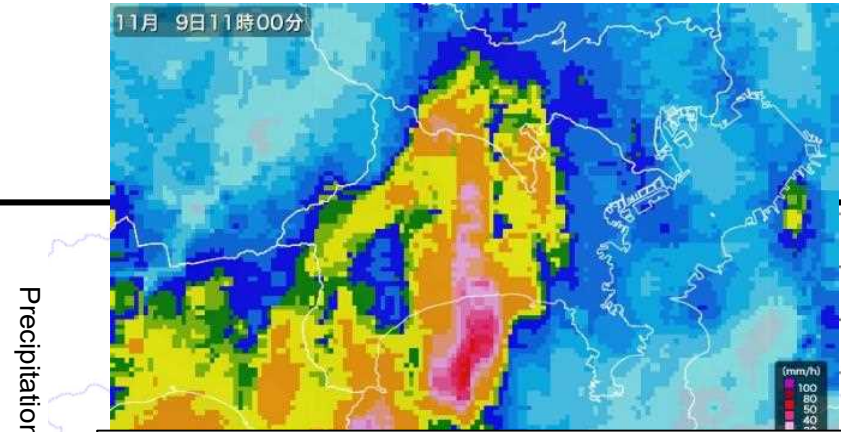
- We confirmed that rainfall information generated by the Japan Meteorological Business Support Center was delivered correctly via V2N

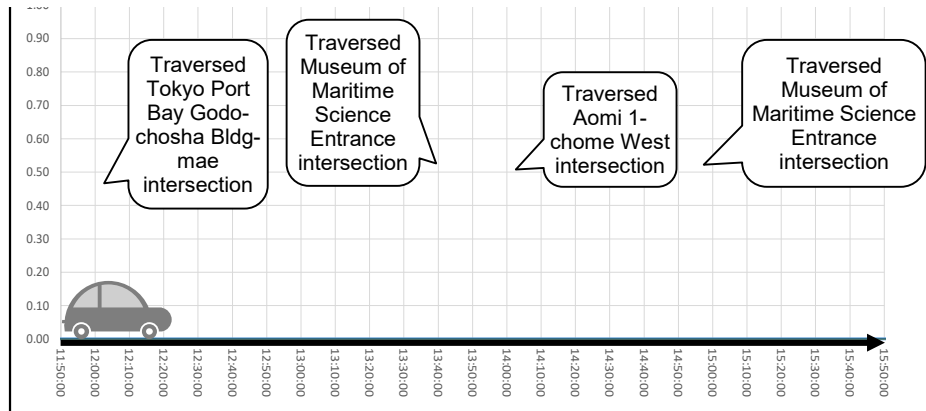
Rainfall volume characteristics when driving in the Odaiba area (11:50-15:50)

■ Current value - 5 min. forecast - 10 min. forecast - 15 min. forecast  
 - 20 min. forecast - 25 min. forecast - 30 min. forecast

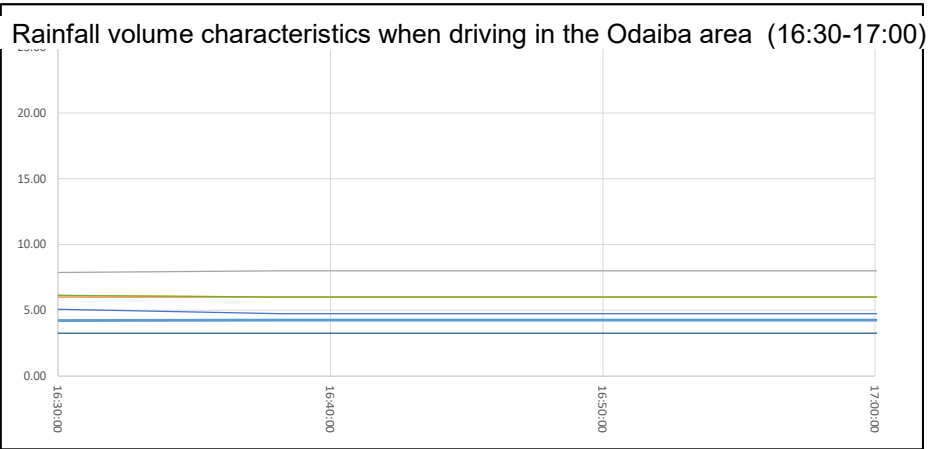
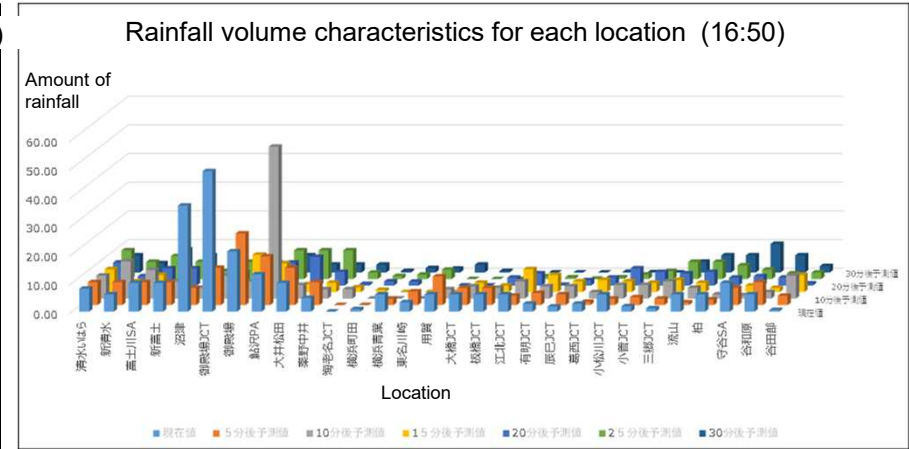
- We confirmed that vehicles were provided, in chronological order, with information on the amount of rainfall for the mesh segment in which the vehicle was located
- We confirmed that long-range rainfall information could also be received in the Odaiba area via V2N

- Current value - 5 min. forecast - 10 min. forecast - 15 min. forecast
- 20 min. forecast - 25 min. forecast - 30 min. forecast

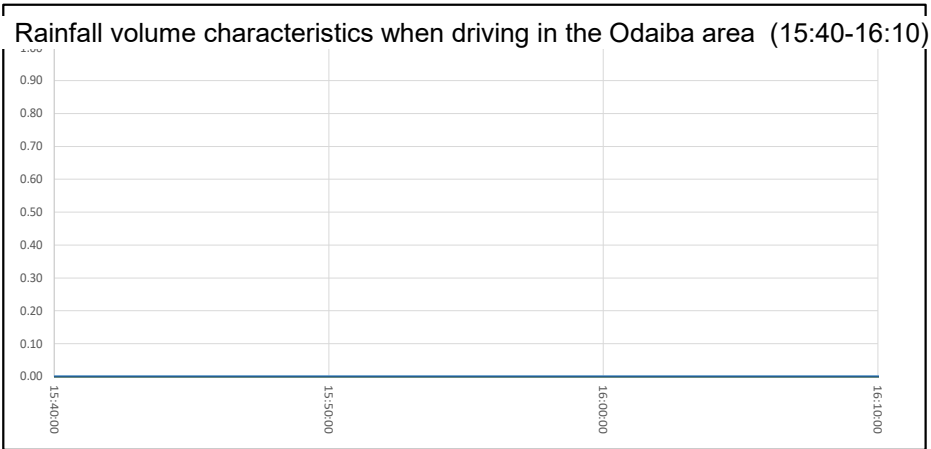
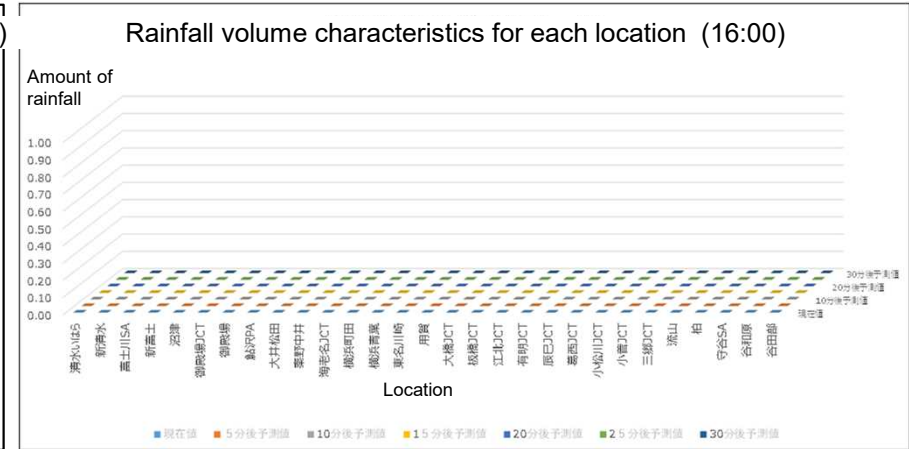
- We confirmed that vehicles received, in chronological order, with information on the amount of rainfall for the mesh segment in which the vehicle was located (because it was clear, the amount of rainfall was zero)
- We confirmed that long-range rainfall information could also be received in the Odaiba area via V2N

- Current value - 5 min. forecast - 10 min. forecast - 15 min. forecast
- 20 min. forecast - 25 min. forecast - 30 min. forecast

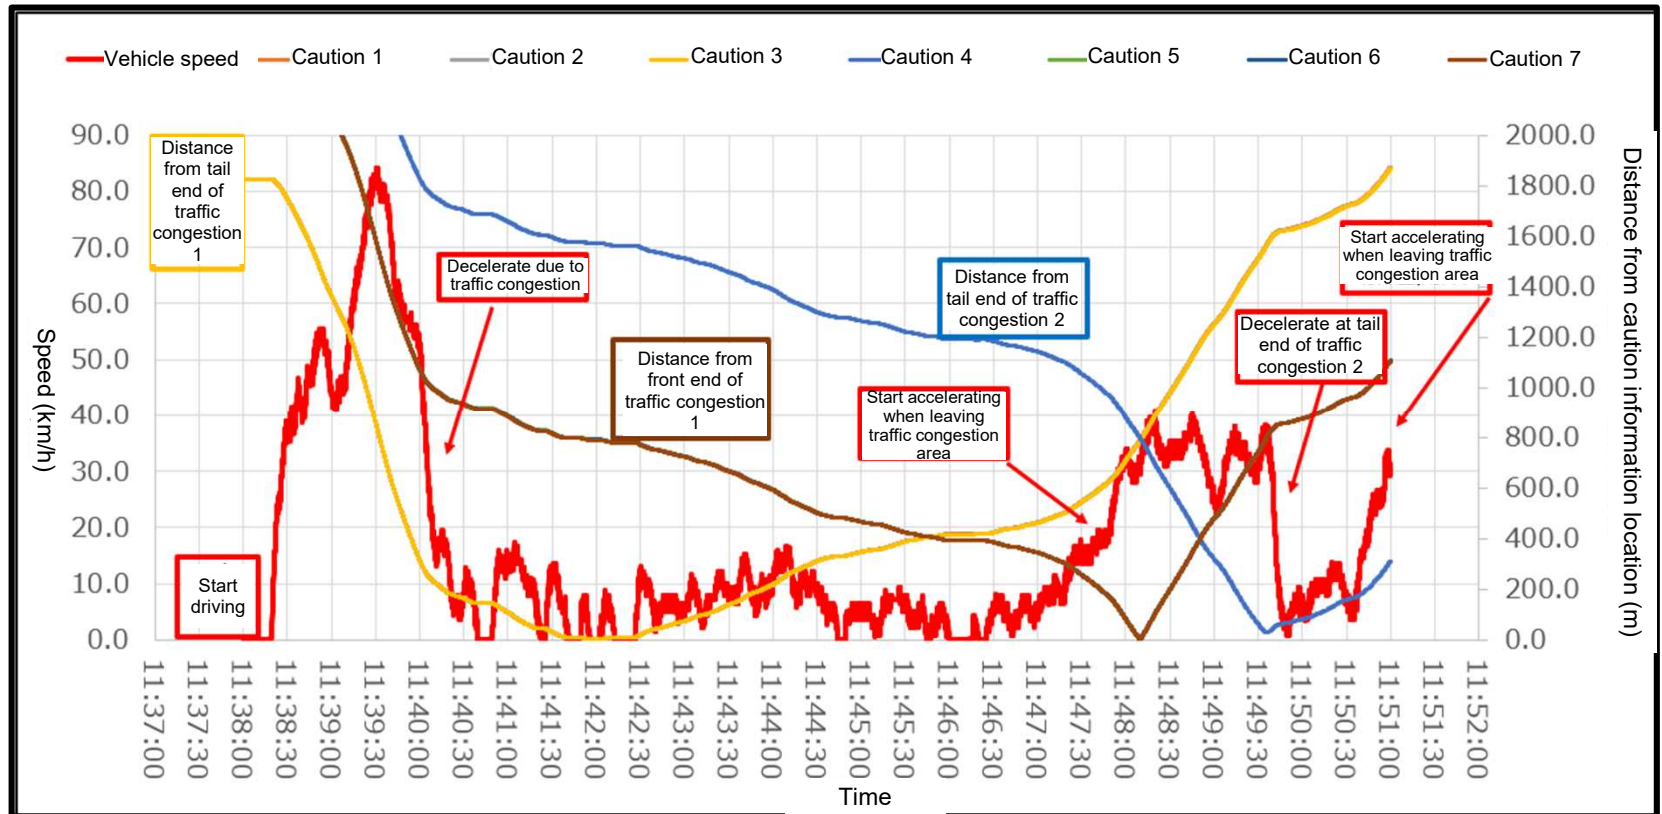
November 30, 2021, 11:37-11:52

- Traffic congestion tail end/front end location information was received and checked for consistency against test vehicle acceleration and deceleration data

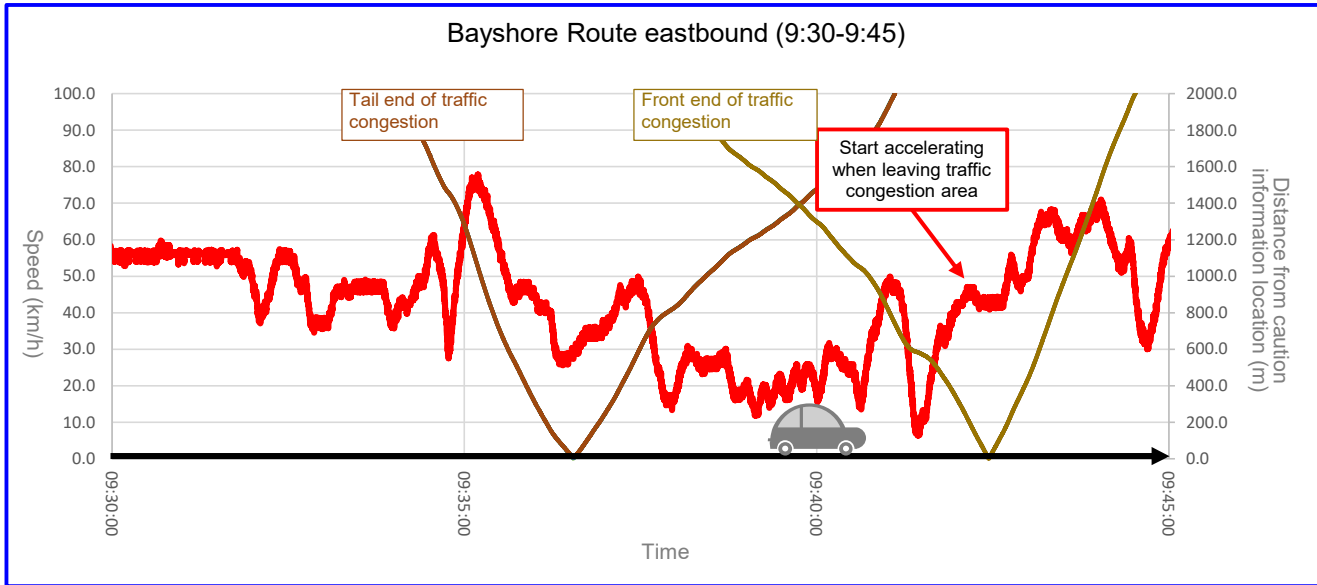
- We confirmed that vehicles decelerated when they approached the tail ends of traffic congestion and began accelerating once they passed the front ends of traffic congestion

- : Traffic congestion front end,
- ▲ : Traffic congestion tail end
- : Driving area (9:30-9:45)
- : Test vehicle location (approx. 9:40)

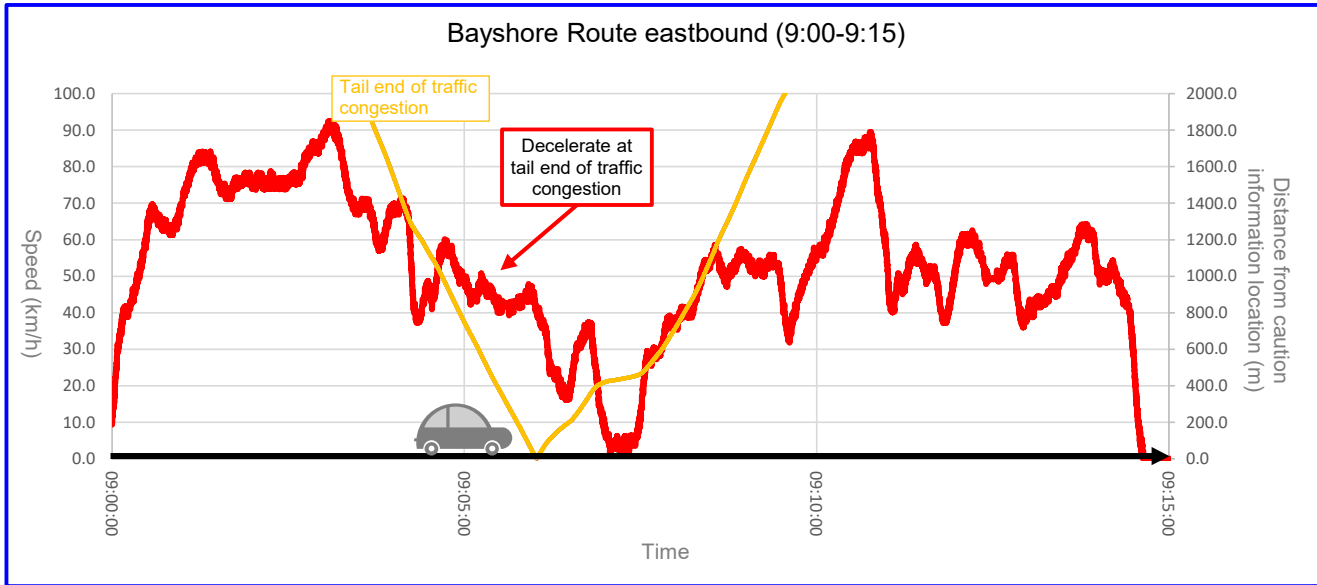
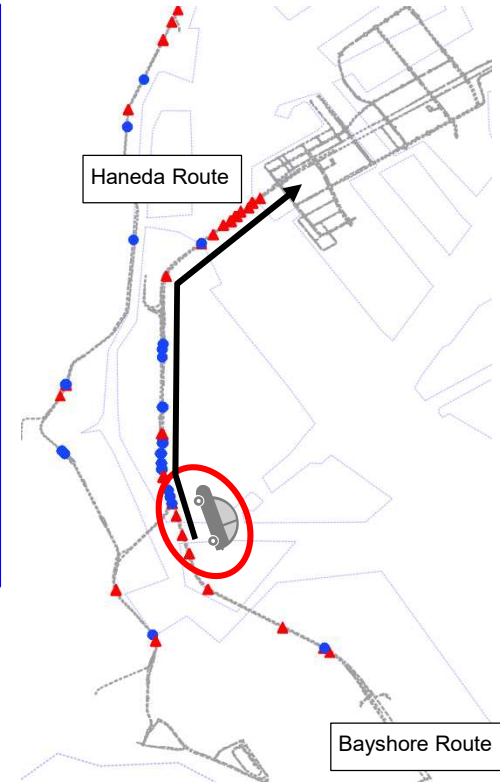
- We confirmed that vehicles decelerated as they approached the tail ends of traffic congestion areas

- : Traffic congestion front end,
- ▲ : Traffic congestion tail end
- : Driving area (9:00-9:15)
- : Test vehicle location (approx. 9:05)

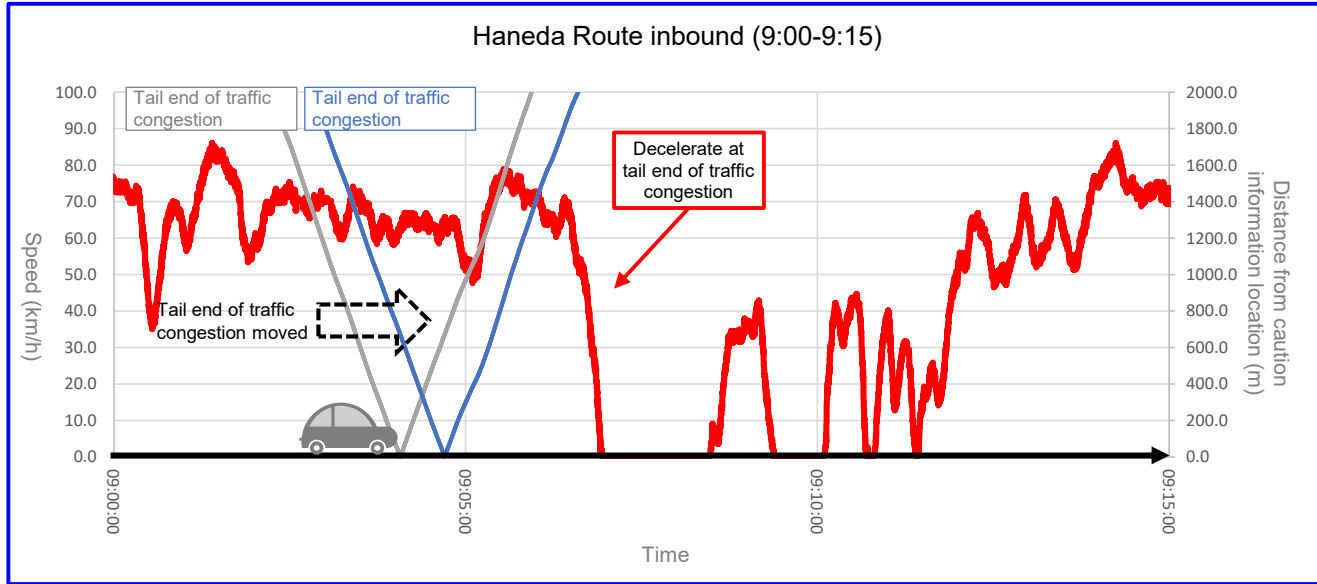
- We confirmed that vehicles decelerated as they approached the tail ends of traffic congestion areas (the locations of the tail ends of traffic congestion areas moved)

- : Traffic congestion front end,
- ▲ : Traffic congestion tail end
- : Driving area (9:00-9:15)
- : Test vehicle location (approx. 9:03)

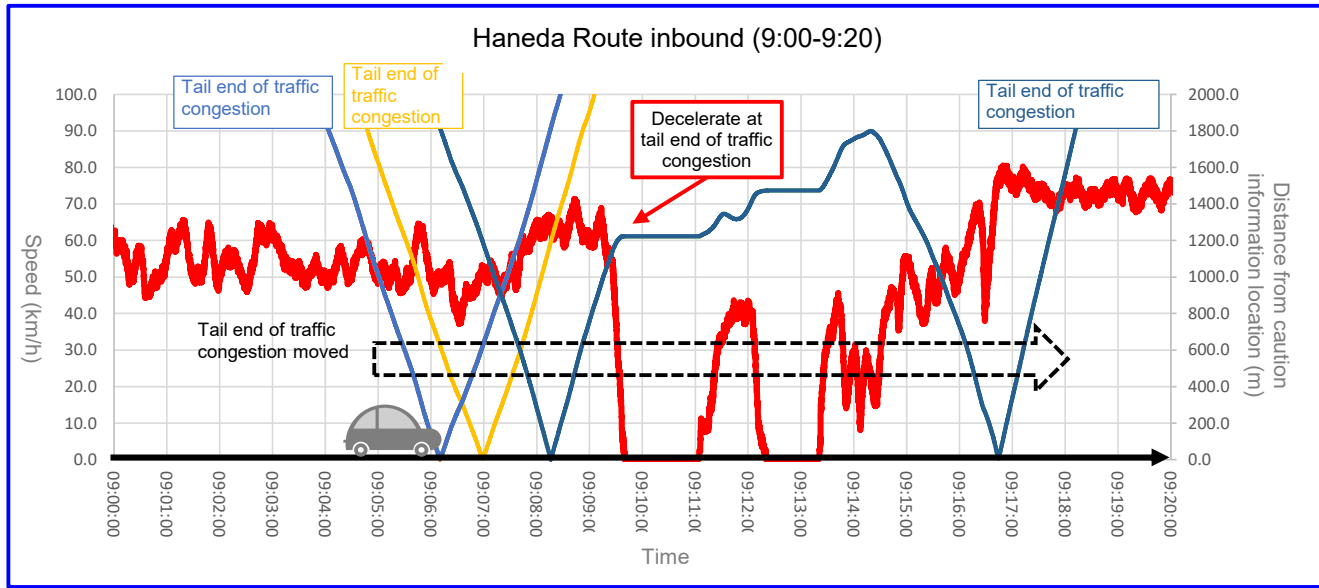
- We confirmed that vehicles decelerated as they approached the tail ends of traffic congestion areas (the locations of the tail ends of traffic congestion areas moved)

- : Traffic congestion front end,
- ▲ : Traffic congestion tail end
- : Driving area (9:00-9:20)
- : Test vehicle location (approx. 9:06)

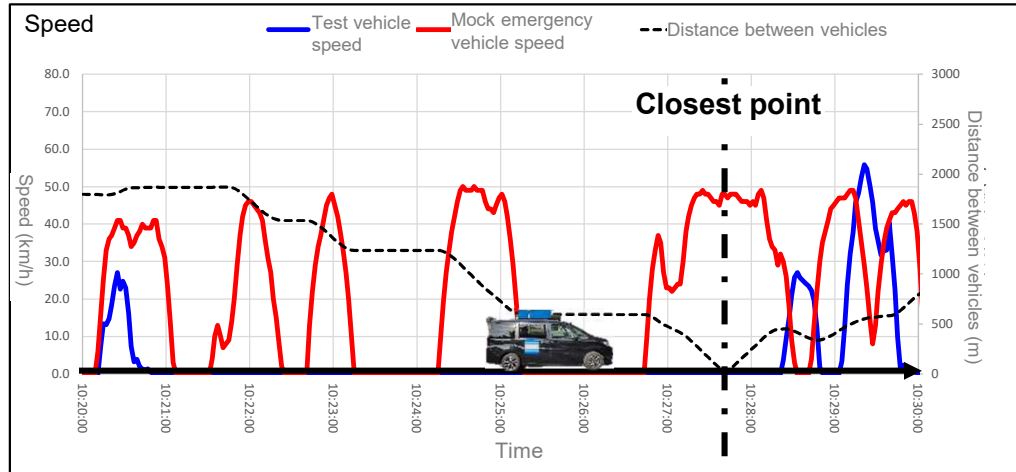
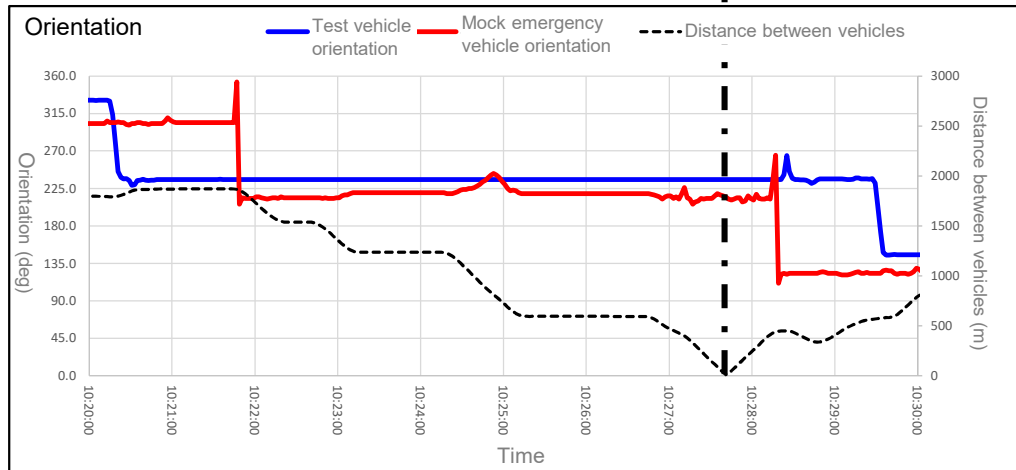
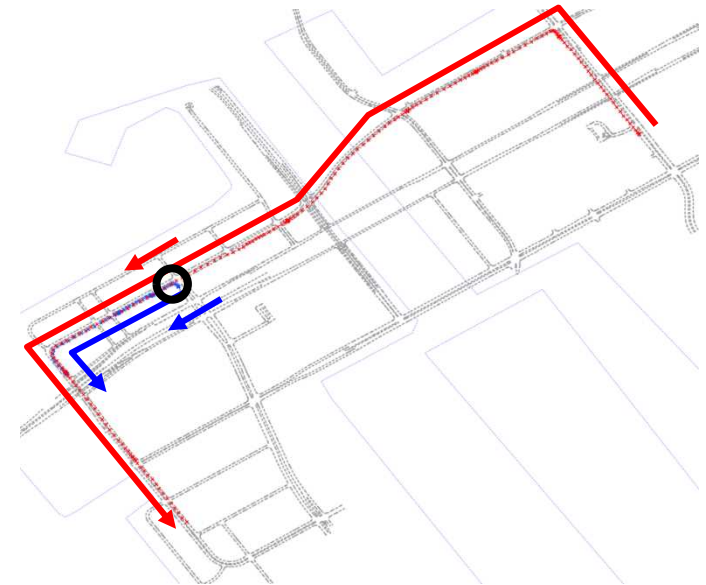
- At approximately 10:28, the mock emergency vehicle, driving forward along the route, was confirmed to have passed the test vehicle, which was stopped near the Daiba intersection

- ◆ : Route traveled by test vehicle (10:20-10:30)
- ◆ : Route traveled by the mock emergency vehicle
- : Closest point (approx. 10:27:40)

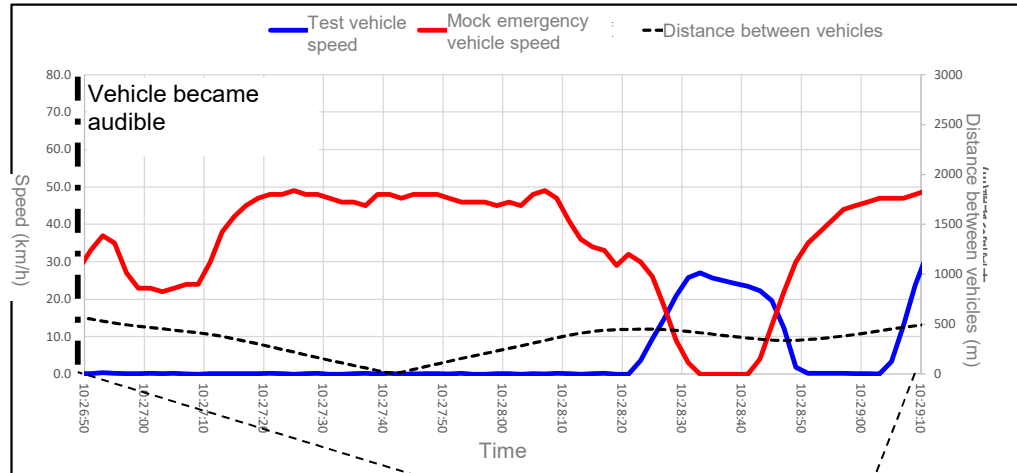
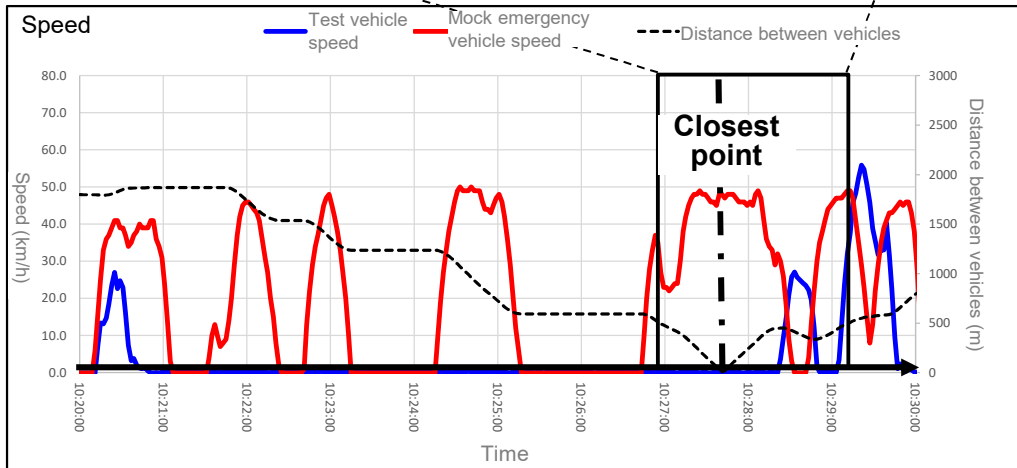
- At roughly 10:28, the mock emergency vehicle, driving forward along the route, was confirmed to have passed the test vehicle, which was stopped near the Daiba intersection

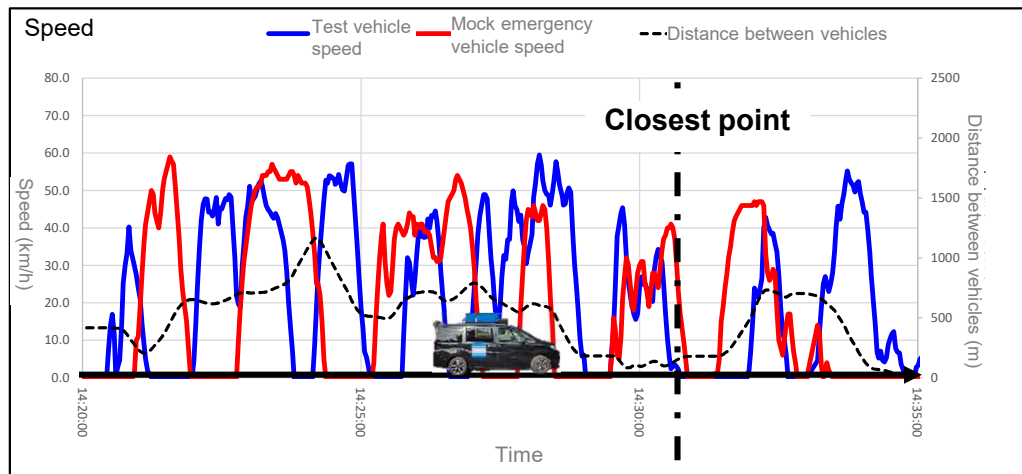
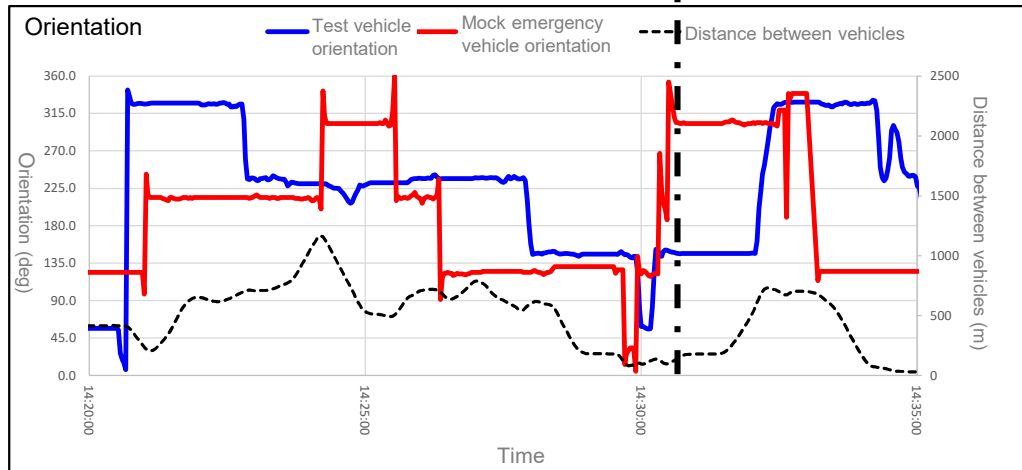
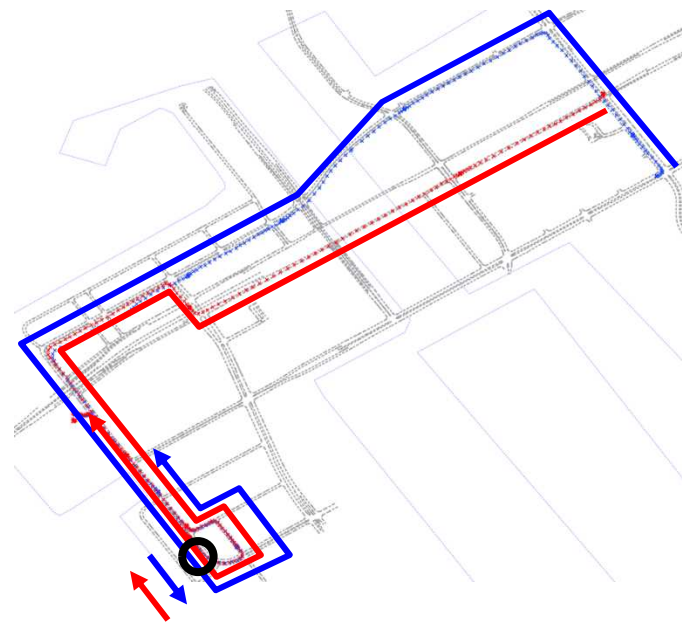
- At roughly 14:30, the mock emergency vehicle, driving the route in reverse, was confirmed as driving between the Tokyo Port Bay Godo-chosha Bldg intersection and the Telecom Station-mae intersection

- ◆ : Route traveled by test vehicle (14:20-14:35)
- ◆ : Route traveled by the mock emergency vehicle
- : Closest point (approx. 14:30:24)

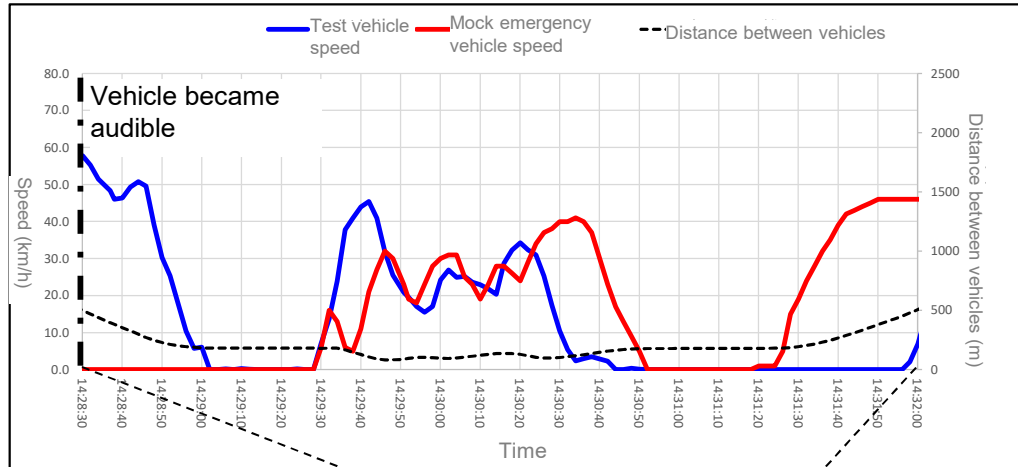
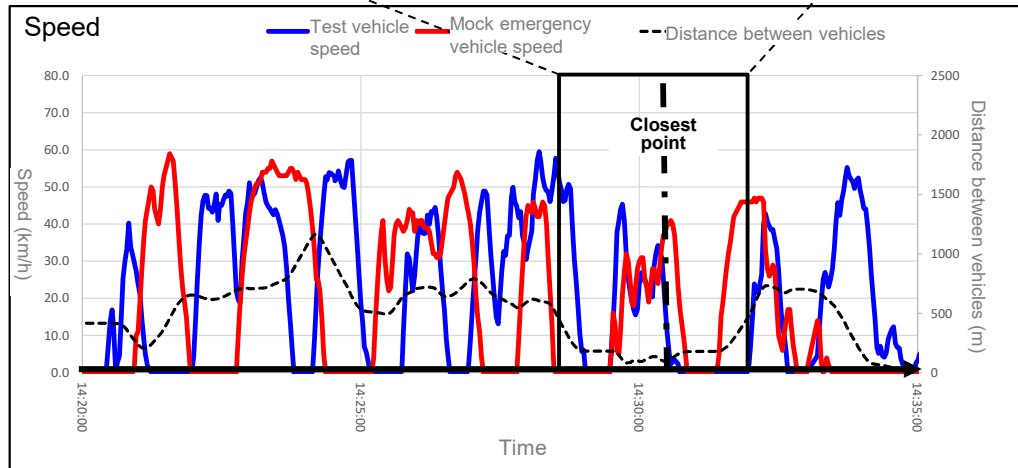
- At roughly 14:30, the mock emergency vehicle, driving the route in reverse, was confirmed as driving between the Tokyo Port Bay Godo-chosha Bldg intersection and the Telecom Station-mae intersection

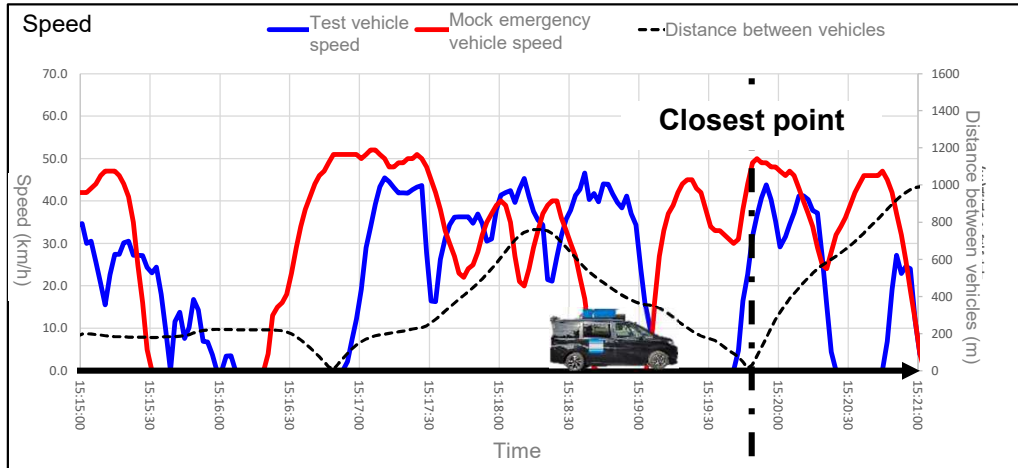
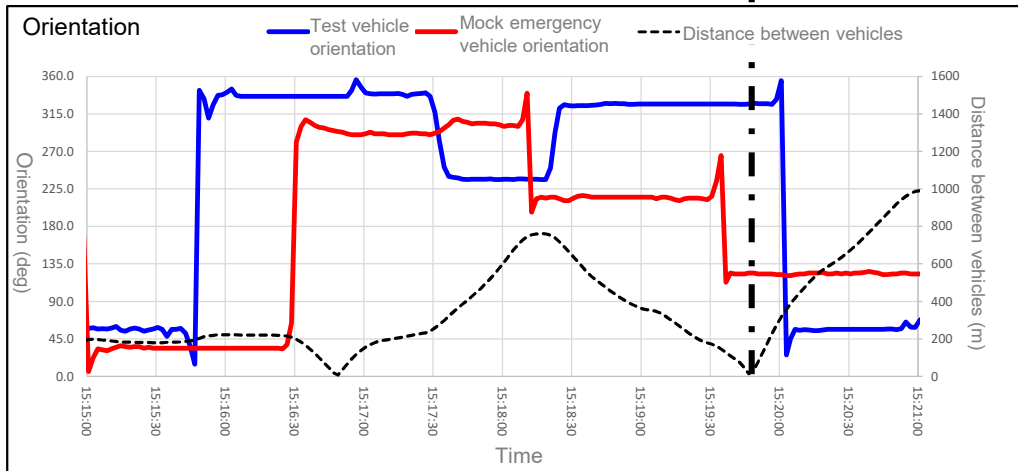
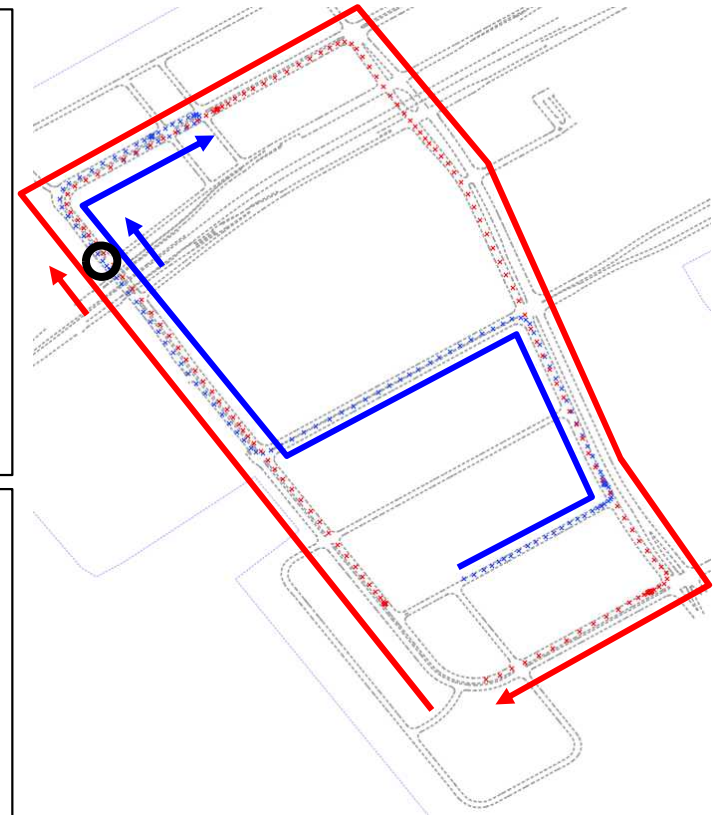
- At roughly 15:20, the mock emergency vehicle, driving forward along the route, was confirmed just beyond the Shiokaze Park North intersection

- :Route traveled by test vehicle (15:15-15:21)
- :Route traveled by the mock emergency vehicle
- :Closest point (approx. 15:19:46)

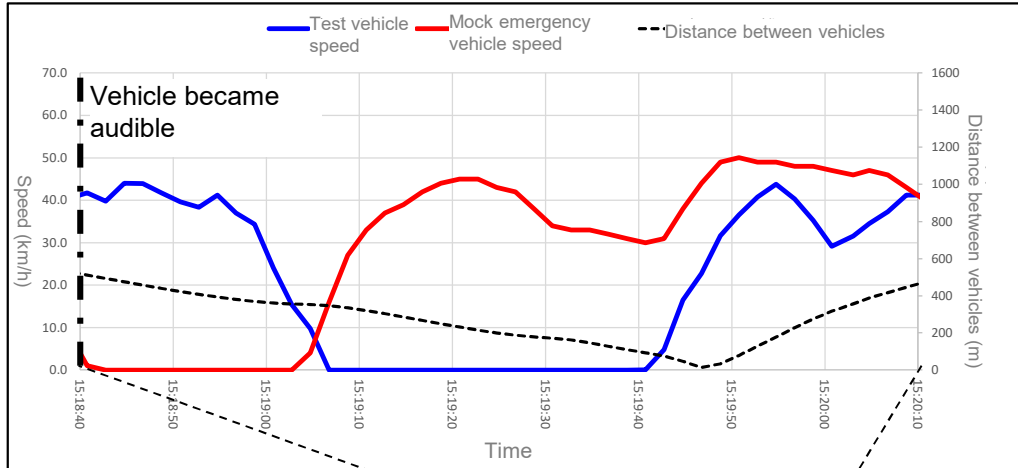
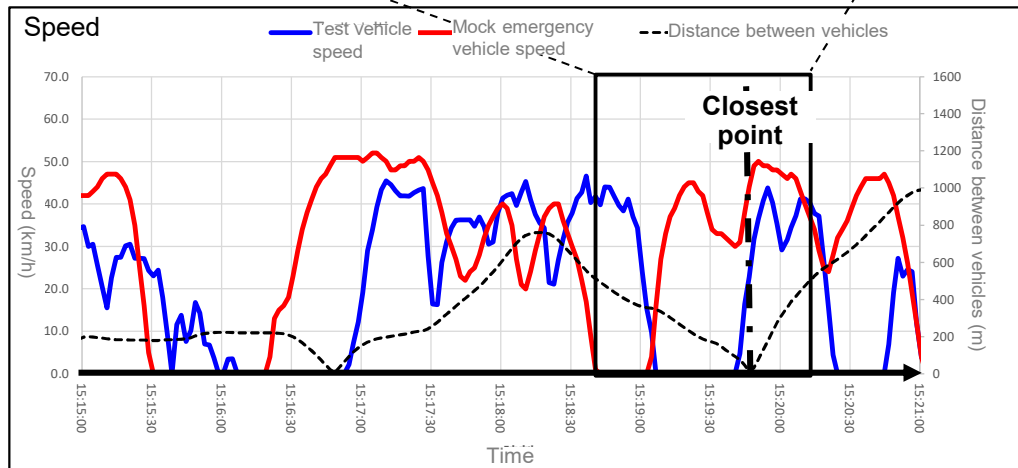
- At roughly 15:20, the mock emergency vehicle, driving forward along the route, was confirmed just beyond the Shiokaze Park North intersection

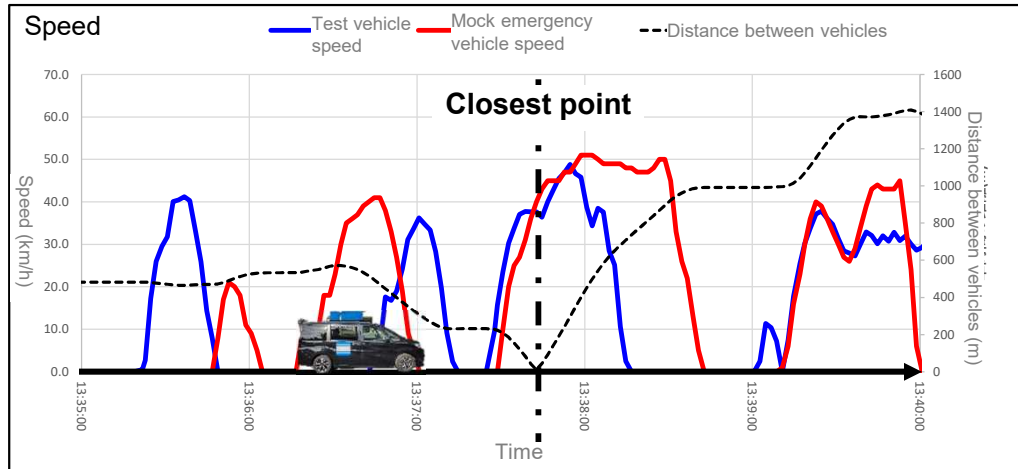
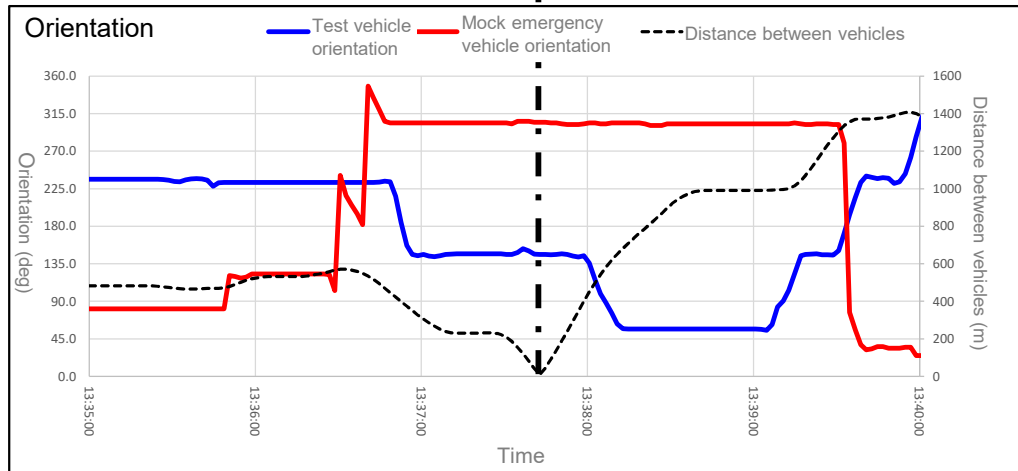
- At roughly 13:38, the mock emergency vehicle, driving the route in reverse, was confirmed just beyond the Tokyo Wangan Police Station-mae intersection

- ➡ :Route traveled by test vehicle (13:35-13:40)
- ➡ :Route traveled by the mock emergency vehicle
- :Closest point (approx. 13:37:42)

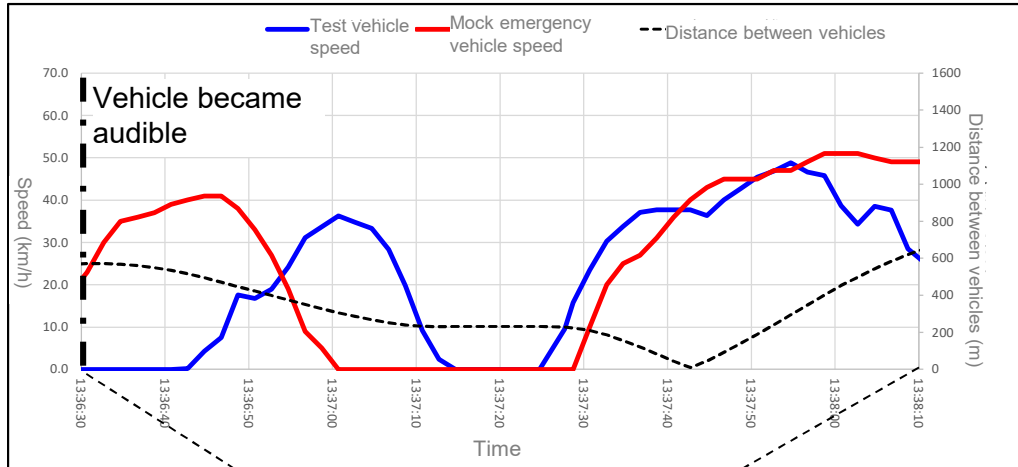
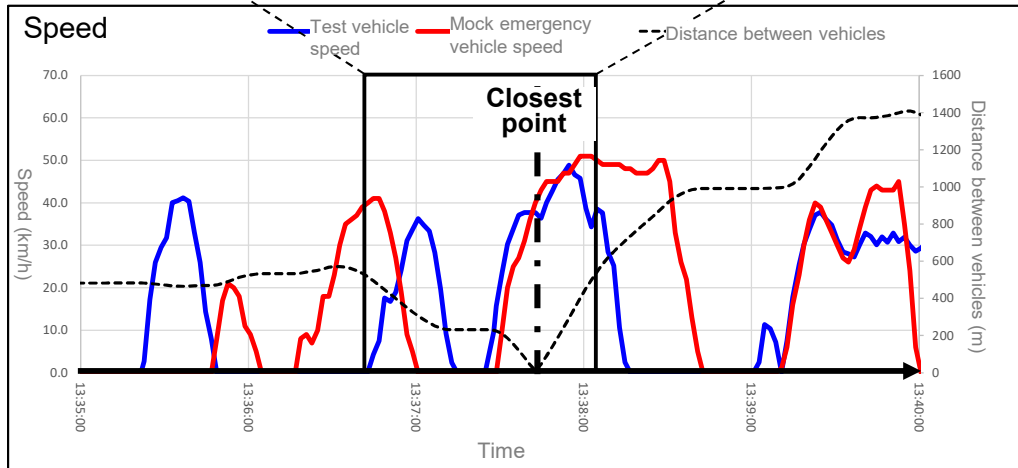
- At roughly 13:38, the mock emergency vehicle, driving the route in reverse, was confirmed just beyond the Tokyo Wangan Police Station-mae intersection

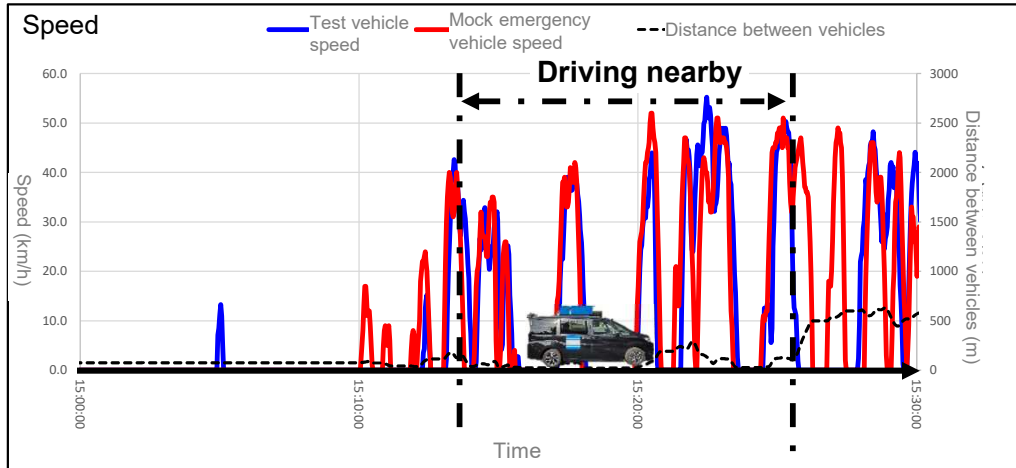
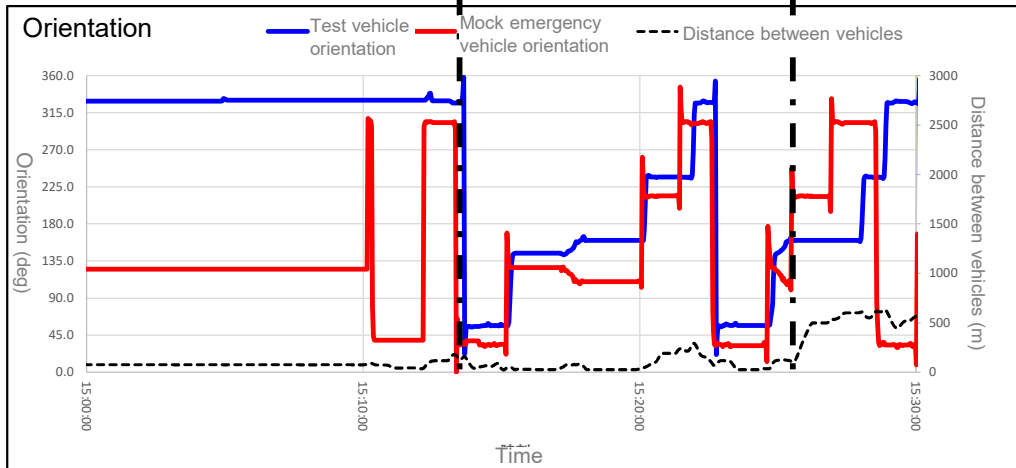
- Between 15:13 and 15:26, the mock emergency vehicle, driving forward on route E, was confirmed to be driving near the test vehicle

- ◆ :Route traveled by test vehicle (15:00-15:30)
- ◆ :Route traveled by the mock emergency vehicle
- \* The mock emergency vehicle drove near the test vehicle from 15:13 to 15:26
