"Cross-ministerial Strategic Innovation Promotion Program (SIP)  
Phase Two - Automated Driving (Expansion of Systems and Services)  
/Implementation of FOTs in the Tokyo Waterfront Area"  
**- FY2021 Results Report Overview -**  
**Appendix**

FOTs in the Tokyo Waterfront Area Consortium  
Mitsubishi Electric Corporation (representative)

March 2022

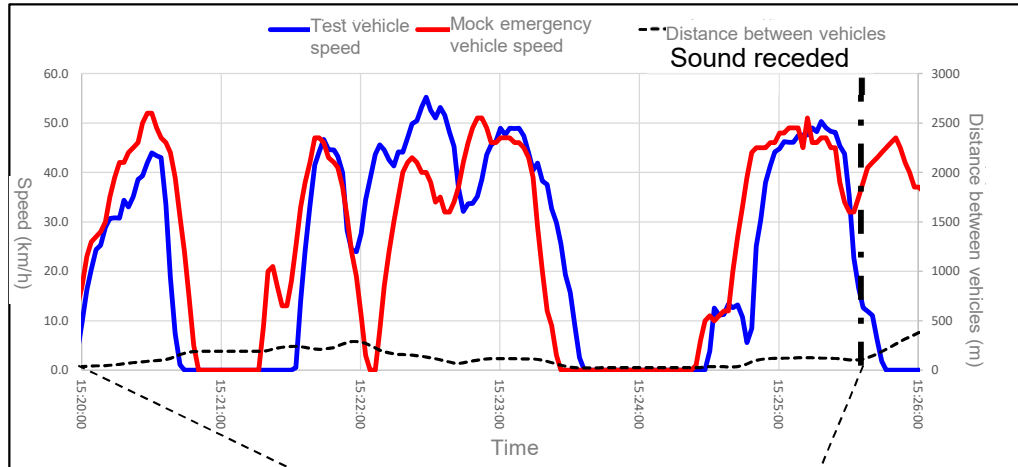
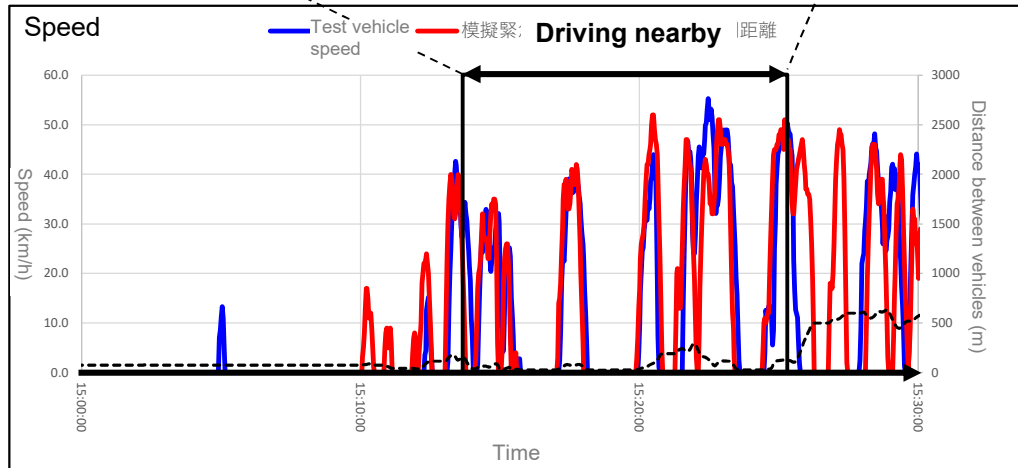
- Between 15:13 and 15:26, the mock emergency vehicle, driving forward on route E, was confirmed to be driving near the test vehicle

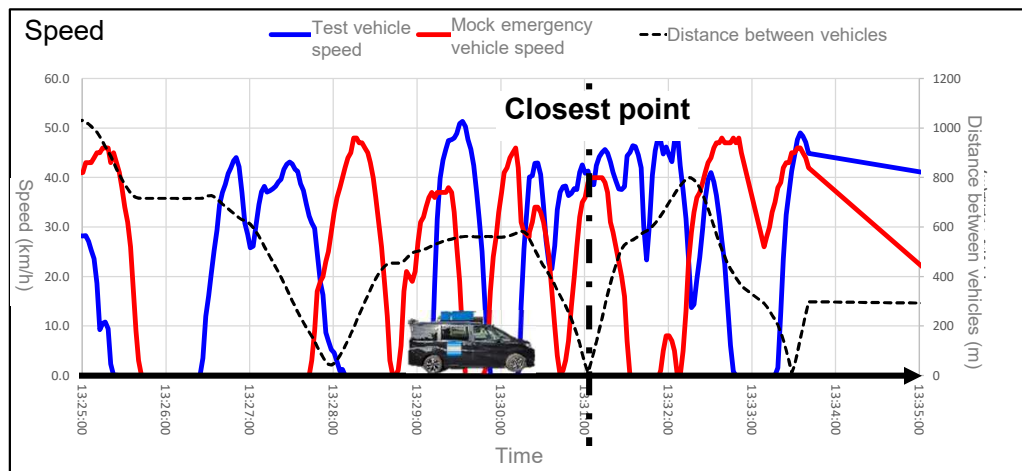
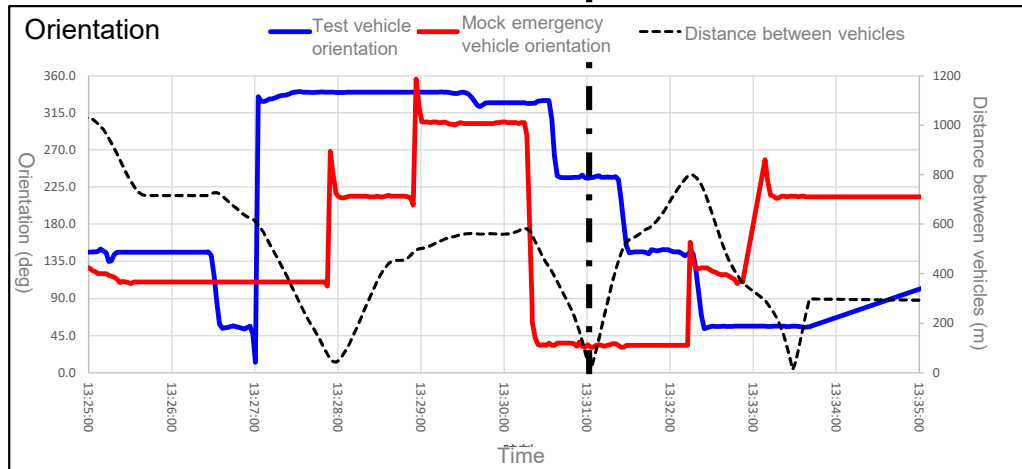
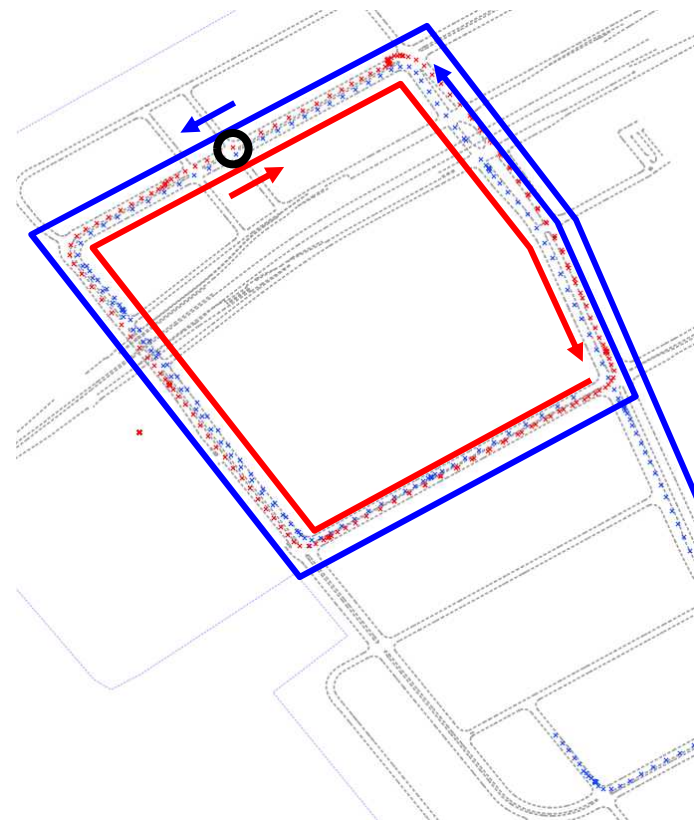
- At roughly 13:31, the mock emergency vehicle, driving the route in reverse, was confirmed near the Daiba Ekimae No. 2 (East) intersection

- :Route traveled by test vehicle (13:25-13:37)
- :Route traveled by the mock emergency vehicle
- :Closest point (approx. 13:31:02)

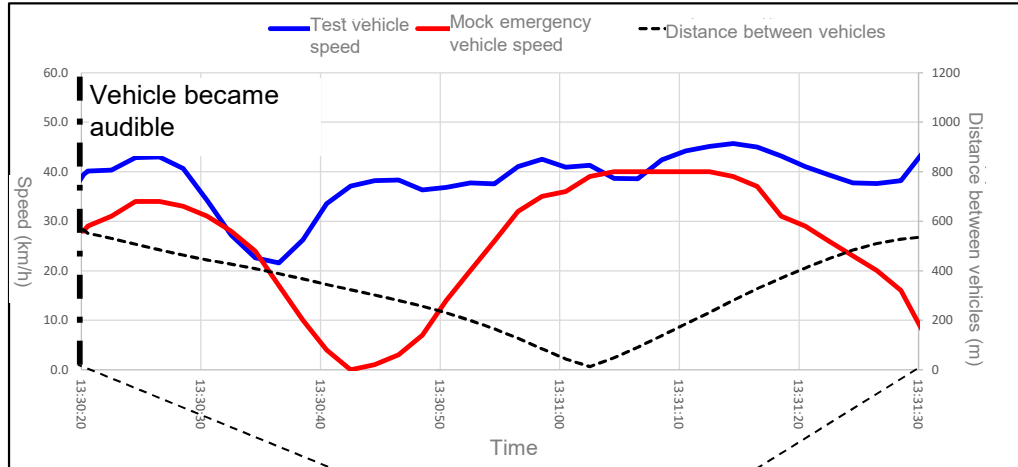
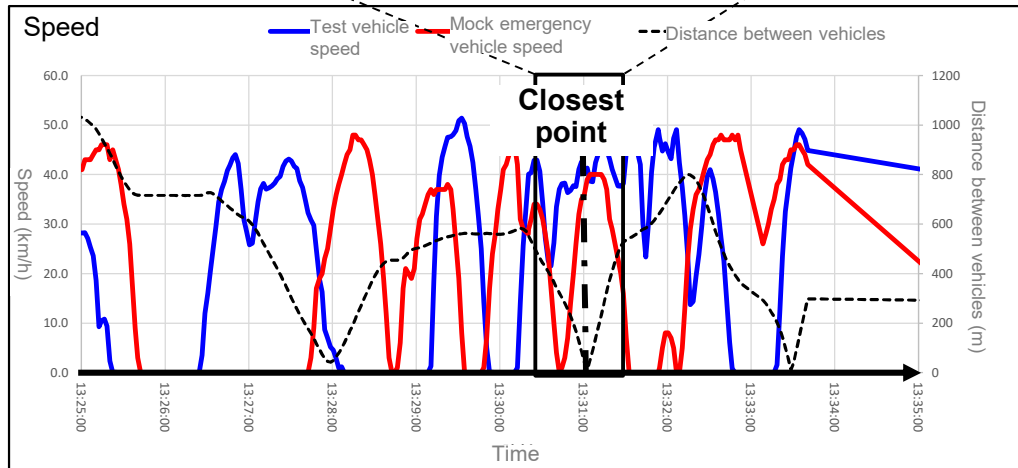
- At roughly 13:31, the mock emergency vehicle, driving the route in reverse, was confirmed near the Daiba Ekimae No. 2 (East) intersection

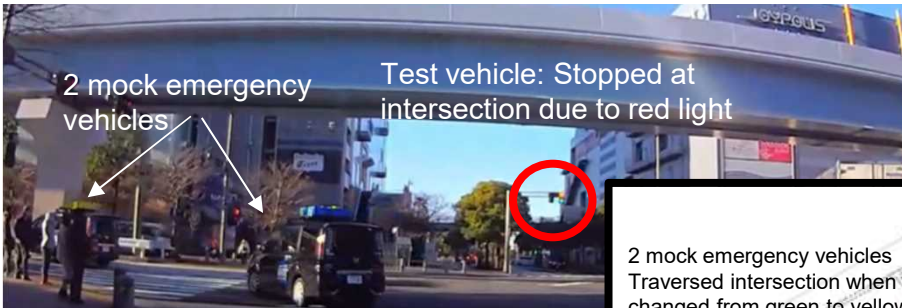
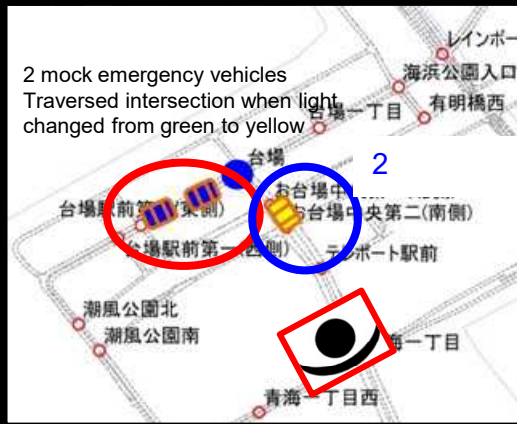
- When entering the Daiba intersection (with confirmed information), the traffic color change from yellow to red was confirmed in the traffic signal prediction information as well

Decelerated in order to stop at intersection (15:20:38)

Fully stopped at intersection (15:20:46)

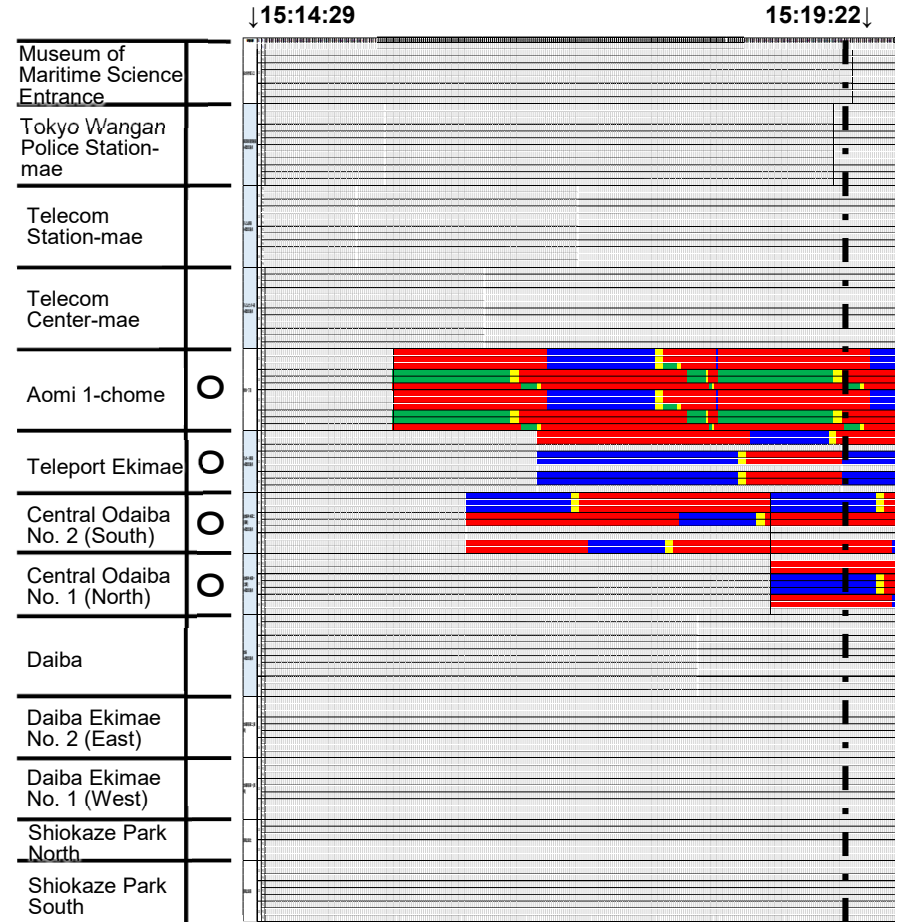
- Traffic signal prediction information was received between Aomi 1-chome and Central Odaiba No. 1 (North)

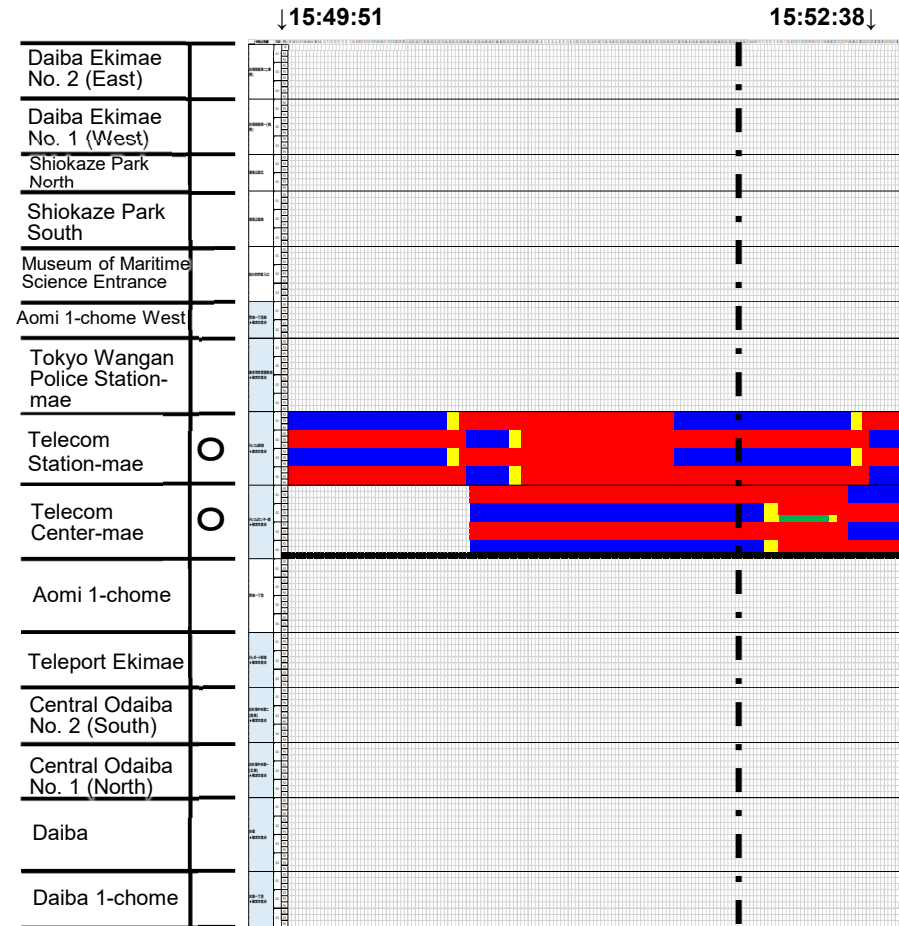
- Traffic signal prediction information was received for the 2 intersections in front of the vehicle, including the Telecom Station-mae intersection

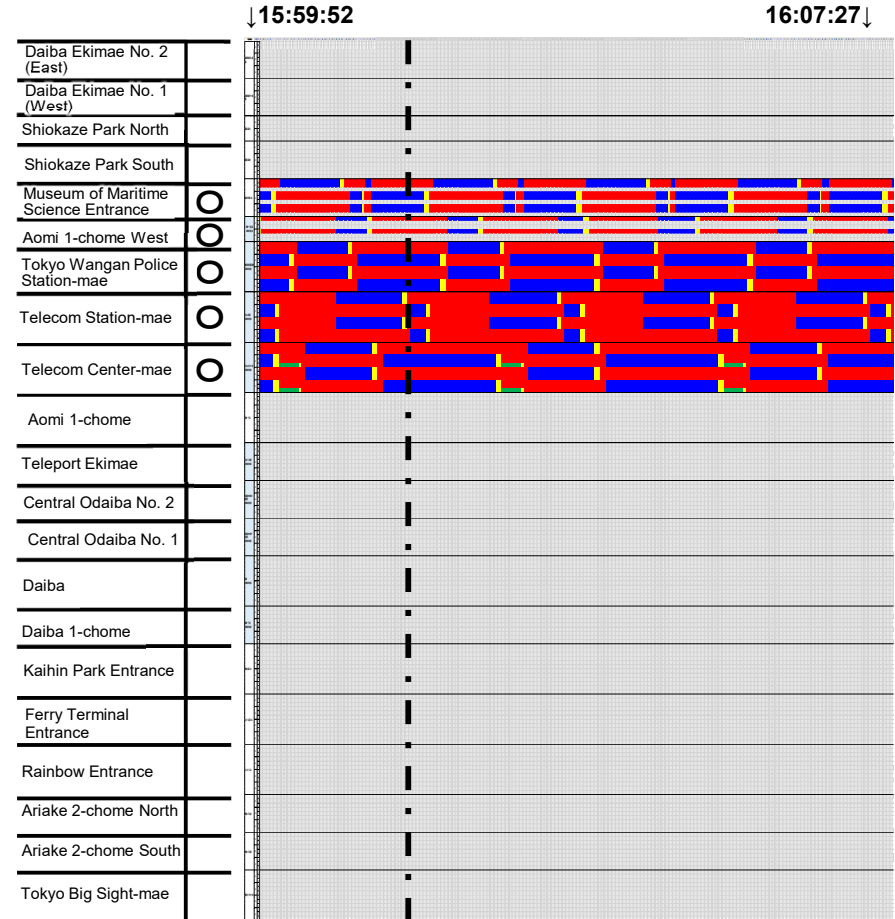
- Information was received for 5 surrounding intersections, including the Telecom Station-mae intersection

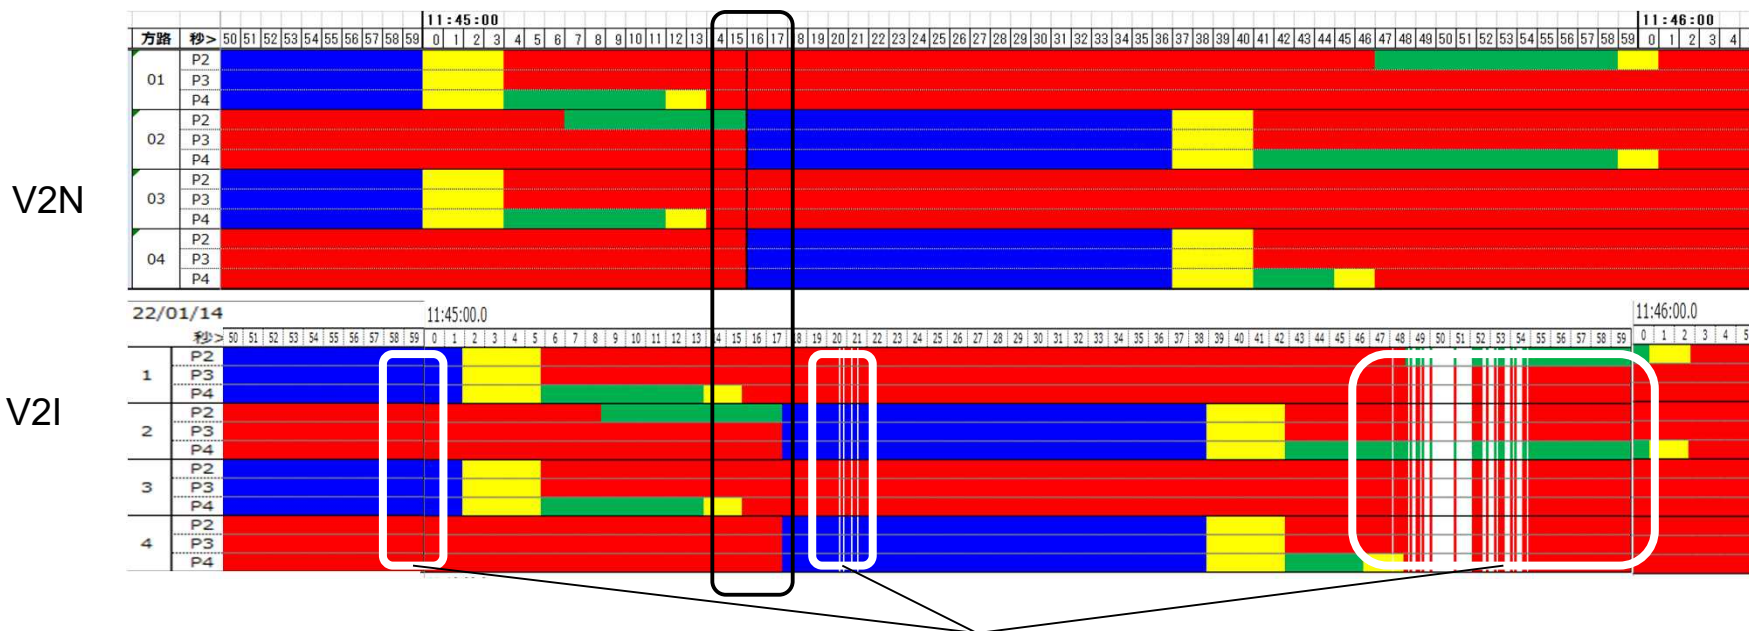
- We confirmed that aspect information identical to the V2I traffic signal information was generated
- We determined that there was a deviation of roughly two seconds between the time in the V2N traffic signal prediction information and the data time of the V2I traffic signal information (roughly equal to the traffic signal time,  $\pm 300$  ms) (the cause will need to be investigated in the future, and countermeasures will need to be deliberated on)

There was a deviation of roughly two seconds at the start of the cycle

There is data loss during road-to-vehicle communication via V2I (due to multipath transmission), but with V2N, at the start of the cycle, two cycle's worth of traffic signal color information is provided, so there is no data loss

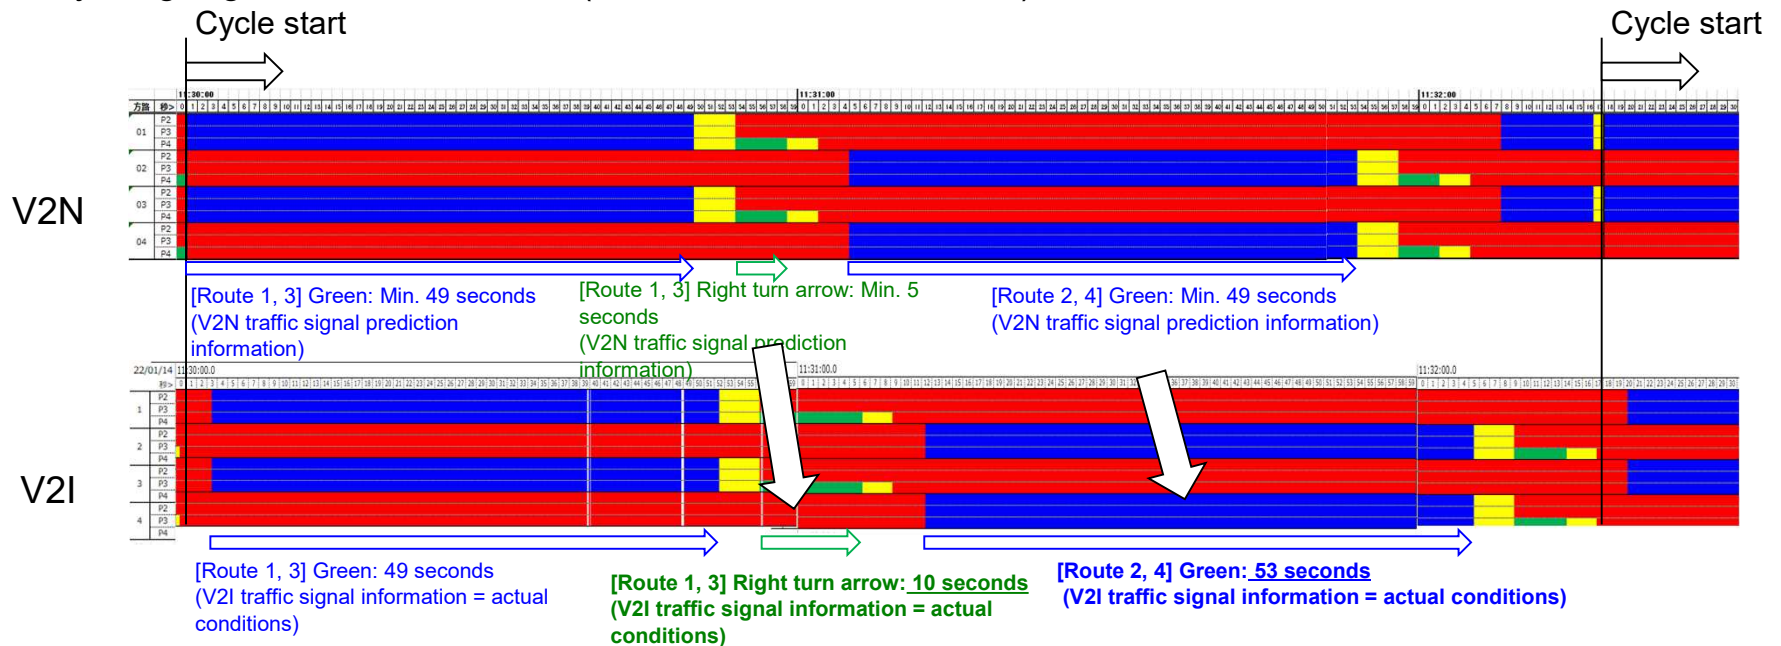
### Tokyo Big Sight-mae intersection (1/14 11:30:00 to 11:32:30)

Extensions to traffic signal aspects at intersections with margins are not reflected in V2N traffic signal prediction information

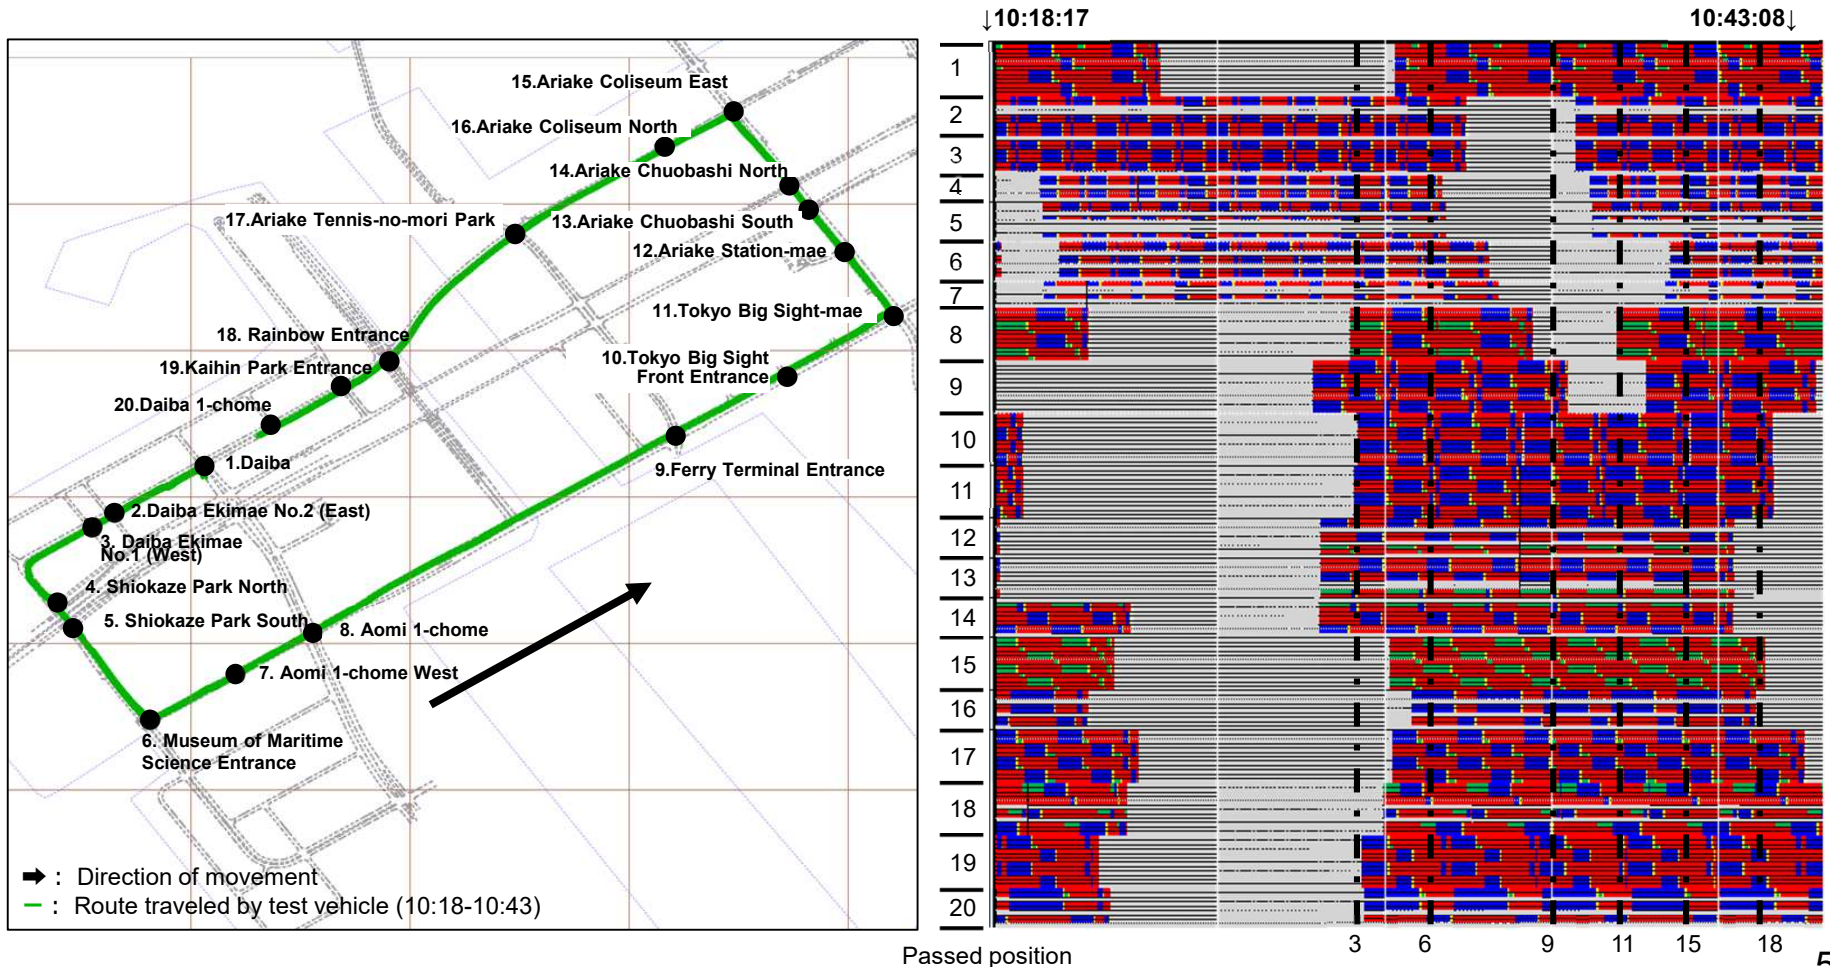
### 1) Route A

- Vehicles drove counterclockwise along the route, starting from Daiba, and we confirmed that traffic signal prediction information was received as shown in the figure at bottom right

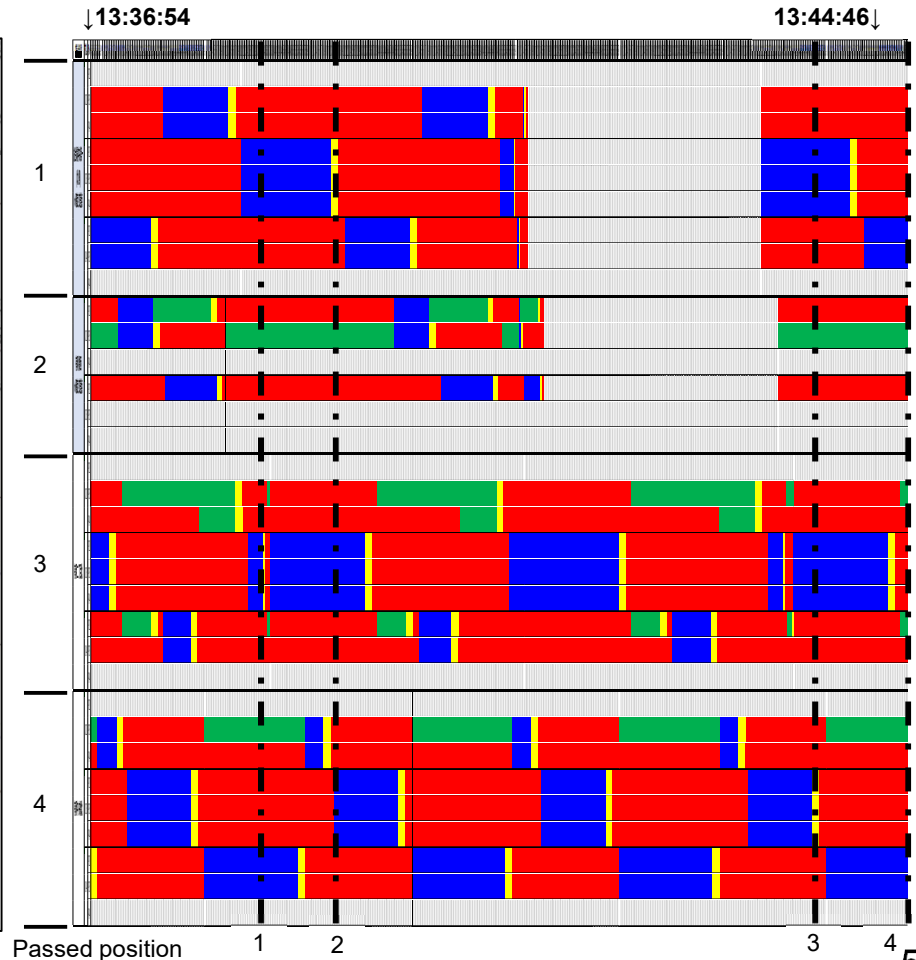
- Vehicles drove east from Central Odaiba No. 1 (North) and we confirmed that traffic signal prediction information was received as shown in the figure at bottom right

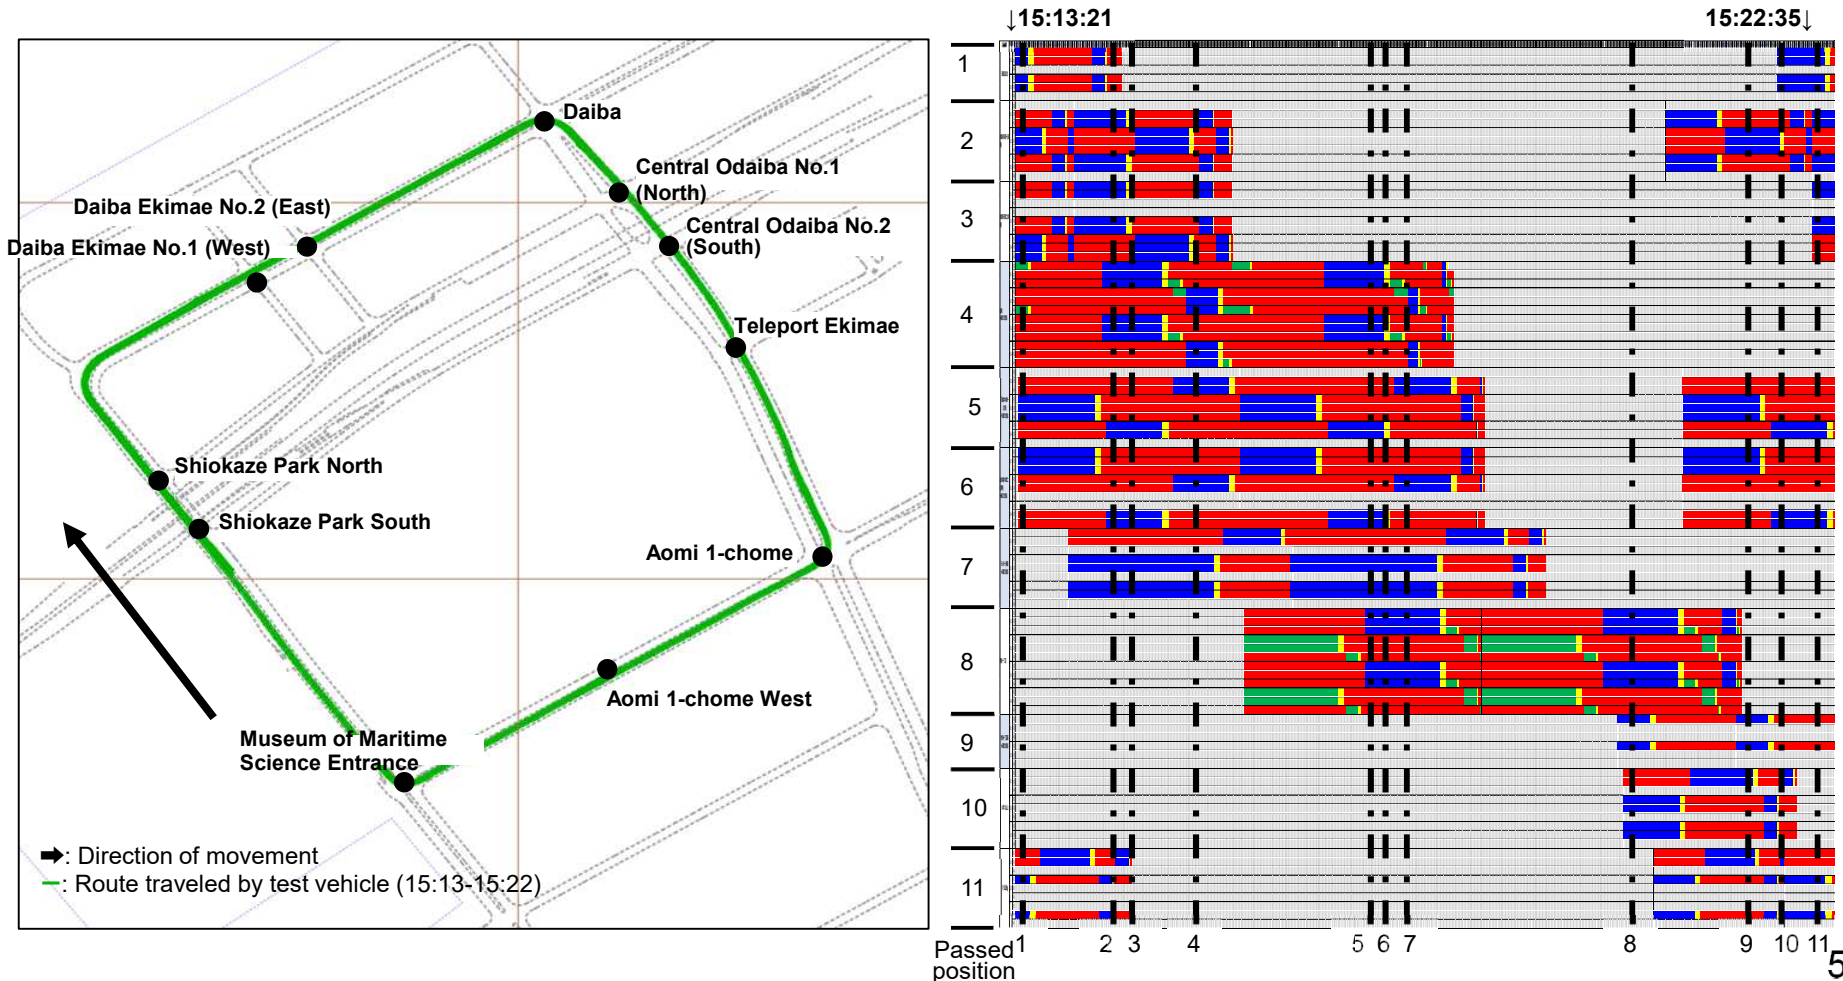
- Vehicles drove clockwise along the route, starting from Shiokaze Park North, and we confirmed that traffic signal prediction information was received as shown in the figure at bottom right
